# Senior Center

## Detailed Report

**Address: 21251 Stevens Creek Boulevard, Cupertino, CA 95014**

**Cupertino  
Facility Condition Assessment**

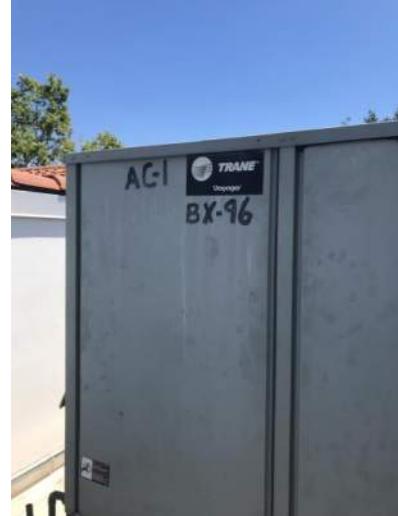
**Record ID** 442  
**System** D3030 - COOLING SYSTEMS

**Item No.** D3030.10.020  
**Floor/Room:** 1  
**Priority:** 2  
**Quantity/Unit of Measure:** 1/EA  
**Total Deficiency Cost:** \$139,200  
**Deficiency Description:** *Packaged AC unit is approaching the end of its expected useful life.*

**Comments:** *Packaged Unit*

**Description of Work:** *Provide equipment replacement and installation.*

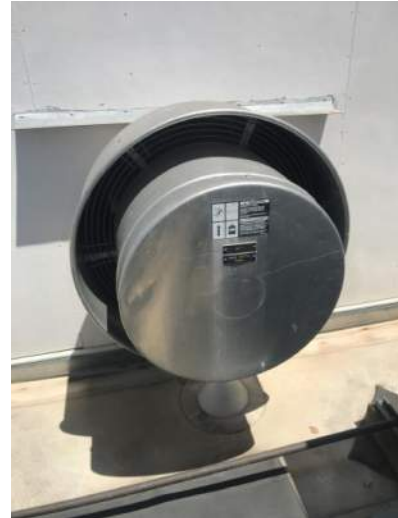
**Record ID** 443  
**System** D3060 - VENTILATION

**Item No.** D3060.30.005  
**Floor/Room:** Roof  
**Priority:** 4  
**Quantity/Unit of Measure:** 1/EA  
**Total Deficiency Cost:** \$8,360  
**Deficiency Description:** *Roof exhaust fan is approaching the end of its expected useful life.*

**Comments:** *Exhaust Fan*

**Description of Work:** *Provide equipment replacement and installation.*

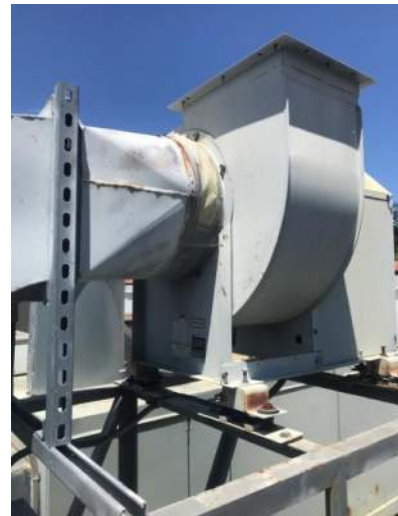
**Record ID** 444  
**System** D3060 - VENTILATION

**Item No.** D3060.30.011  
**Floor/Room:** Roof  
**Priority:** 4  
**Quantity/Unit of Measure:** 1/EA  
**Total Deficiency Cost:** \$18,970  
**Deficiency Description:** *Utility exhaust fan is approaching the end of its expected useful life.*

**Comments:** *Exhaust Fan*

**Description of Work:** *Provide equipment replacement and installation.*

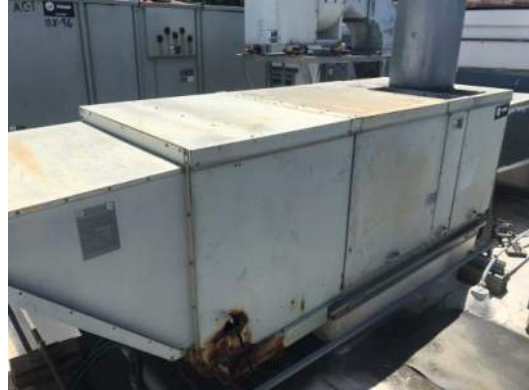
**Record ID** 445  
**System** D3050 - FACILITY HVAC DISTRIBUTION SYSTEMS  
**Item No.** D3050.50.006  
**Floor/Room:** Roof  
**Priority:** 2  
**Quantity/Unit of Measure:** 1/EA  
**Total Deficiency Cost:** \$78,310  
**Deficiency Description:** *Air handler is approaching the end of its expected useful life.*  
**Description of Work:** *Provide equipment replacement and installation.*  
**Comments:** *Air Handler*

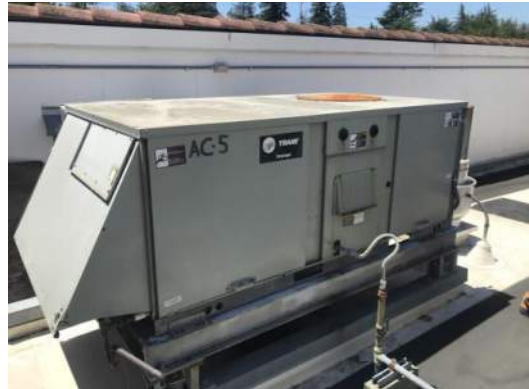
**Record ID** 446  
**System** D3030 - COOLING SYSTEMS  
**Item No.** D3030.10.018  
**Floor/Room:** Roof  
**Priority:** 2  
**Quantity/Unit of Measure:** 1/EA  
**Total Deficiency Cost:** \$52,230  
**Deficiency Description:** *Packaged AC unit is approaching the end of its expected useful life.*  
**Description of Work:** *Provide equipment replacement and installation.*  
**Comments:** *Packaged Unit*

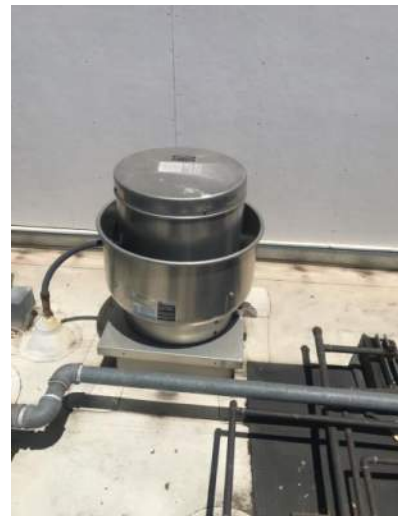
**Record ID** 447  
**System** D3060 - VENTILATION  
**Item No.** D3060.30.005  
**Floor/Room:** Roof  
**Priority:** 4  
**Quantity/Unit of Measure:** 1/EA  
**Total Deficiency Cost:** \$8,360  
**Deficiency Description:** *Roof exhaust fan is approaching the end of its expected useful life.*  
**Description of Work:** *Provide equipment replacement and installation.*  
**Comments:** *Exhaust Fan*

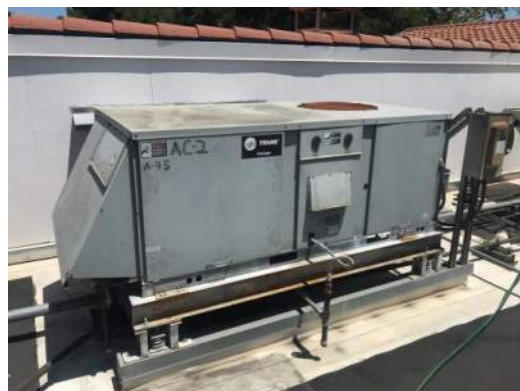
**Record ID** 448  
**System** D3030 - COOLING SYSTEMS

**Item No.** D3030.10.018  
**Floor/Room:** Roof  
**Priority:** 2  
**Quantity/Unit of Measure:** 1/EA  
**Total Deficiency Cost:** \$52,230  
**Deficiency Description:** *Packaged AC unit is approaching the end of its expected useful life.*

**Comments:** *Packaged Unit*

**Description of Work:** *Provide equipment replacement and installation.*

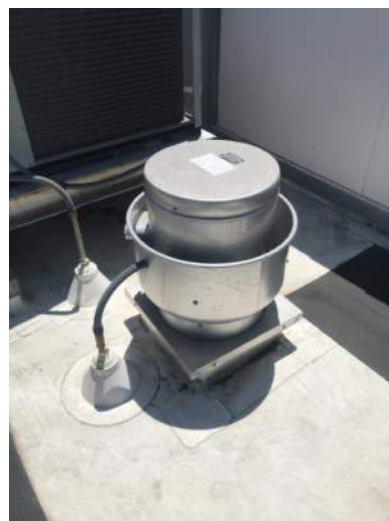
**Record ID** 449  
**System** D3060 - VENTILATION

**Item No.** D3060.30.005  
**Floor/Room:** Roof  
**Priority:** 4  
**Quantity/Unit of Measure:** 1/EA  
**Total Deficiency Cost:** \$8,360  
**Deficiency Description:** *Roof exhaust fan is approaching the end of its expected useful life.*

**Comments:** *Exhaust Fan*

**Description of Work:** *Provide equipment replacement and installation.*

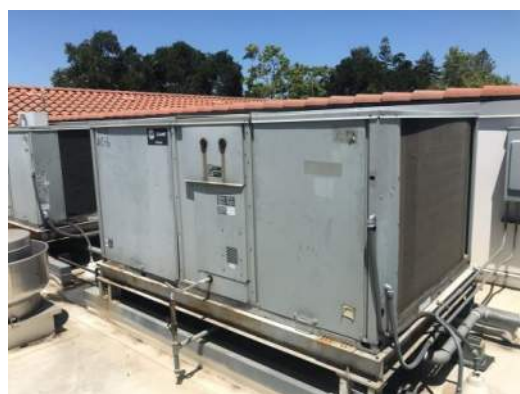
**Record ID** 450  
**System** D3030 - COOLING SYSTEMS

**Item No.** D3030.10.019  
**Floor/Room:** Roof  
**Priority:** 2  
**Quantity/Unit of Measure:** 1/EA  
**Total Deficiency Cost:** \$87,030  
**Deficiency Description:** *Packaged AC unit is approaching the end of its expected useful life.*

**Comments:** *Packaged Unit*

**Description of Work:** *Provide equipment replacement and installation.*

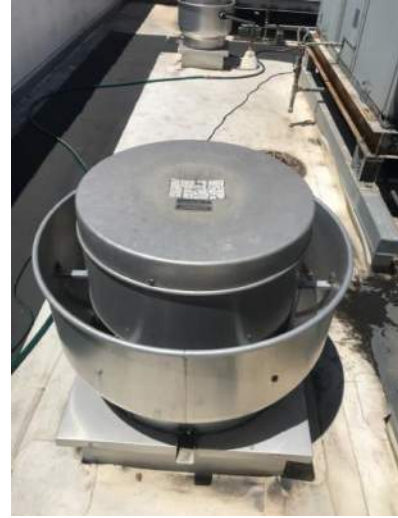
**Record ID** 451  
**System** D3060 - VENTILATION

**Item No.** D3060.30.005  
**Floor/Room:** Roof  
**Priority:** 4  
**Quantity/Unit of Measure:** 1/EA  
**Total Deficiency Cost:** \$8,360  
**Deficiency Description:** *Roof exhaust fan is approaching the end of its expected useful life.*

**Comments:** *Exhaust Fan*

**Description of Work:** *Provide equipment replacement and installation.*

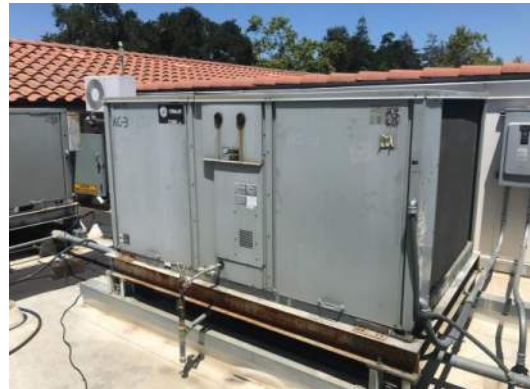
**Record ID** 452  
**System** D3030 - COOLING SYSTEMS

**Item No.** D3030.10.019  
**Floor/Room:** Roof  
**Priority:** 2  
**Quantity/Unit of Measure:** 1/EA  
**Total Deficiency Cost:** \$87,030  
**Deficiency Description:** *Packaged AC unit is approaching the end of its expected useful life.*

**Comments:** *Packaged Unit*

**Description of Work:** *Provide equipment replacement and installation.*

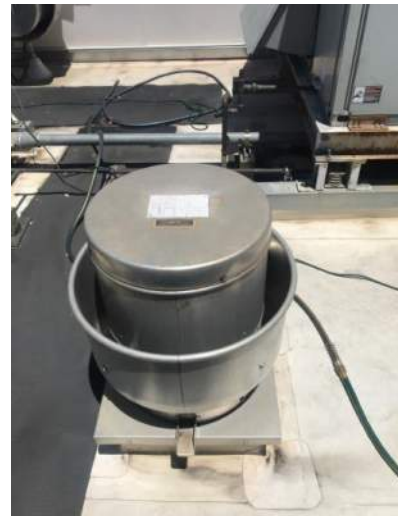
**Record ID** 453  
**System** D3060 - VENTILATION

**Item No.** D3060.30.005  
**Floor/Room:** Roof  
**Priority:** 4  
**Quantity/Unit of Measure:** 1/EA  
**Total Deficiency Cost:** \$8,360  
**Deficiency Description:** *Roof exhaust fan is approaching the end of its expected useful life.*

**Comments:** *Exhaust Fan*

**Description of Work:** *Provide equipment replacement and installation.*

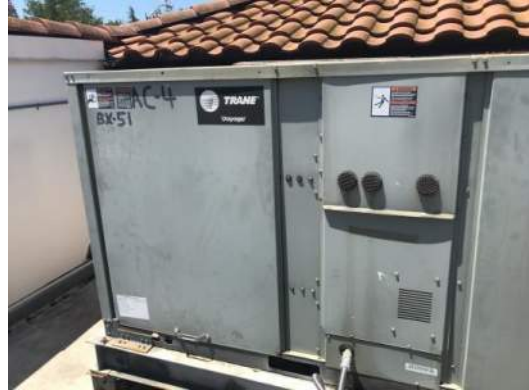
**Record ID** 454  
**System** D3030 - COOLING SYSTEMS

**Item No.** D3030.10.019  
**Floor/Room:** Roof  
**Priority:** 2  
**Quantity/Unit of Measure:** 1/EA  
**Total Deficiency Cost:** \$87,030  
**Deficiency Description:** *Packaged AC unit is approaching the end of its expected useful life.*

**Comments:** *Packaged Unit*

**Description of Work:** *Provide equipment replacement and installation.*

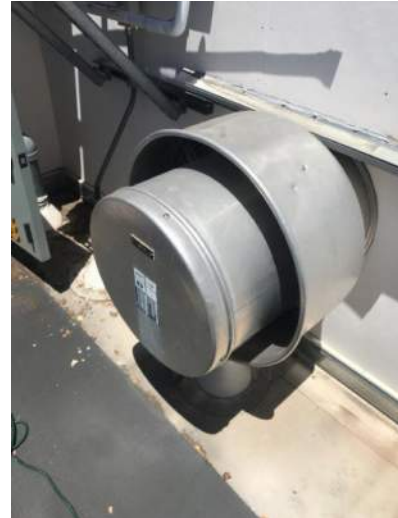
**Record ID** 455  
**System** D3060 - VENTILATION

**Item No.** D3060.30.005  
**Floor/Room:** Roof  
**Priority:** 4  
**Quantity/Unit of Measure:** 1/EA  
**Total Deficiency Cost:** \$8,360  
**Deficiency Description:** *Roof exhaust fan is approaching the end of its expected useful life.*

**Comments:** *Exhaust Fan*

**Description of Work:** *Provide equipment replacement and installation.*

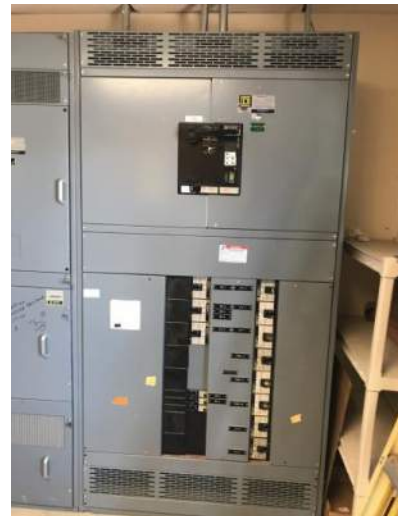
**Record ID** 457  
**System** D5020 - ELECTRICAL SERVICE AND DISTRIBUTION

**Item No.** D5020.10.305  
**Floor/Room:** 1  
**Priority:** 3  
**Quantity/Unit of Measure:** 1/EA  
**Total Deficiency Cost:** \$37,430  
**Deficiency Description:** *The 1000A metered main switchboard (3P, 120/208 ) is approaching the end of its expected useful life.*

**Comments:** *Metered Switchboard*

**Description of Work:** *Replace the existing metered main switchboard with a new metered main switchboard.*

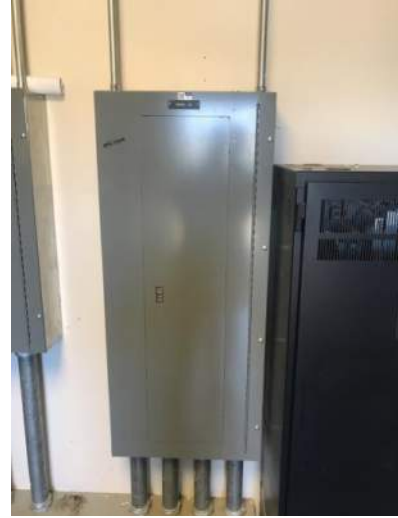
**Record ID** 461  
**System** D5020 - ELECTRICAL SERVICE AND DISTRIBUTION  
**Item No.** D5020.30.1008  
**Floor/Room:** 1  
**Priority:** 3  
**Quantity/Unit of Measure:** 1/EA  
**Total Deficiency Cost:** \$21,020  
**Deficiency Description:** *The 225A (120/208, 3P) panelboard is past its expected useful life.*  
**Description of Work:** *Replace the existing panelboard with a new panelboard.*  
**Comments:** *Panelboard*

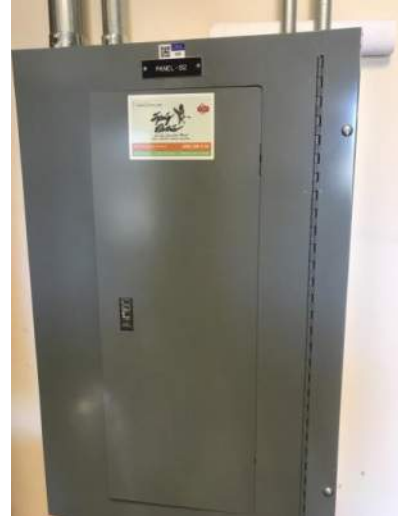
**Record ID** 462  
**System** D5020 - ELECTRICAL SERVICE AND DISTRIBUTION  
**Item No.** D5020.30.1008  
**Floor/Room:** 1  
**Priority:** 3  
**Quantity/Unit of Measure:** 1/EA  
**Total Deficiency Cost:** \$21,020  
**Deficiency Description:** *The 225A (120/208, 3P) panelboard is past its expected useful life.*  
**Description of Work:** *Replace the existing panelboard with a new panelboard.*  
**Comments:** *Panelboard*

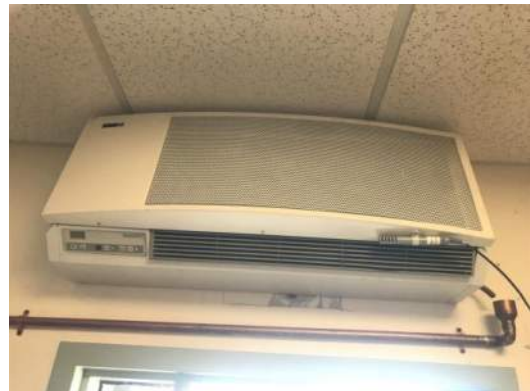
**Record ID** 464  
**System** D3030 - COOLING SYSTEMS  
**Item No.** D3030.70.043  
**Floor/Room:** 1  
**Priority:** 3  
**Quantity/Unit of Measure:** 1/EA  
**Total Deficiency Cost:** \$30,830  
**Deficiency Description:** *Split system with fan coil and outdoor condensing unit is approaching the end of its expected useful life.*  
**Description of Work:** *Provide equipment replacement and installation.*  
**Comments:** *Mini Split*

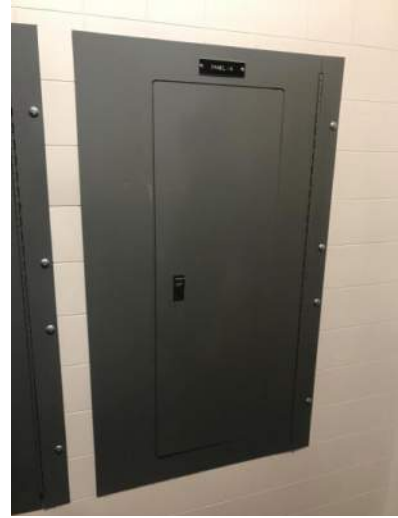
**Record ID** 476  
**System** D5020 - ELECTRICAL SERVICE AND DISTRIBUTION  
**Item No.** D5020.30.1008  
**Floor/Room:** 1 / Kitchen  
**Priority:** 3  
**Quantity/Unit of Measure:** 1/EA  
**Total Deficiency Cost:** \$21,020  
**Deficiency Description:** *The 225A (120/208, 3P) panelboard is past its expected useful life.*

**Comments:** *Panelboard*

**Description of Work:** *Replace the existing panelboard with a new panelboard.*

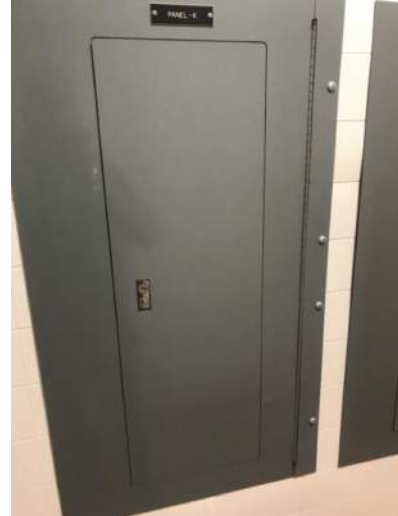
**Record ID** 477  
**System** D5020 - ELECTRICAL SERVICE AND DISTRIBUTION  
**Item No.** D5020.30.1008  
**Floor/Room:** 1 / Kitchen  
**Priority:** 3  
**Quantity/Unit of Measure:** 1/EA  
**Total Deficiency Cost:** \$21,020  
**Deficiency Description:** *The 225A (120/208, 3P) panelboard is past its expected useful life.*

**Comments:** *Panelboard*

**Description of Work:** *Replace the existing panelboard with a new panelboard.*
