# BRIDGE INSPECTION REPORT

## Routine Inspection

BRIDGE NO.:  
**37C0220**

STRUCTURE NAME:  
**STEVENS CREEK**

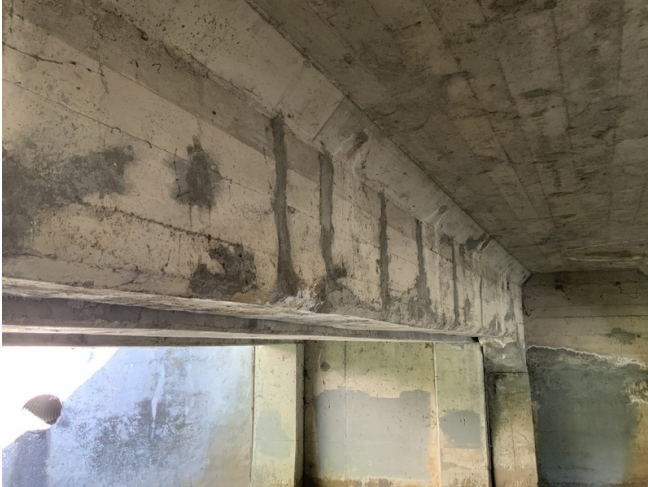
Photo 1

| Elem No. | Defect/Prot Defect | Element Description | Env | Total Qty | Units | Qty in each Condition State | | | |
|---|---|---|---|---|---|---|---|---|---|
| There are patched areas of various sizes throughout Girders 3 through 6. See Photo 1. | | | | | | | | | |

Typical patched girder areas, as seen on Girder 3

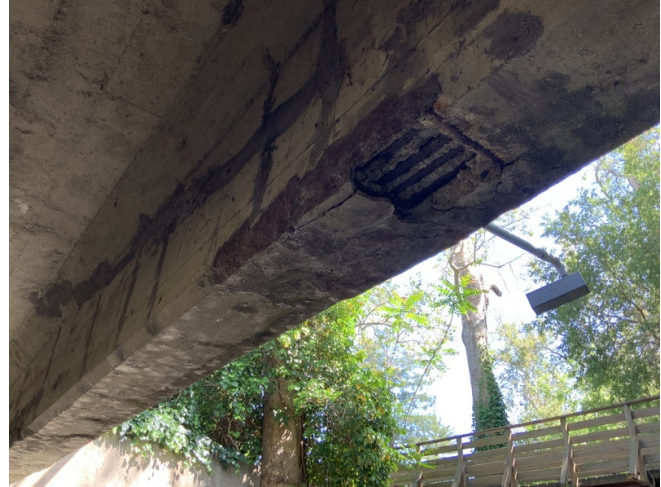
Photo 2

| Elem No. | Defect/Prot Defect | Element Description | Env | Total Qty | Units | Qty in each Condition State | | | |
|---|---|---|---|---|---|---|---|---|---|
| The bottom of Girder 6 has a spalled area near the quarter span point. This spall is approximately 2 feet long by 12 inches wide by 2.5 inches deep with exposed, lightly corroded rebars. See Photo 2. | | | | | | | | | |

Spall with exposed rebar in the bottom of Girder 6

| Chip out any unsound concrete in Girder 6. Clean and patch with a suitable material. (Revised 05/31/22 L. Nash) | | | | | | |

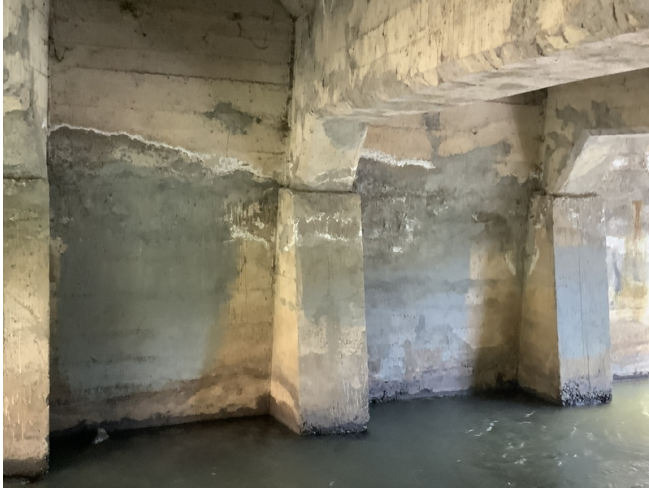
The original portion of the abutments has numerous patched areas of various sizes. See Photo 3.

Photo 3  
Patched areas on Abutment 2

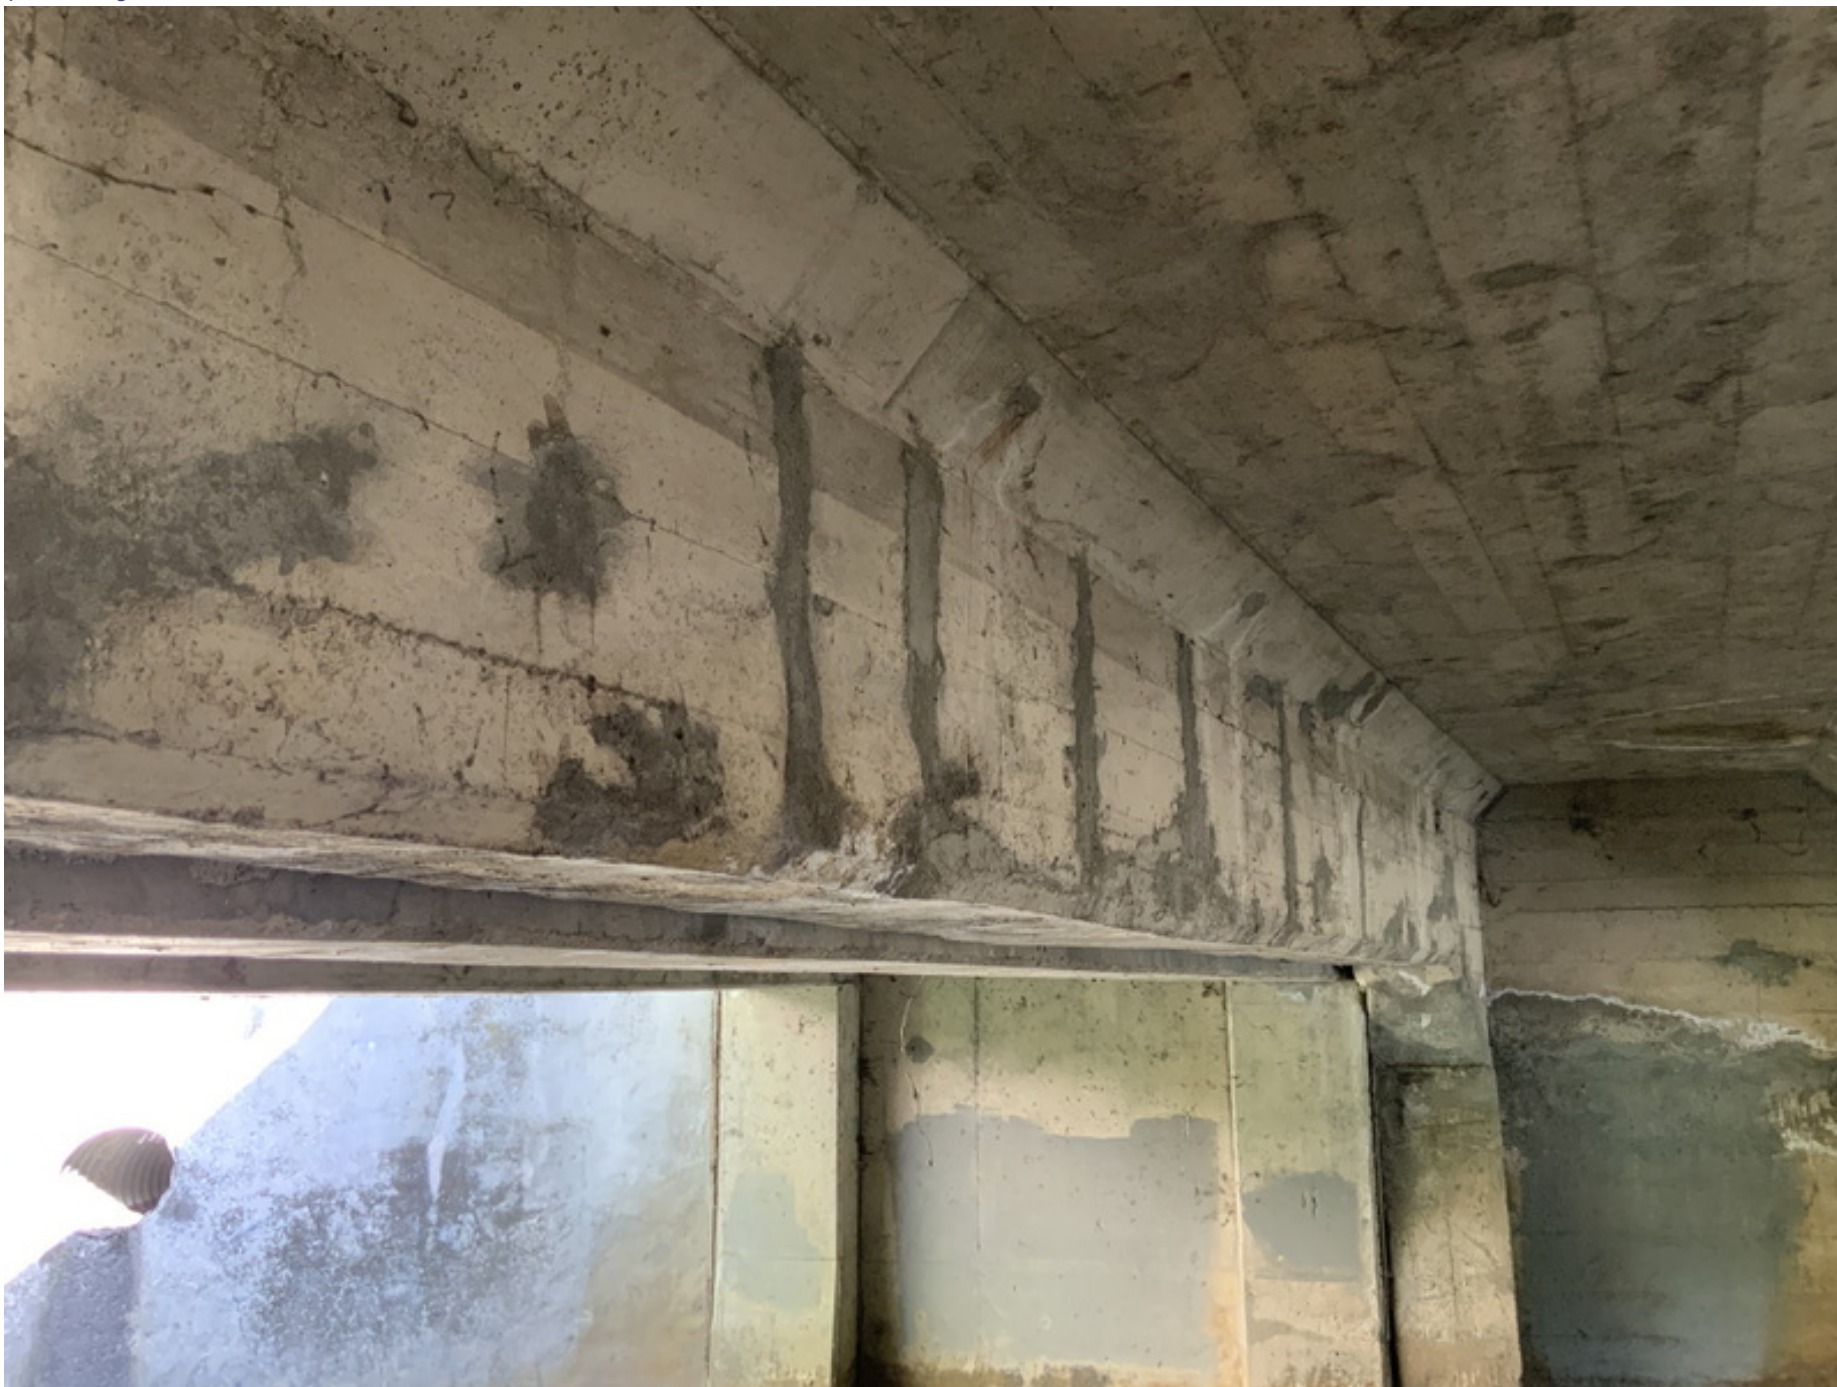
Photo #1

Typical patched girder areas, as seen on Girder 3

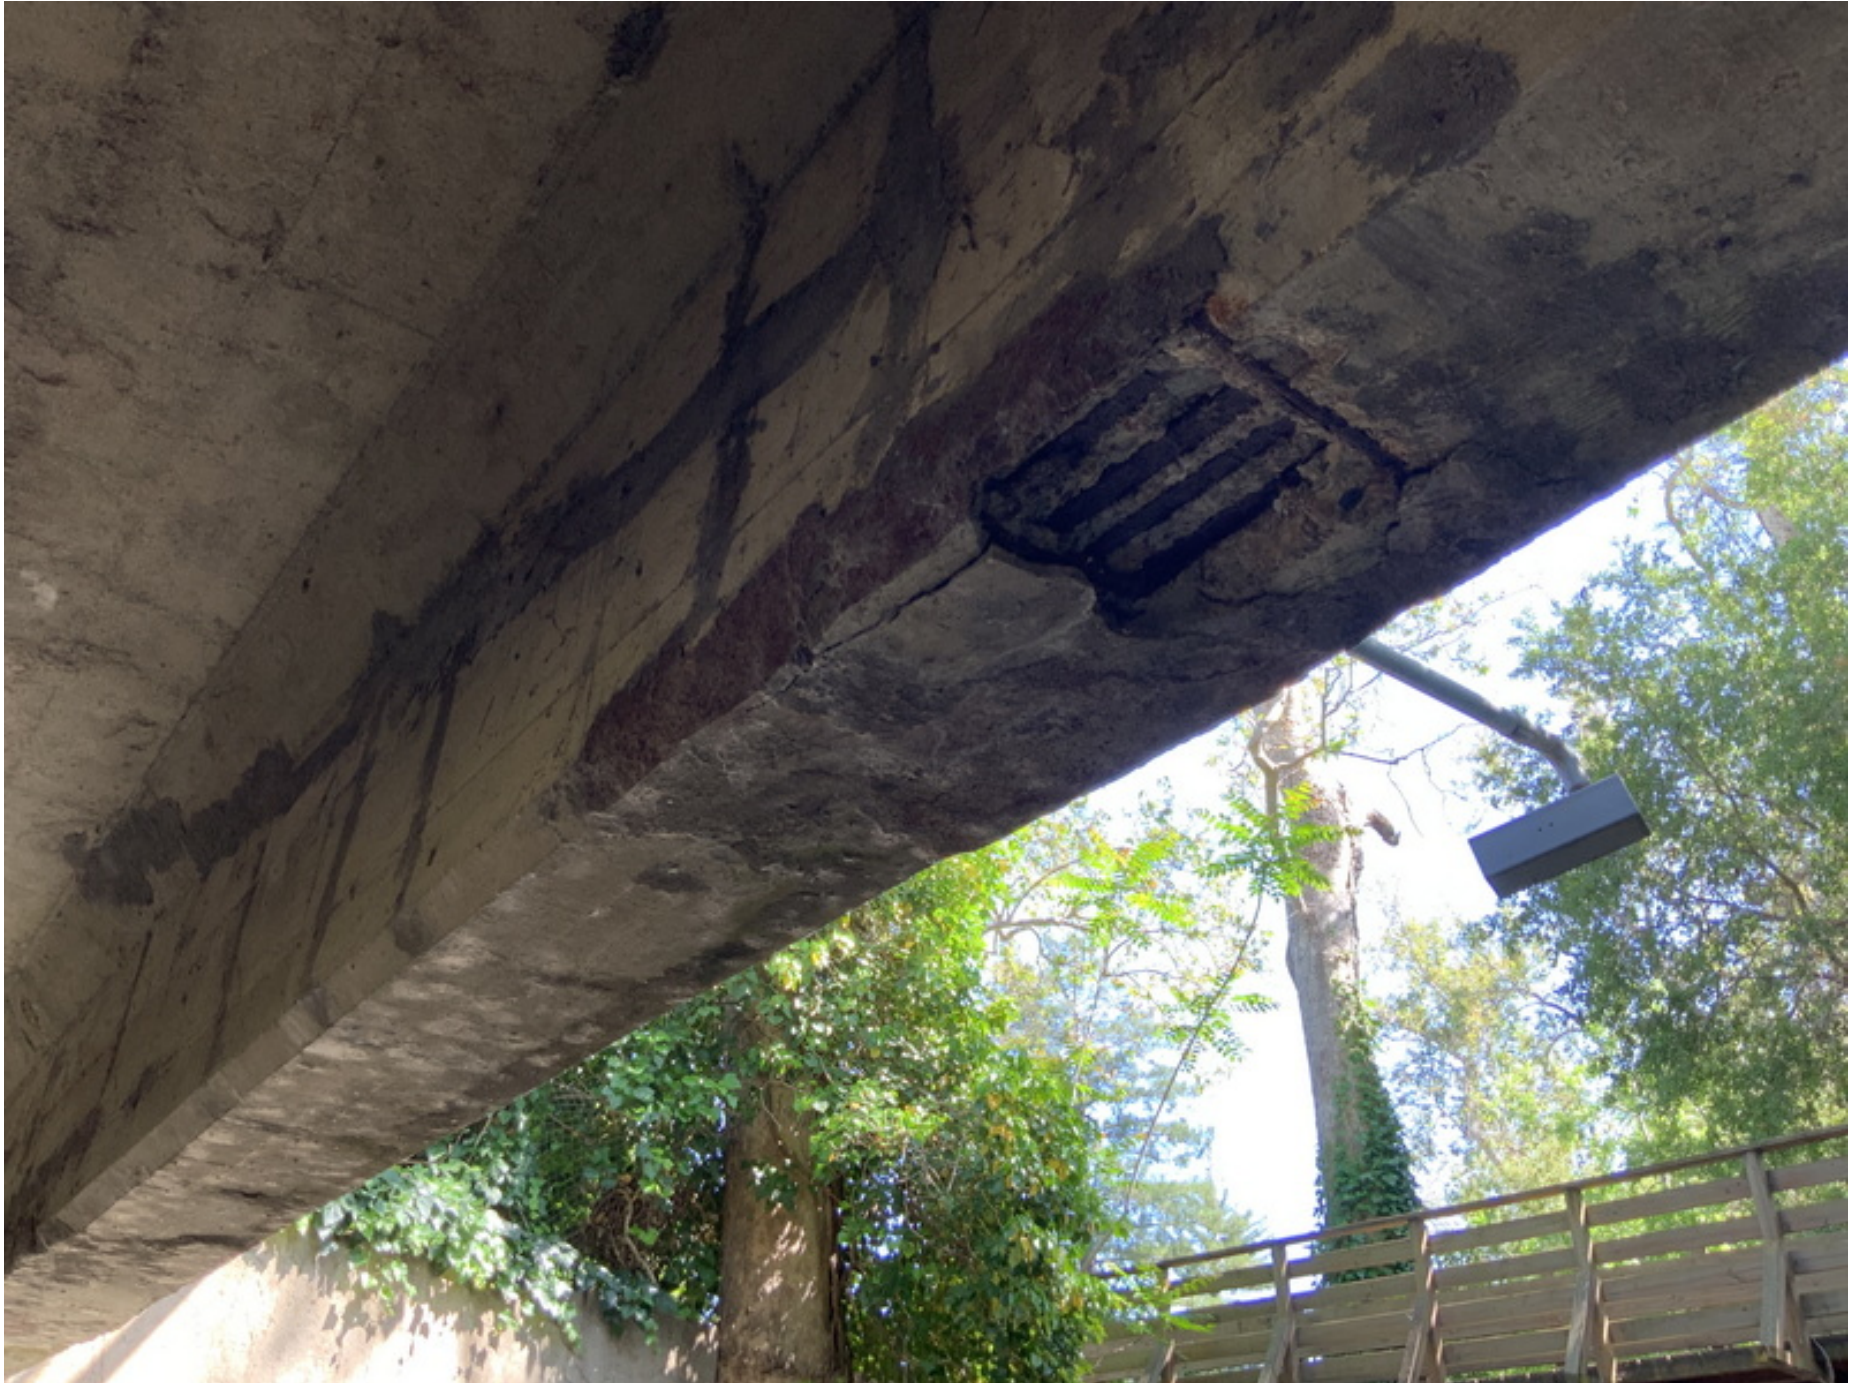
Photo #2  
Spall with exposed rebar in the bottom of Girder 6

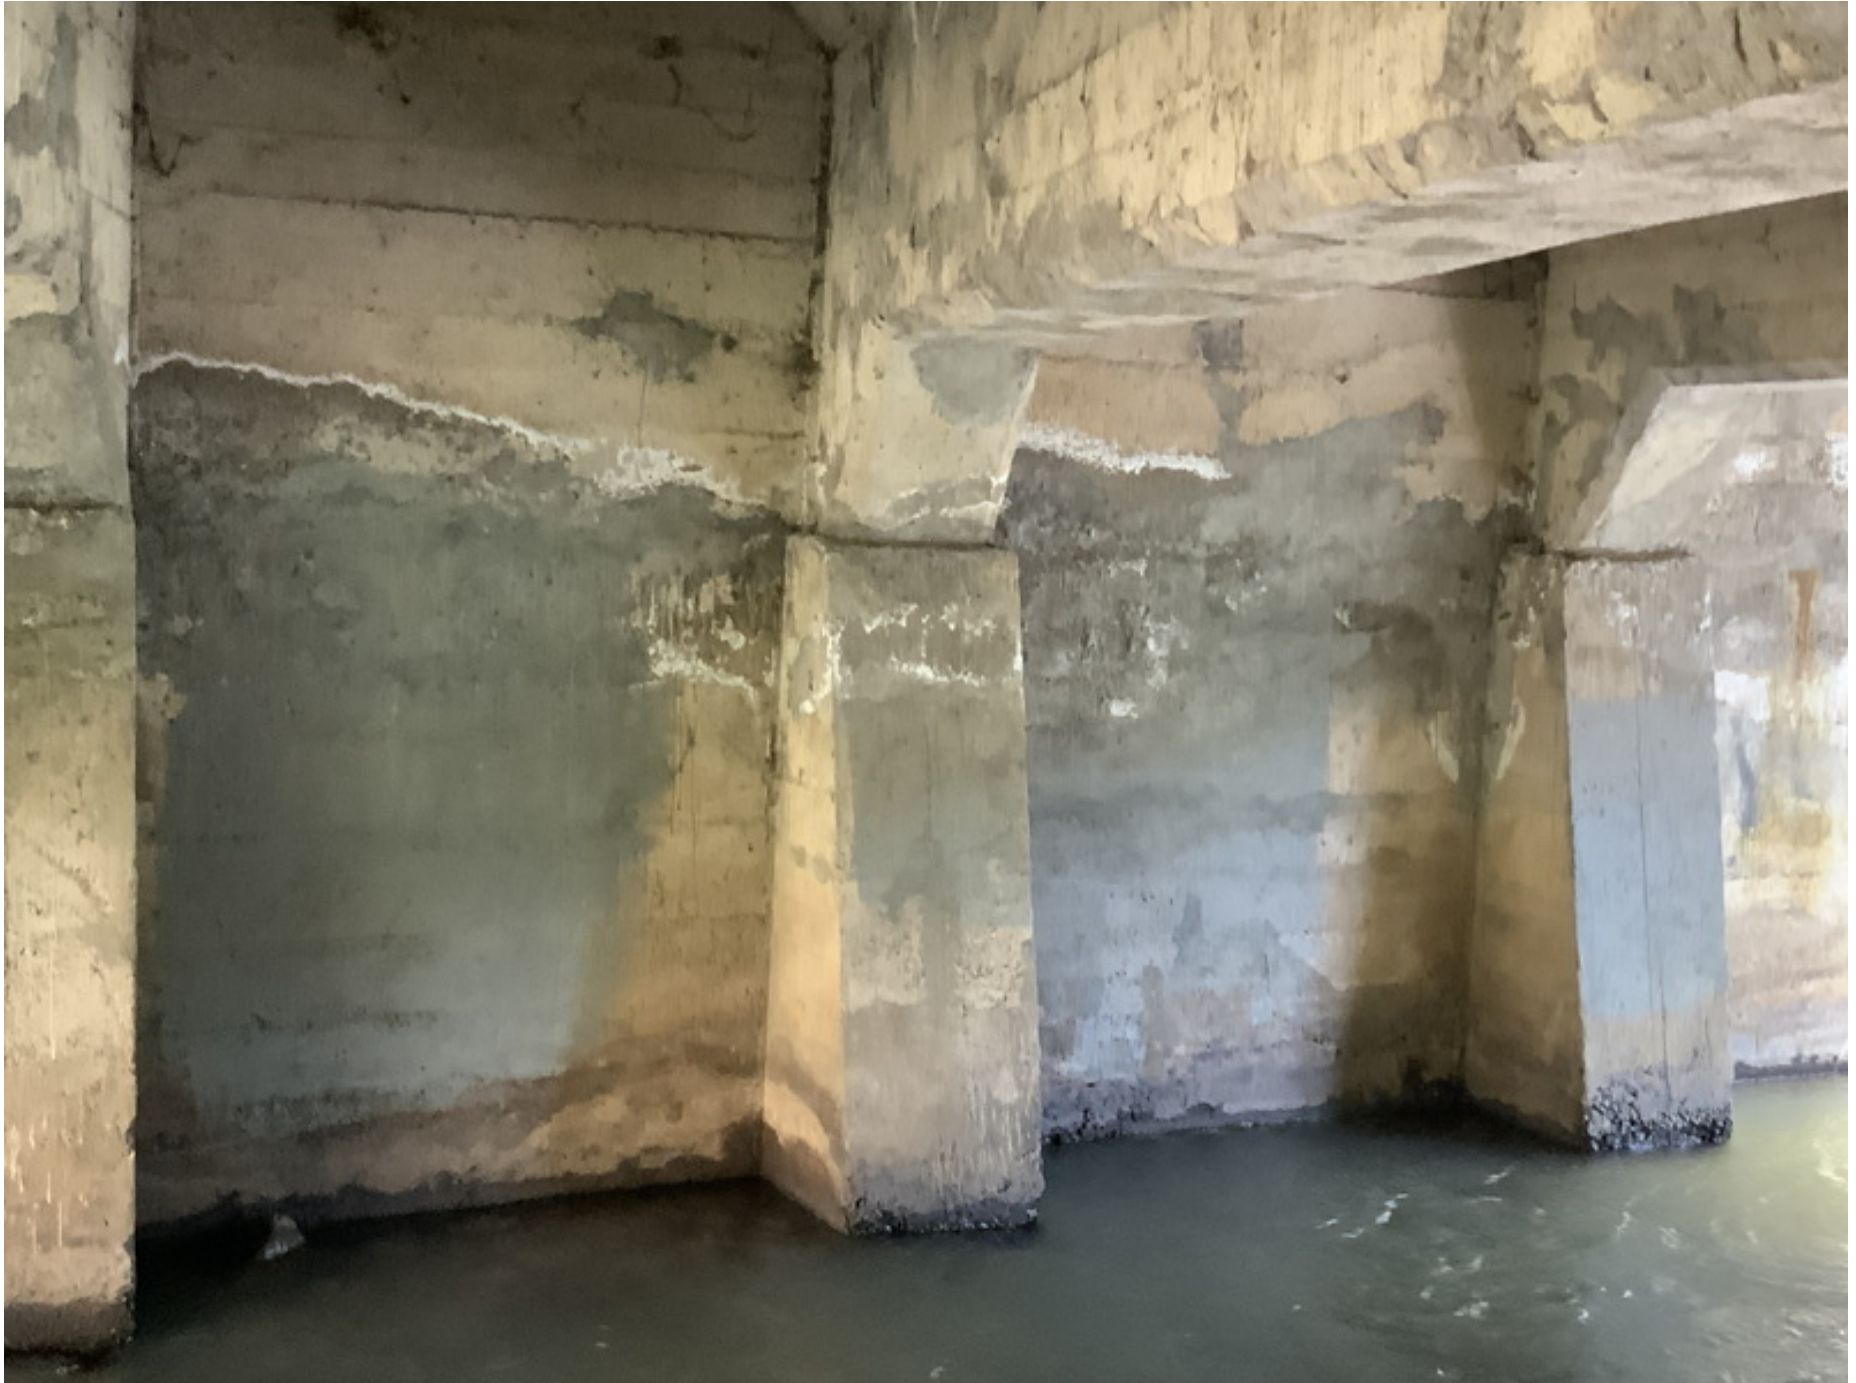
Photo #3

Patched areas on Abutment 2
