# ARBORIST REPORT AND TREE PROTECTION PLAN

10046 Bianchi Way, Cupertino CA 95014  
July 2023

Arborist Report & Tree Protection Plan for  
10046 Bianchi Way  
Cupertino, California 95014

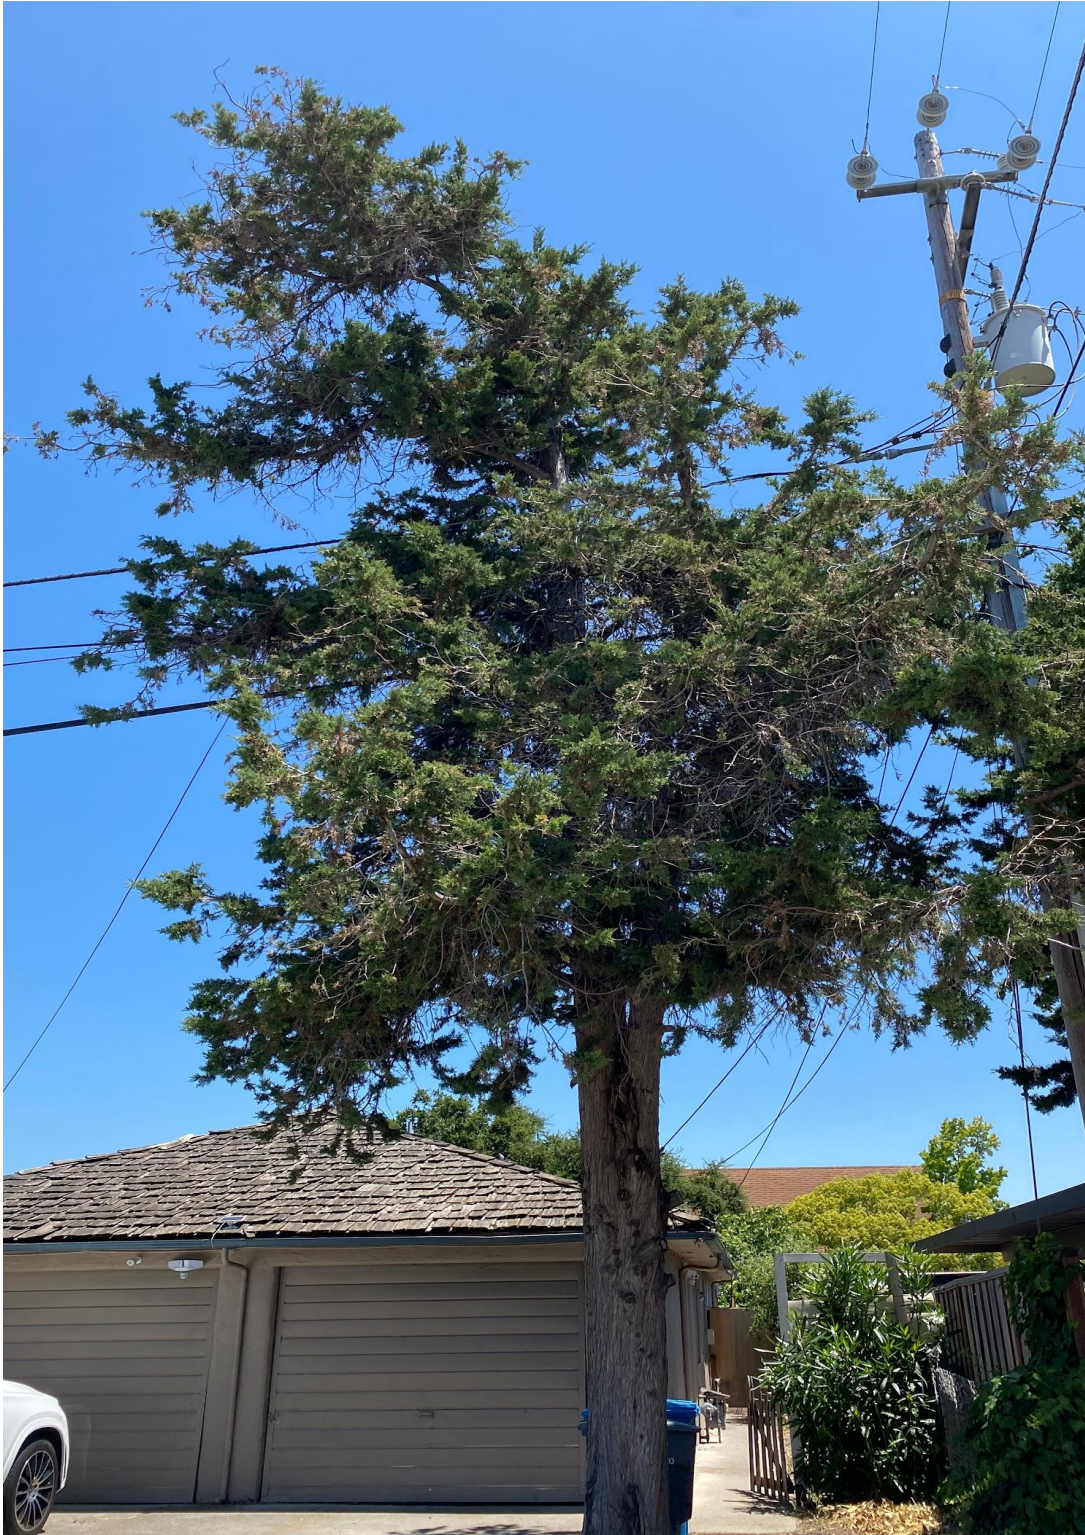
**Photo 1. Tree #1 is a Monterey cypress in poor condition that will be removed for the project**

- Trees 1, 6, 7, 8, and 9 are within the footprint of the proposed construction and will require removal.
- Trees 5 and 10 are both in poor condition and the impact of the demolition and construction on the CRZ of the trees will be too significant, requiring these trees to be removed as well.

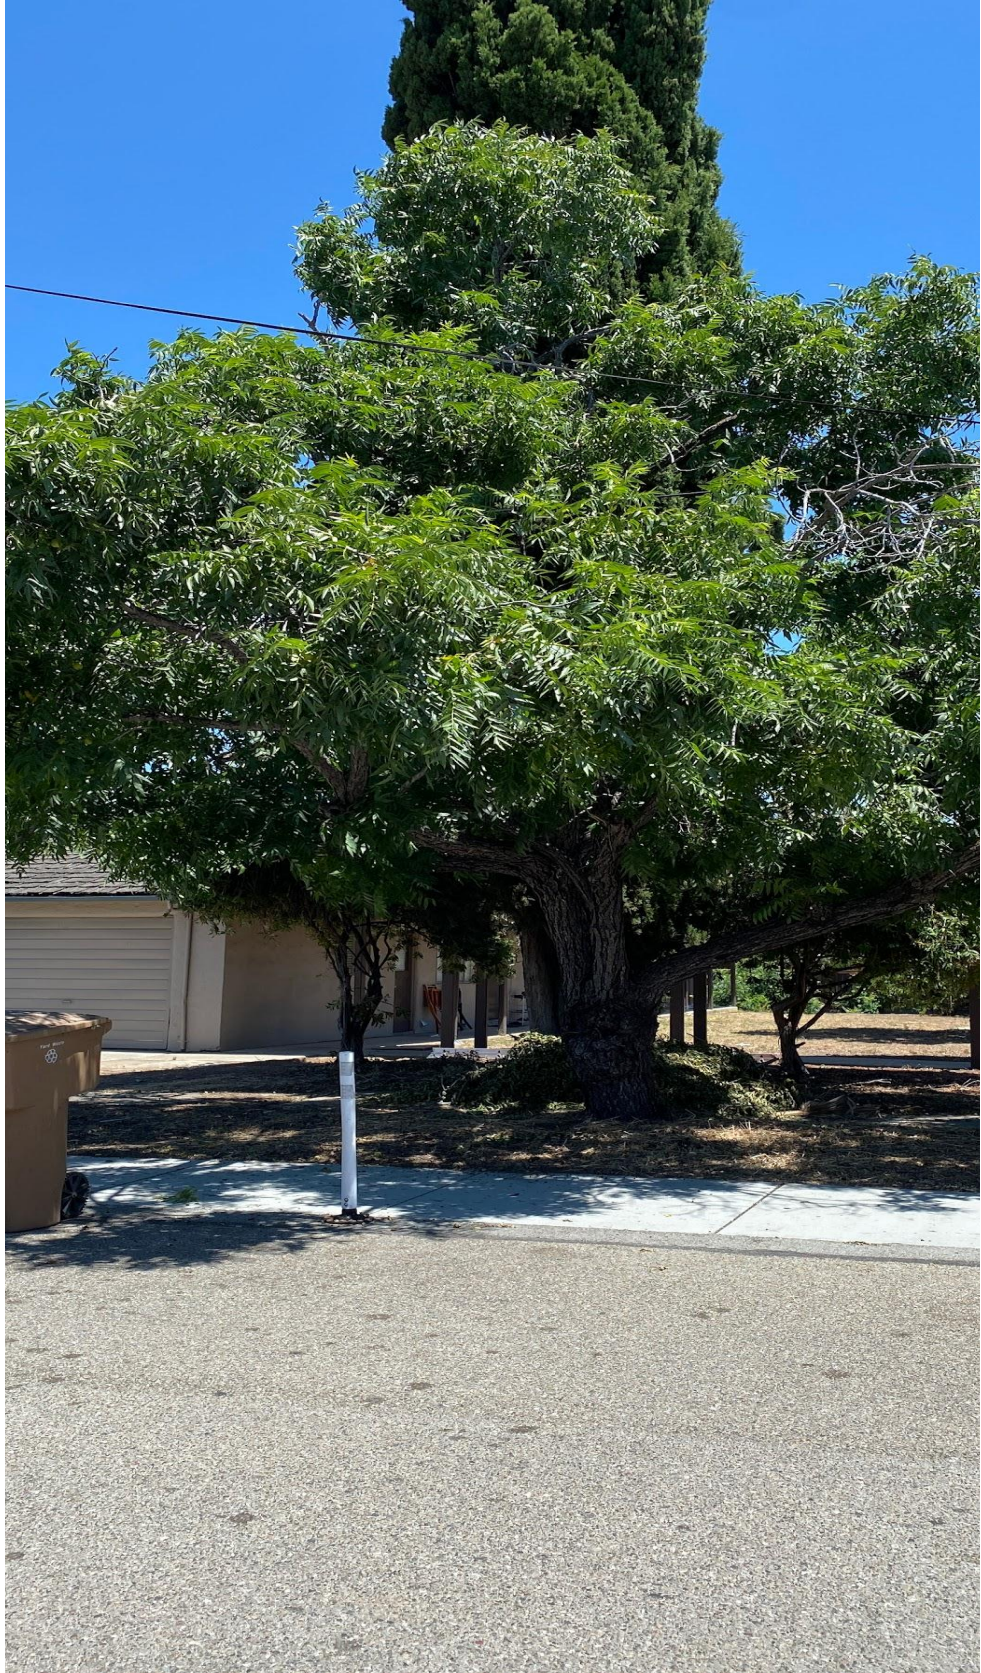
**Photo 2. Tree #5 is in poor condition and will be removed for the project.**

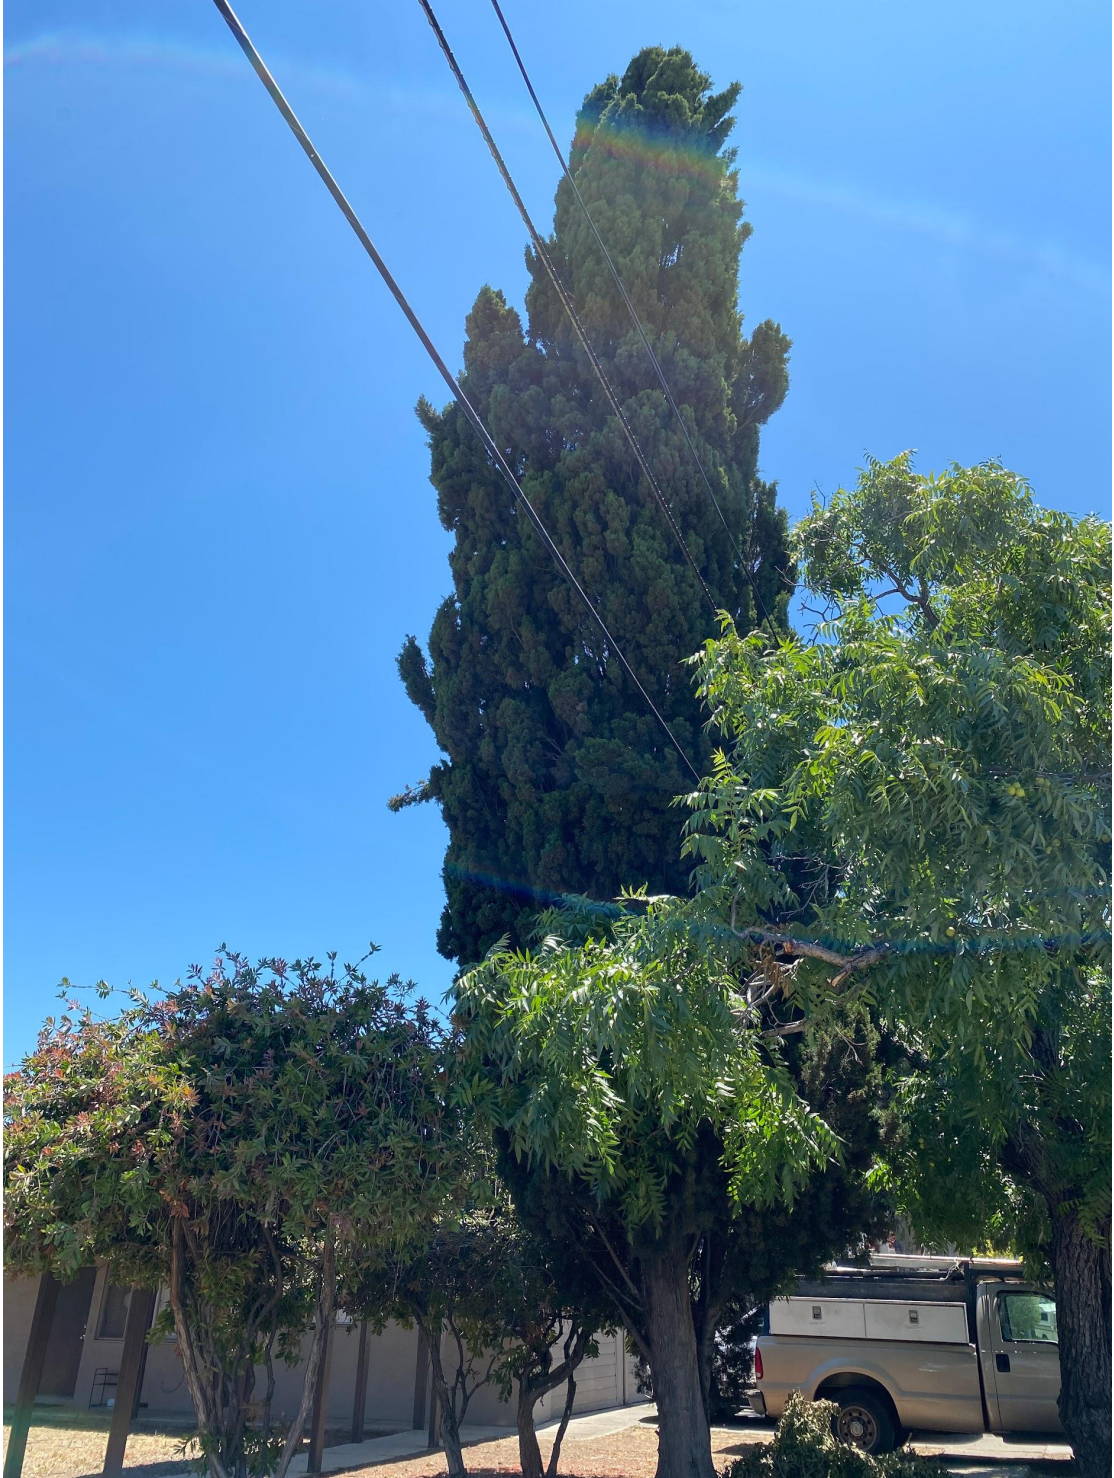
**Photo 3. Tree #6 is in goof condition, but is in the footprint of the proposed project and will require removal**

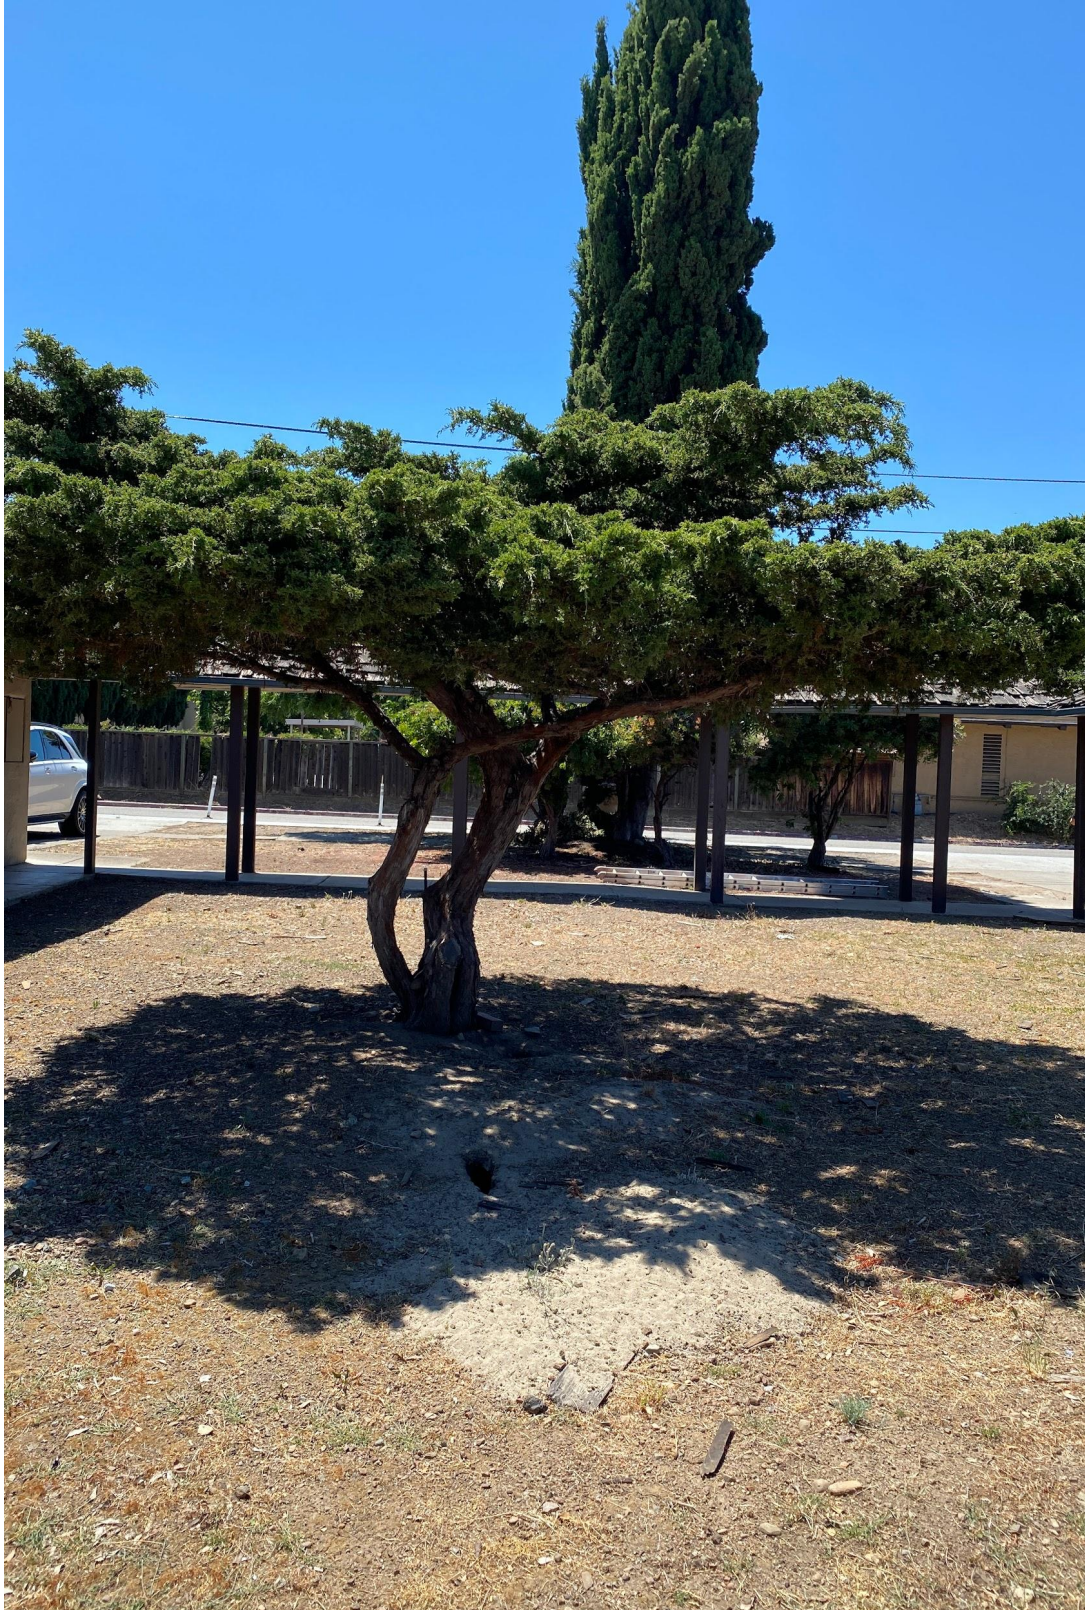
**Photo 4. Tree #7 is in good condition but is in the footprint of the planned construction and will require removal**

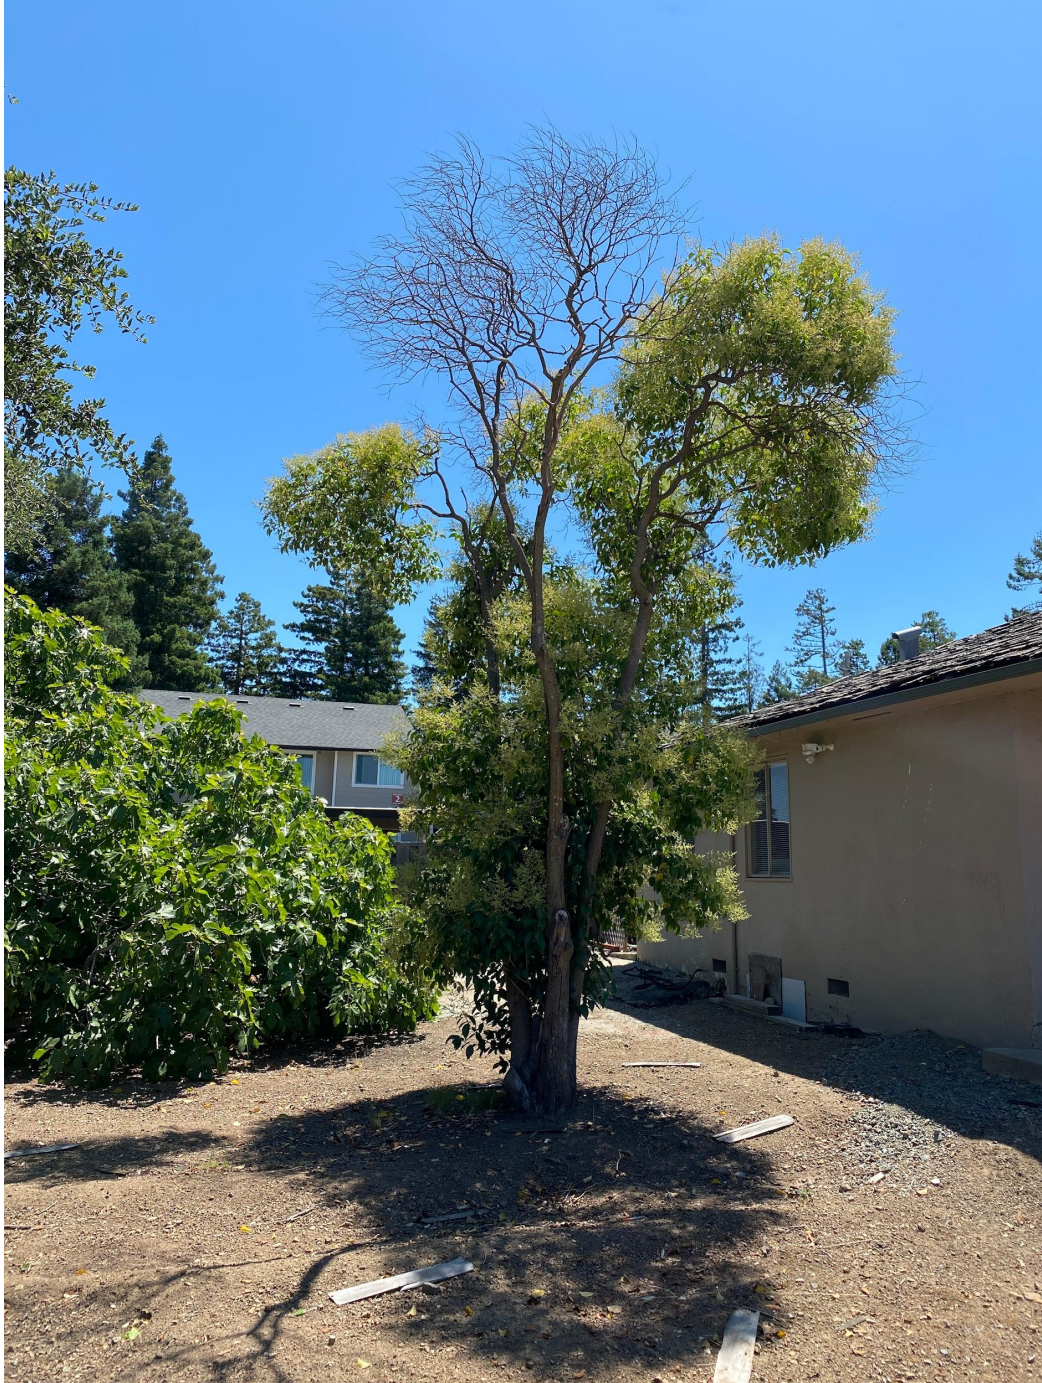
**Photo 5. Tree #8 is in poor condition and will be removed as part of the project**

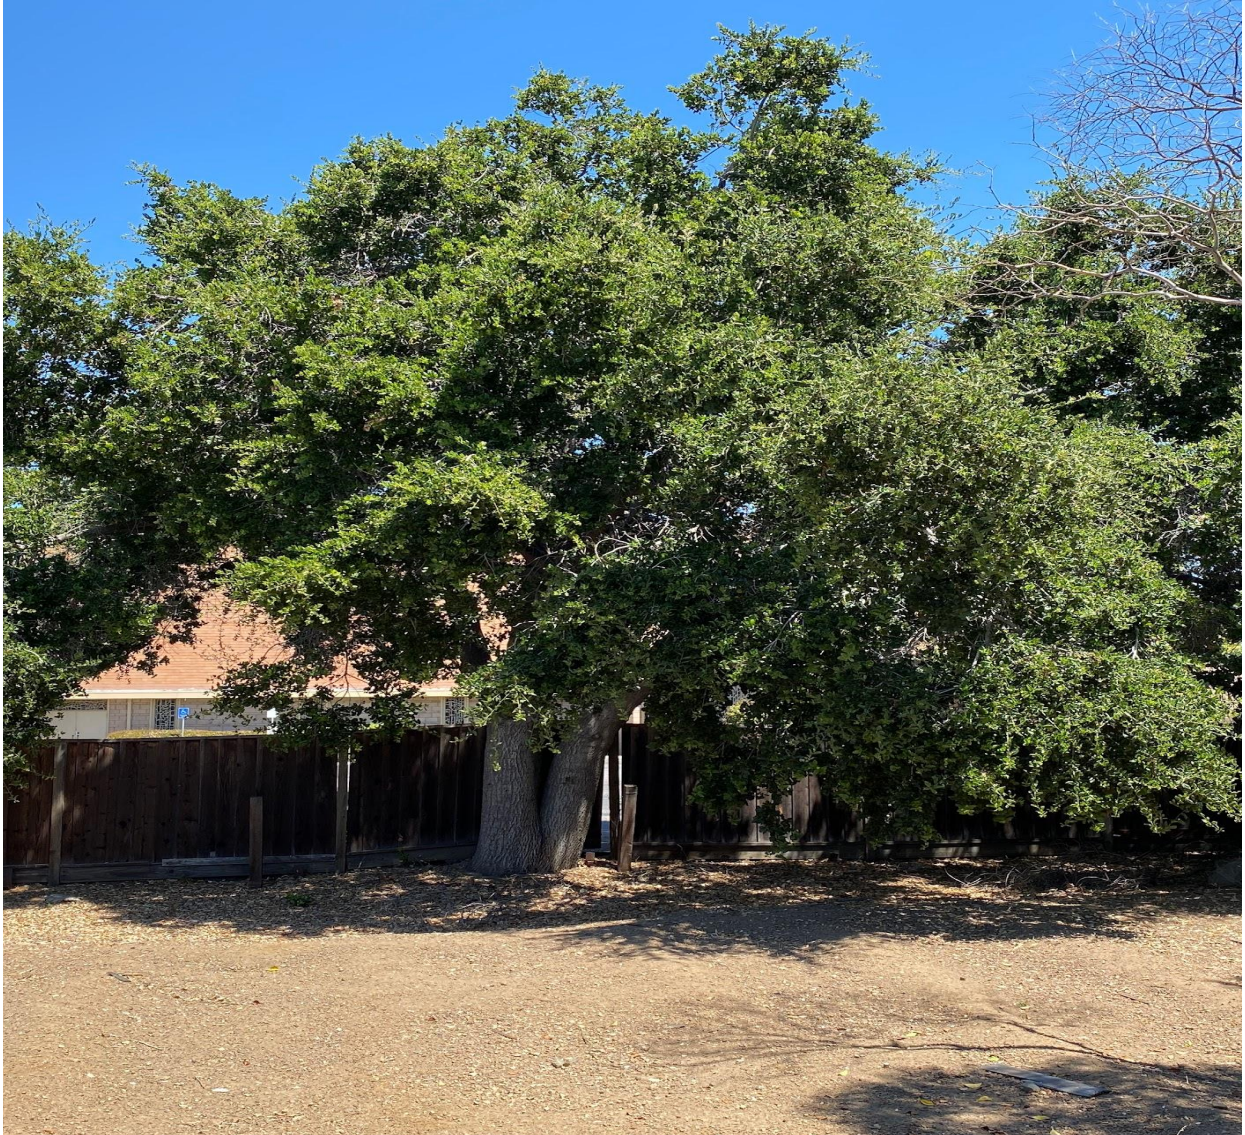
Tree 9 is at the back property line. It is pushing the good neighbor fence and has caused damage to the parking lot of the church on the other side of the fence from the subject property. Due to the location of this tree directly on the property line, this tree appears to be a volunteer that was allowed to mature over time.

The planned construction is scheduled to have excavation within less than 7 ft of this tree’s trunk, putting trenching right through the middle of the 17 ft SRZ, which is the area of the root zone, which cannot be disturbed due to severe risk of health or structural impacts (see Root Zone Calculations section for more details), and well into the 38.5 ft CRZ, which is the area where minimal disturbance should take place. *Quercus agrifolia* has a low tolerance for root damage, and an impact this severe is likely to be catastrophic to the health and/or structure of this tree, contributing to an untimely decline or tree failure. Without making significant plan changes, which will affect the density usage of this parcel, retaining this tree is not advised. Even with design changes, the tree will need to undergo significant root pruning, which may still affect the health and structure, but also is likely to result in reaction growth of new roots that will damage the hardscape and foundations of the new homes, leading to costly repairs and the removal of this tree within as few as five to ten years. Removal of tree 9 is recommended.

**Photo 6. Tree #9, located on the property line, will have significant construction impacts and requires removal**

9	Coast live oak	80%	65%	70%	Y	Y	Buried Root Collar, Included Bark/Weak Union, Co-Dominant Stems, Large Deadwood (3"+), Small Deadwood (1-2"), Branch Decay
10	Common fig	85%	30%	30%	Y	Y	Trunk Decay, Included Bark/Weak Union, Co-Dominant Stems, Broken Limbs, Tree has already failed
11	Monterey cypress	80%	60%	60%	N	N	Small Deadwood (1-2"), Overhead Utilities

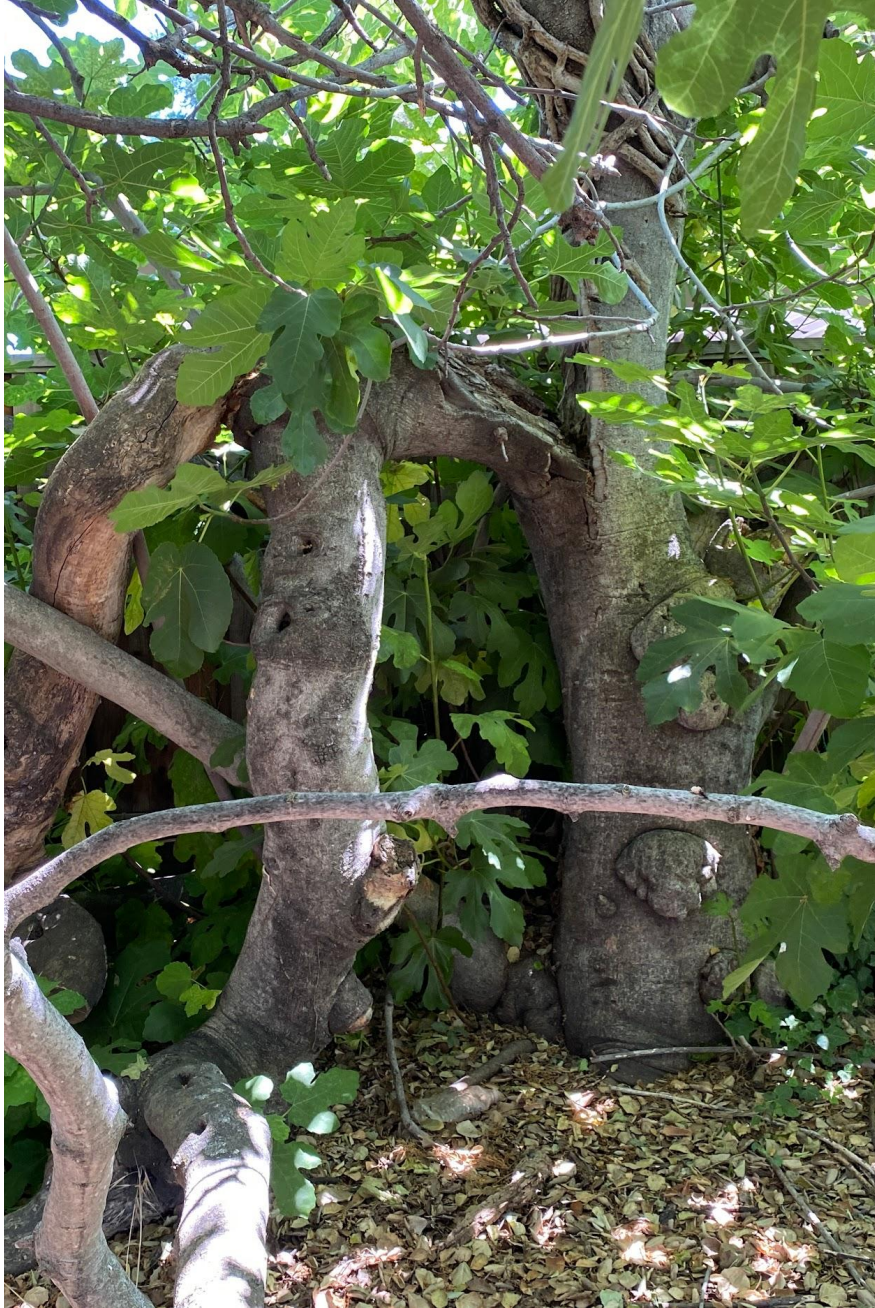
**Photo 7. Tree #10 is a poor-condition fig tree in partial failure that will be removed as part of the project**

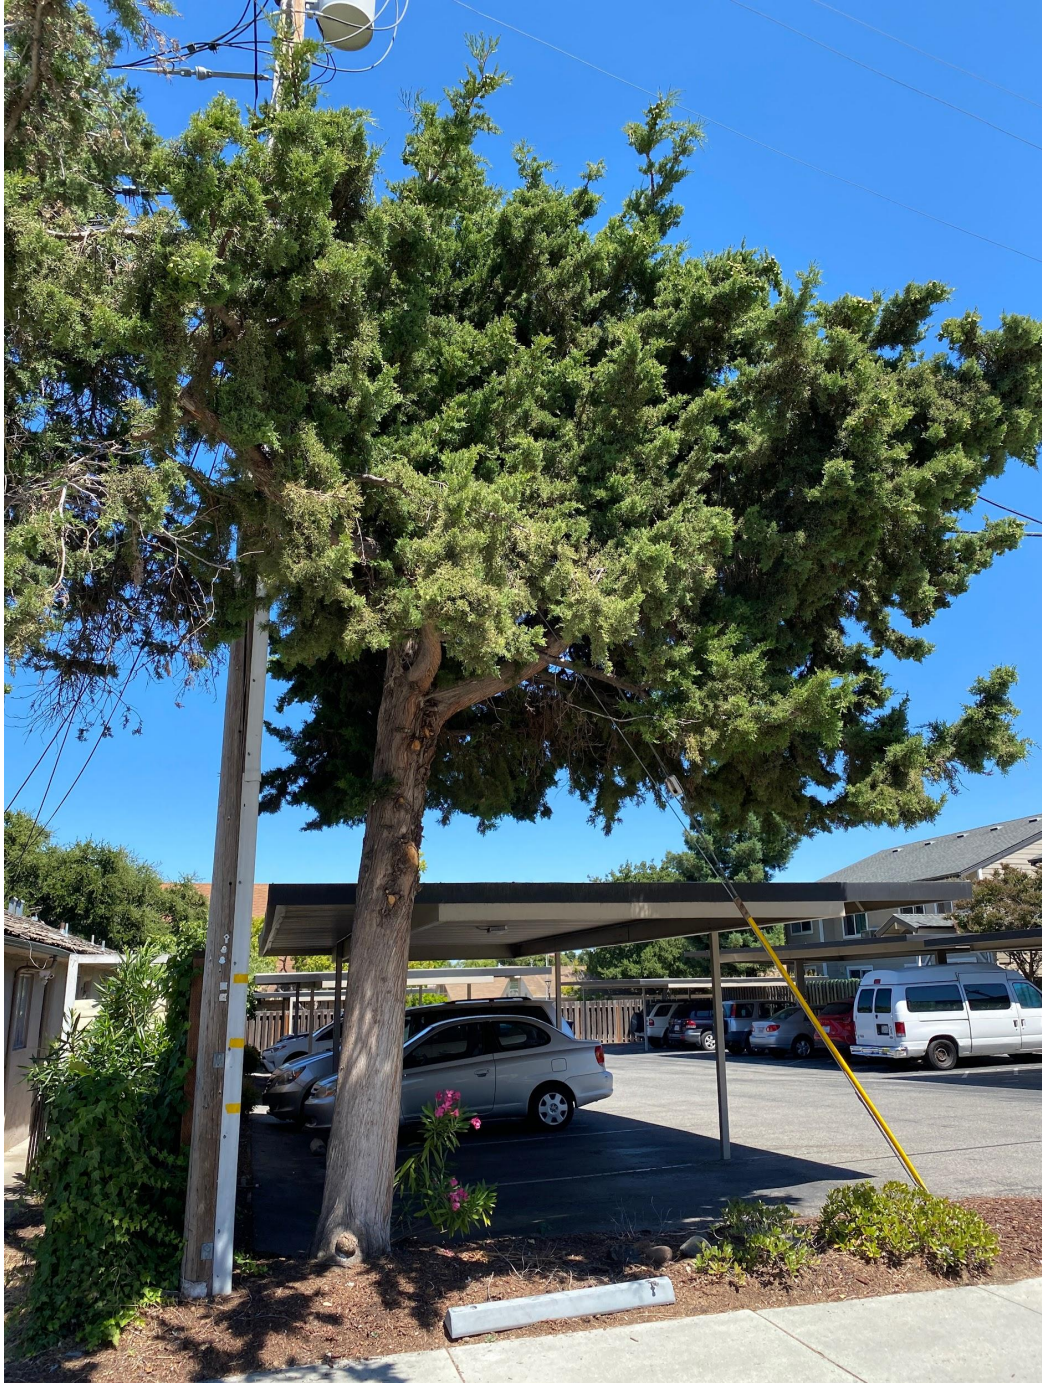
**Photo 8. Tree #11, the neighboring Monterey cypress is in fair condition and will require tree protection**

- Tree 11 TPZ fencing should be installed to encompass as much of the TPZ that overhangs the subject property. If the neighbors agree, it is recommended that TPZ fencing fully encompass the tree and extend onto the property where the tree is located.
