September 5, 2024 (revised December 18, 2025)

This revised arborist report addresses the proposed residential development at 20807-20883 Stevens Creek Blvd, Cupertino. This revision addresses comments from the city and their contract arborist. Changes to the report are highlighted in **red text** for visibility.

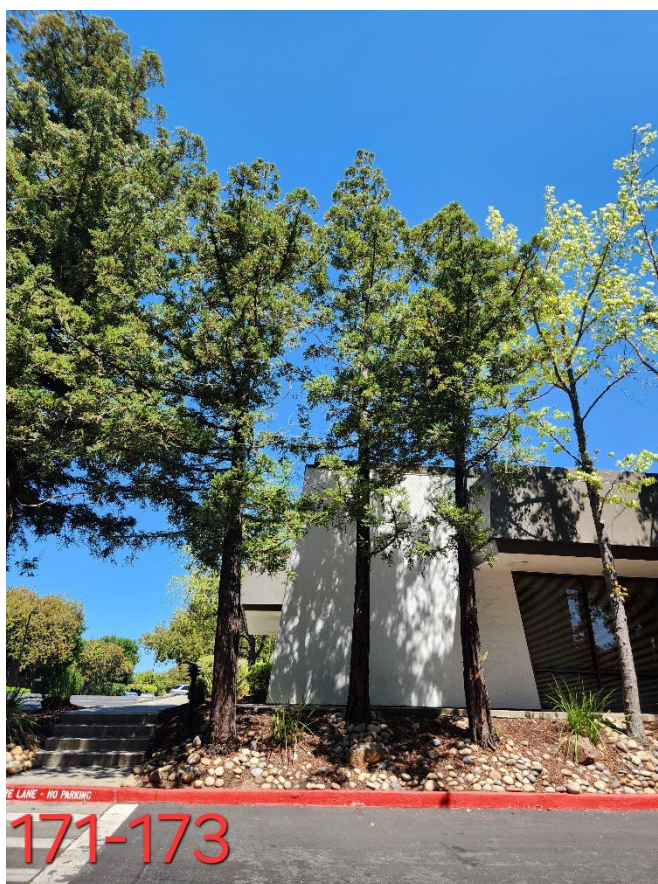
Figure 1. Many trees are planted in small areas that may support one mature tree, at most (sometimes 0 trees; #171-173 shown above).

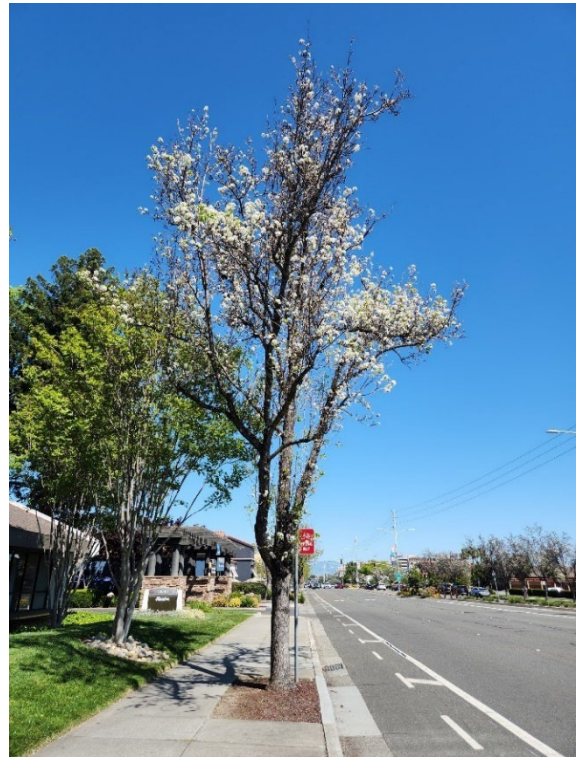
Figure 2. Callery pear #233 is one of the 6 sidewalk trees. They were originally proposed for removal but now remain per city request in cut-outs that are similar or larger to the existing cut-outs.

Additionally, there are six Callery pears growing in sidewalk planters along the Stevens Creek Blvd frontage (*Pyrus calleryana*, Figure 2). They include trees #2, 5, 7, 8, 10 & 233; I assume these are City-owned trees. The pears are relatively young trees but are close to their maximum height. Although this tree has excellent fall color and attractive flowers, its benefits stop there. The species is notorious for its poor structure, as evidenced by multiple narrow stems that originate from the same height on the trunk. As each stem grows thicker, it pushes on its neighbor and the weakest stem(s) will break. Additionally, it's highly susceptible to fire blight, a bacterial disease spread by rain & pollinators. The disease kills branch tips and continues to progress lower in the tree. To manage this disease, the trees must be regularly sprayed before infection begins, and branches must be pruned several inches below the affected area. Over time, Callery pears are often disfigured by management pruning. These trees were originally proposed for removal because of their structure and species, but they will now be retained per city request. **Based on the latest landscape plans, the new sidewalk planters will be the same size or slightly larger. Since there is evidence of concrete lifting and/or repair, excavation should proceed by hand around larger roots. An arborist should be consulted for recommendations if roots \geq 1" diameter and larger are encountered.**

Based on the latest landscape plans, the new sidewalk planters will be the same size or slightly larger. Since there is evidence of concrete lifting and/or repair, excavation should proceed by hand around larger roots. An arborist should be consulted for recommendations if roots \geq 1" diameter and larger are encountered.

- For sidewalk pear trees #2, 5, 7, 8, 10 & 233, hand excavate around roots ≥ 1 " diameter or larger. Consult the Project Arborist for recommendations before root pruning.

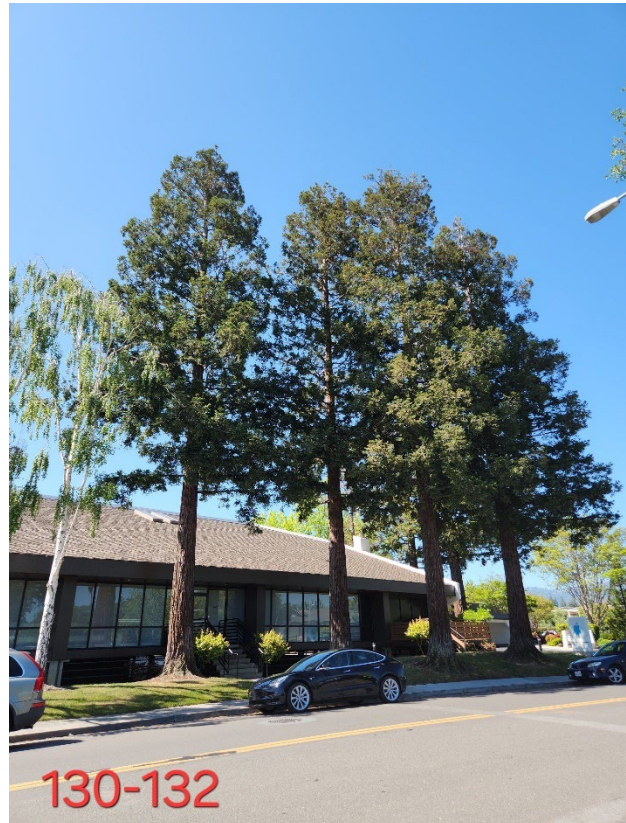
There are three California-native species on the site: coast live oak, coast redwood, Monterey pine. The most abundant species is coast redwood (*Sequoia sempervirens*), which is native to the coast and not Cupertino. In their natural habitat, they receive a significant amount of water through fog. In warmer inland regions like Cupertino, redwoods must be sustained by high quantities of water which is at odds with state & local water restrictions (Figure 3). A spectrum of drought stress is reflected in tree health in the on-site trees – the healthy redwoods (#235-244) at the southwest end are relatively protected by two buildings, while the redwoods at the east property line are more exposed and stressed. Some of the redwoods on the east side have died or were pruned aggressively to clear the power lines. Since they are large trees, they also need more of their root systems preserved to remain healthy and stable after construction. Unfortunately, due to the density of the new development, adequate space cannot be provided. All 75 redwoods will be removed for construction.

Figure 3. The coast redwoods are the dominant tree but are not native to the area and have high water needs. Ample irrigation, like for turf, is needed to maintain health. (Trees #130-132 will be removed due to proposed buildings and Silva cells)

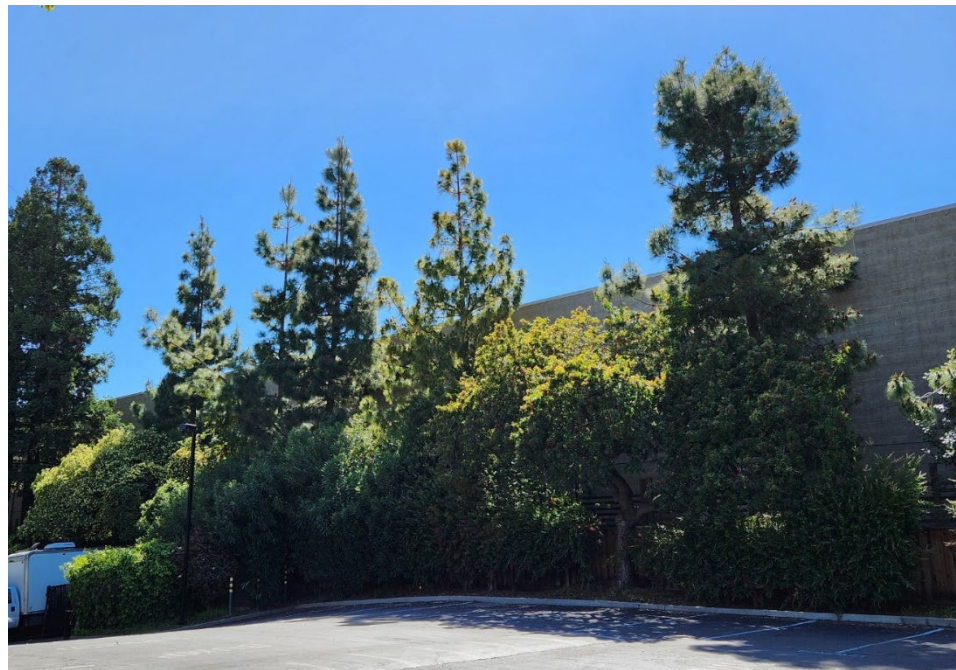
Figure 4. A row of Canary Island pines grow behind the Whole Foods building; their roots are likely to grow into the property (#250-254 shown above). The landscape area should be fenced off up to the parking lot & an arborist must monitor storm drain work next to the trees.

west property line. Minimizing impact to off-site trees is crucial – legally, a property owner does not have the right to harm their neighbors' trees. There are nine Canary Island pines planted next to the Whole Foods building, approximately 6' from the property line fence (*Pinus canariensis*, trees #250-258; Figure 4). A short concrete border is visible below the fence, but its depth is not clear. On the subject property, there is a tall retaining wall by trees #250 & 251 and a wider landscape area by trees #252-258. If the concrete border extends several feet below grade, it may act as a root barrier, but roots will often return to the surface once they bypass the barrier. The existing parking lot may have limited root growth – the subgrade is normally very compacted and unattractive for roots. Over time, as asphalt degrades and becomes more permeable to water, roots may start to extend under the pavement. To be safe, I assume that roots will have grown past the property line into the landscape area.

The adjacent street was originally much closer to the property line, which would have damaged the roots of the pines. I recommended that the design be changed to preserve the existing landscape area, thereby protecting most of the roots on the subject property. While the road was shifted, a new storm drain will run parallel to the property line through the landscape area. Because of site constraints, it may be difficult to further relocate this line, especially with four other utilities running through the street. I highly recommend exploring methods that do not involve open trenching to avoid damaging large roots; excavation should only proceed with an arborist on site. The latest grading plan also shows a 3.5' tall retaining wall at 5' from the property line. This puts the new wall just outside the existing landscape area in the current parking lot. The wall will be ~11' from the trees, which is an acceptable distance especially since their roots have already been affected by the asphalt. There are no substantial changes to my recommendations, except that an arborist should also be present when the wall footing is excavated.

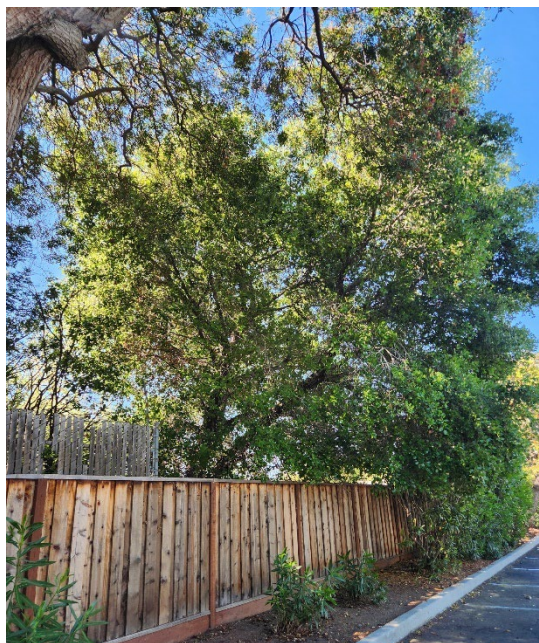
North of the pines are two coast live oaks (*Quercus agrifolia*, #260 & 264, Figure 5). They are young and healthy, therefore more resilient to construction impacts. Proposed grading will start at the property line with the following impacts:

- Tree #260: >3' drop over about 16'; grading starts 8' from the tree. Impact is low, no changes to recommendations (Should the contractors encounter roots ≥ 1 " diameter by tree #260, they should consult an arborist for recommendations.)
- Tree #264: 1.5' drop starting 4' from the trunk. Impact is likely acceptable, but an arborist shall monitor the process to prevent unnecessary root damage.

Figure 5. Coast live oak #260 overhangs the site – it should be protected with temporary fencing.

- If roots ≥ 1 " diameter are encountered during excavation or grading by coast live oak #260, consult the Project Arborist for recommendations.
- For Canary Island pines #142 & 143, hand excavate along the sidewalk within 8' of trunk. Consult the Project Arborist for recommendations before root pruning.

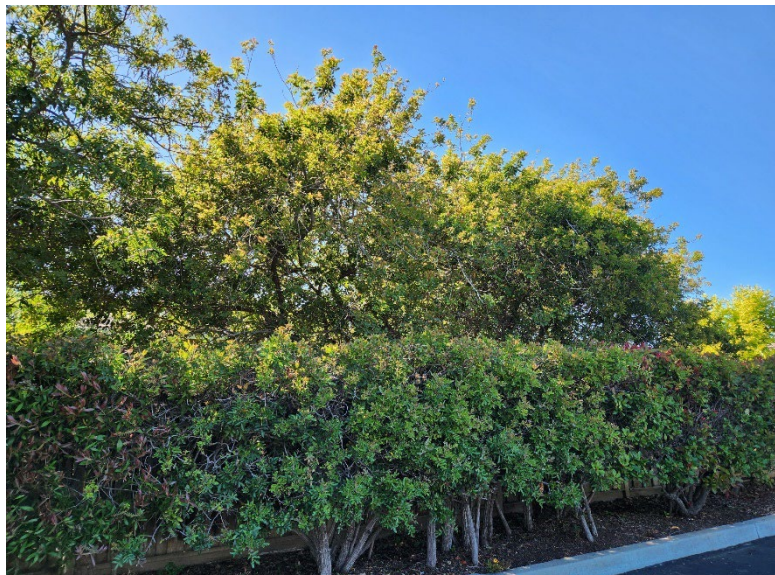
The last off-site tree is a Brazilian pepper at the north end of the site (*Schinus terebinthifolia*, #266, Figure 6). This species is notoriously weedy, in part due to its seed production and highly variable habit. It can grow as a vine, shrub, and tree - all on the same plant. This specimen is more like a grove of multiple volunteers. The Brazilian peppers I reviewed for this project have disproportionately high numbers of trunks relative to the size of their canopies. If the trees had 1/3 to 1/2 of their current trunks, they would still have a similar-sized canopy – instead, each trunk only supports a smaller percentage of the total foliage. The species has a good tolerance to construction impacts, but I still recommend

Figure 6. Brazilian pepper #266 is a cluster made up of several separate trunks; the hedge on the property also includes pepper stems. An arborist shall be on-site to monitor grading next to this cluster.

having an arborist on site while the road is graded next to the tree. Minor grading is expected, with a half foot drop down from the property line. Some root pruning is likely to occur, so supplemental irrigation is needed to mitigate stress that may result. The method of watering will likely vary depending on the stage of construction, e.g. using water trucks early on when water lines are not complete.

- The Project Arborist shall also be on-site during grading for the road by coast live oak #264 and Brazilian pepper #266. Regularly moisten the soil by this tree with methods available during that phase of construction (e.g. water truck, soaker hoses).
