September 5, 2024 (revised December 18, 2025)

This revised arborist report addresses the proposed residential development at 20807-20883 Stevens Creek Blvd, Cupertino. This revision addresses comments from the city and their contract arborist. Changes to the report are highlighted in **red text** for visibility.

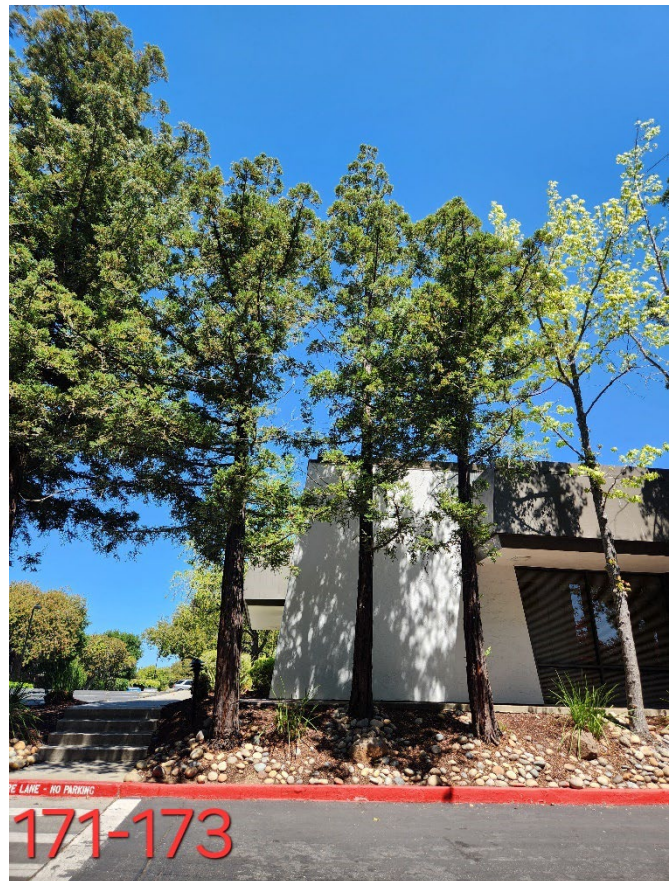
Figure 1. Many trees are planted in small areas that may support one mature tree, at most (sometimes 0 trees; #171-173 shown above).

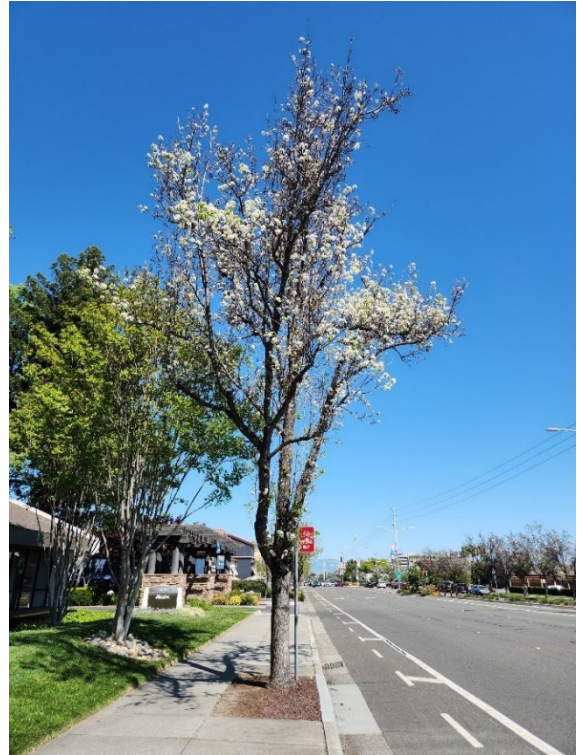
Figure 2. Callery pear #233 is one of the 6 sidewalk trees. They were originally proposed for removal but now remain per city request in cut-outs that are similar or larger to the existing cut-outs.

| ID # | Species | DBH (in) | Health | Structure | Dripline (NESW, ft) | Appraised Value | Notes | Actions |
|---|---|---|---|---|---|---|---|---|
| 233 | Callery pear | 12.5 | Good | Fair-Poor | 8, 12, 10, 10 | | <b>Sidewalk tree (city/off-site?).</b> 3 codominant stems between 6'-7' above grade, two other stems already failed or removed. Curb replaced. Abundant sprouting. <b>Proposed sidewalk planter larger than existing.</b> | <b>Protect with temporary fencing. Hand excavate around roots ≥ 1" and larger and consult arborist for recommendations.</b> |

- For sidewalk pear trees #2, 5, 7, 8, 10 & 233, hand excavate around roots  $\geq 1$ " diameter or larger. Consult the Project Arborist for recommendations before root pruning.

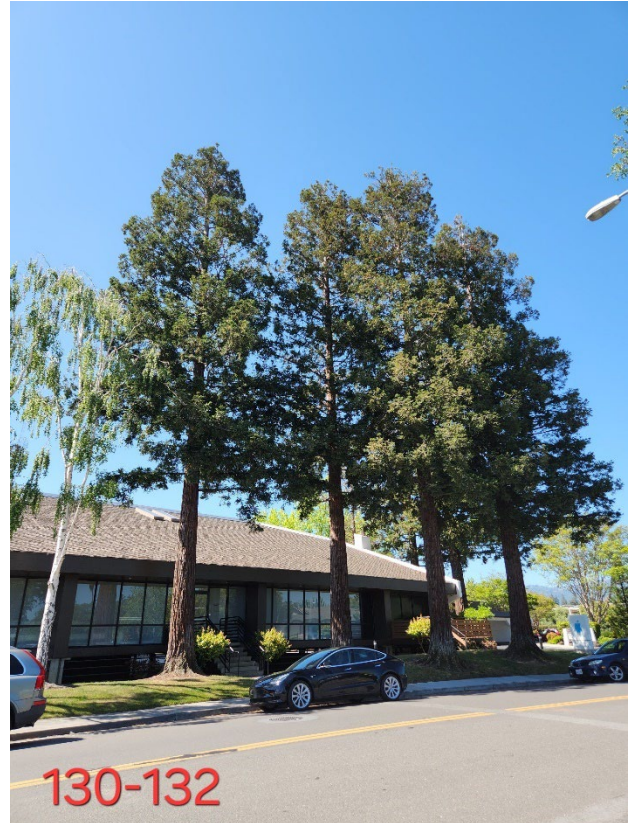
Figure 3. The coast redwoods are the dominant tree but are not native to the area and have high water needs. Ample irrigation, like for turf, is needed to maintain health. (Trees #130-132 will be removed due to proposed buildings and Silva cells)

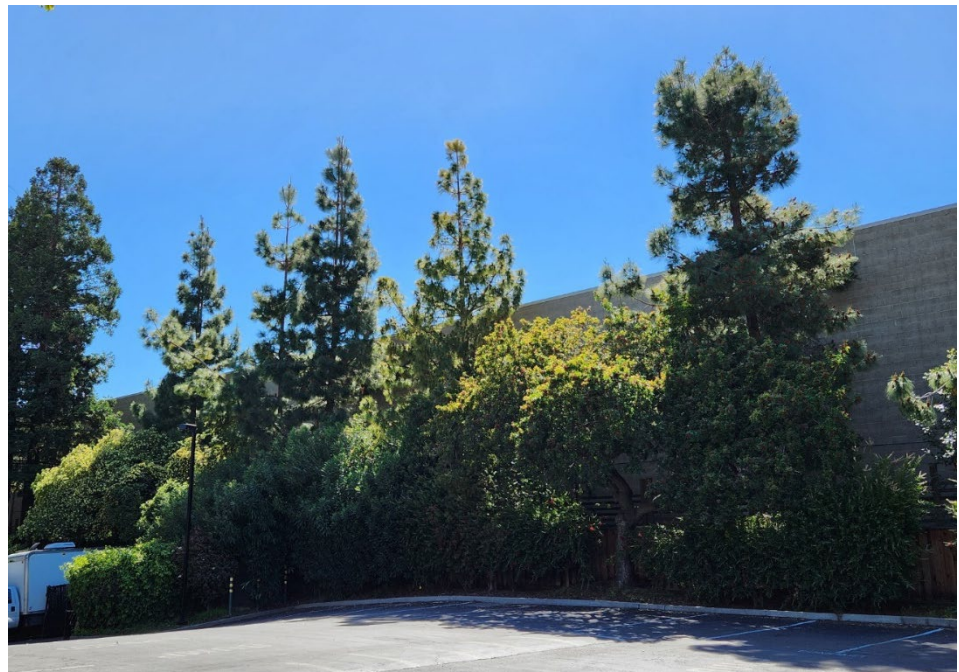
Figure 4. A row of Canary Island pines grow behind the Whole Foods building; their roots are likely to grow into the property (#250-254 shown above). The landscape area should be fenced off up to the parking lot & an arborist must monitor storm drain work next to the trees.

west property line. Minimizing impact to off-site trees is crucial – legally, a property owner does not have the right to harm their neighbors' trees. There are nine Canary Island pines planted next to the Whole Foods building, approximately 6' from the property line fence (*Pinus canariensis*, trees #250-258; Figure 4). A short concrete border is visible below the fence, but its depth is not clear. On the subject property, there is a tall retaining wall by trees #250 & 251 and a wider landscape area by trees #252-258. If the concrete border extends several feet below grade, it may act as a root barrier, but roots will often return to the surface once they bypass the barrier. The existing parking lot may have limited root growth – the subgrade is normally very compacted and unattractive for roots. Over time, as asphalt degrades and becomes more permeable to water, roots may start to extend under the pavement. To be safe, I assume that roots will have grown past the property line into the landscape area.

The adjacent street was originally much closer to the property line, which would have damaged the roots of the pines. I recommended that the design be changed to preserve the existing landscape area, thereby protecting most of the roots on the subject property. While the road was shifted, a new storm drain will run parallel to the property line through the landscape area. Because of site constraints, it may be difficult to further relocate this line, especially with four other utilities running through the street. I highly recommend exploring methods that do not involve open trenching to avoid damaging large roots; excavation should only proceed with an arborist on site. The latest grading plan also shows a 3.5' tall retaining wall at 5' from the property line. This puts the new wall just outside the existing landscape area in the current parking lot. The wall will be ~11' from the trees, which is an acceptable distance especially since their roots have already been affected by the asphalt. There are no substantial changes to my recommendations, except that an arborist should also be present when the wall footing is excavated.

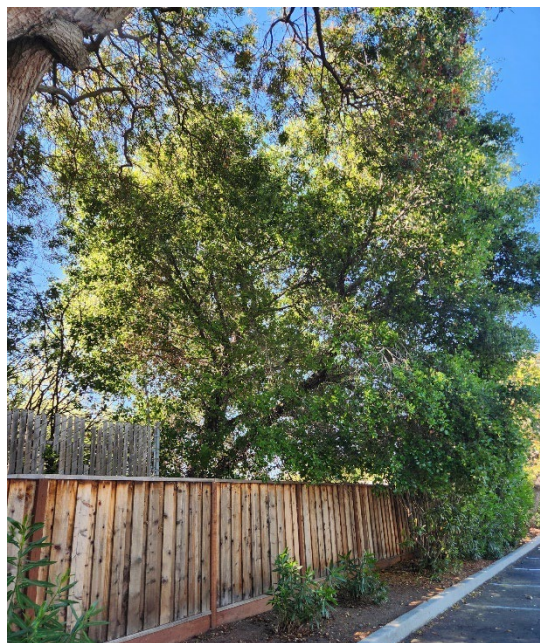
North of the pines are two coast live oaks (*Quercus agrifolia*, #260 & 264, Figure 5). They are young and healthy, therefore more resilient to construction impacts. Proposed grading will start at the property line with the following impacts:

- Tree #260: >3' drop over about 16'; grading starts 8' from the tree. Impact is low, no changes to recommendations (Should the contractors encounter roots  $\geq 1$ " diameter by tree #260, they should consult an arborist for recommendations.)
- Tree #264: 1.5' drop starting 4' from the trunk. Impact is likely acceptable, but an arborist shall monitor the process to prevent unnecessary root damage.

Figure 5. Coast live oak #260 overhangs the site – it should be protected with temporary fencing.

| ID # | Species | DBH (in) | Health | Structure | Dripline (NESW, ft) | Appraised Value | Notes | Actions |
|---|---|---|---|---|---|---|---|---|
| 260 | Coast live oak | 16 | Good | Good-Fair | 20, 18, 10, 15 | | <b>Off site tree, tag on fence.</b> DBH estimated using photo taken over fence, approx. 8' W of property line fence, dripline over hangs by 10'. Codominant stems at 5' above grade, phototropic lean to N away from pepper. Proposed grading ~8' from trunk, more than 3' drop over 16' distance. | Install protection fencing. Consult arborist for recommendations if roots $\geq 1"$ are encountered during grading. |

- If roots  $\geq 1$ " diameter are encountered during excavation or grading by coast live oak #260, consult the Project Arborist for recommendations.
- For Canary Island pines #142 & 143, hand excavate along the sidewalk within 8' of trunk. Consult the Project Arborist for recommendations before root pruning.

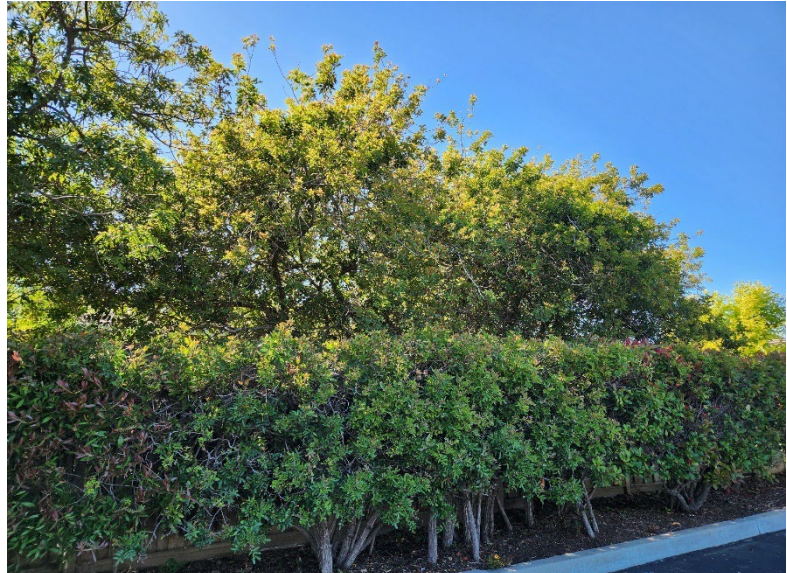
The last off-site tree is a Brazilian pepper at the north end of the site (*Schinus terebinthifolia*, #266, Figure 6). This species is notoriously weedy, in part due to its seed production and highly variable habit. It can grow as a vine, shrub, and tree - all on the same plant. This specimen is more like a grove of multiple volunteers. The Brazilian peppers I reviewed for this project have disproportionately high numbers of trunks relative to the size of their canopies. If the trees had 1/3 to 1/2 of their current trunks, they would still have a similar-sized canopy – instead, each trunk only supports a smaller percentage of the total foliage. The species has a good tolerance to construction impacts, but I still recommend

Figure 6. Brazilian pepper #266 is a cluster made up of several separate trunks; the hedge on the property also includes pepper stems. An arborist shall be on-site to monitor grading next to this cluster.

having an arborist on site while the road is graded next to the tree. Minor grading is expected, with a half foot drop down from the property line. Some root pruning is likely to occur, so supplemental irrigation is needed to mitigate stress that may result. The method of watering will likely vary depending on the stage of construction, e.g. using water trucks early on when water lines are not complete.

- The Project Arborist shall also be on-site during grading for the road by coast live oak #264 and Brazilian pepper #266. Regularly moisten the soil by this tree with methods available during that phase of construction (e.g. water truck, soaker hoses).
