## Arborist Report

**10621 Madera Drive  
Cupertino, CA**

**June 10, 2024**

**Updated September 12, 2025**

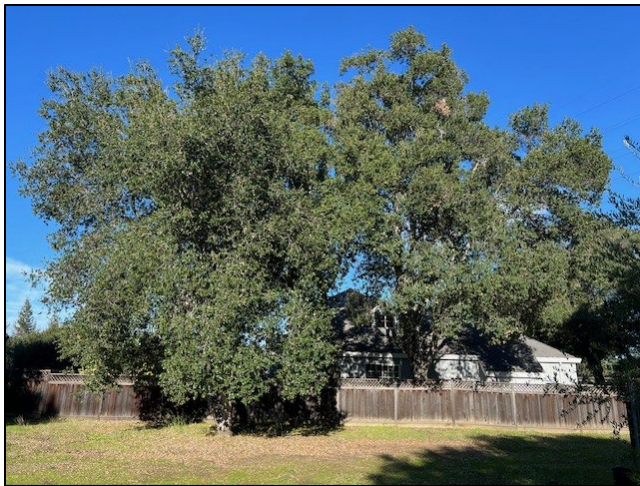
**Photo 1 (right).** Coast live oak #78 was the largest tree on the property with a full crown in good condition.

| Tree No. | Species | Trunk Diameter (in.) | Protected Tree? | Condition<br>1=poor<br>5=excellent | Suitability for Preservation | Comments |
|---|---|---|---|---|---|---|
| 78 | Coast live oak | 32,18 | Yes | 4 | Moderate | Large, wide crown; multiple attachments at 4'; good structure and form. |

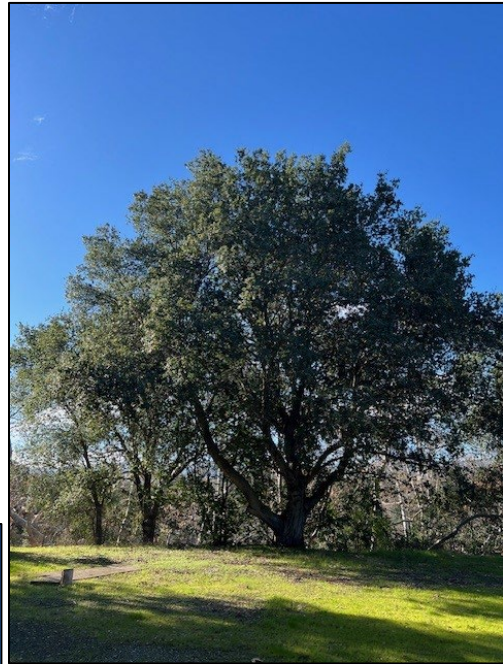
**Photo 2 (left).** Coast live oaks #71 (R) and 72 (L) were overhanging the property on the west side.

| Tree No. | Species | Trunk Diameter (in.) | Protected Tree? | Condition<br>1=poor<br>5=excellent | Suitability for Preservation | Comments |
|---|---|---|---|---|---|---|
| 71 | Coast live oak | 28 | Yes | 3 | Moderate | Off-site; large crown; codominant trunk at 6'; fair structure and form; estimated DBH, tag on fence. |
| 72 | Coast live oak | 18 | Yes | 3 | Moderate | Off-site; medium crown; one-sided south; poor structure and form; estimated DBH, tag on fence. |

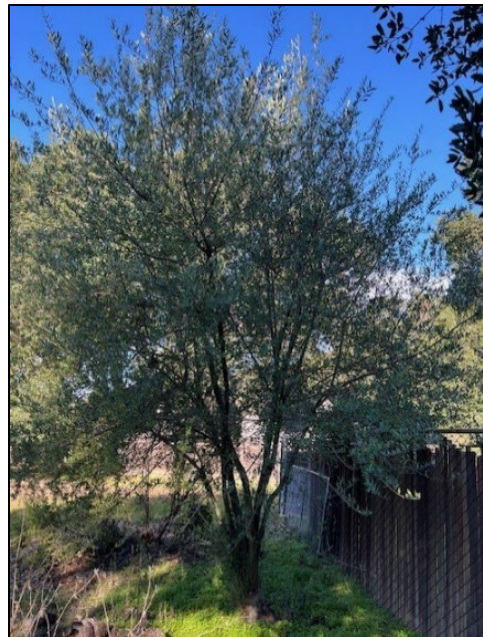
Olive #87 was in poor condition with a small crown. The crown was comprised of multiple attachments arising from 1 foot, creating a tree with poor structure and form (Photo 3). The tree was likely cut down to one foot and left to resprout. The trunk diameter was 7 inches.

**Photo 3.** Olive #87 had multiple attachments at the base creating poor structure and form.

| Tree No. | Species | Trunk Diameter (in.) | Protected Tree? | Condition<br>1=poor<br>5=excellent | Suitability for Preservation | Comments |
|---|---|---|---|---|---|---|
| 87 | Olive | 7 | No | 2 | Low | Small crown; poor structure and form; multiple attachments at base; DBH taken below attachments. |
