Senior Center

Detailed Report

Address: 21251 Stevens Creek Boulevard, Cupertino, CA 95014

**Cupertino
Facility Condition Assessment**

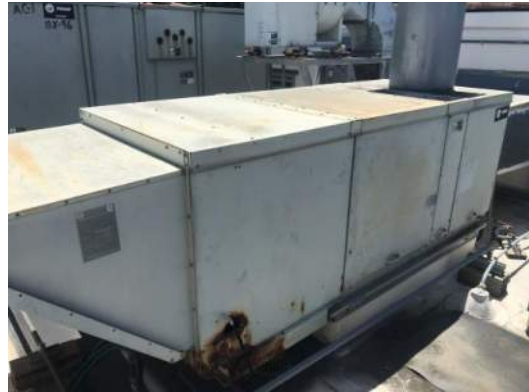
Record ID 445
System D3050 - FACILITY HVAC DISTRIBUTION SYSTEMS
Item No. D3050.50.006
Floor/Room: Roof
Priority: 2
Quantity/Unit of Measure: 1/EA
Total Deficiency Cost: \$78,310
Deficiency Description: *Air handler is approaching the end of its expected useful life.*
Description of Work: *Provide equipment replacement and installation.*
Comments: *Air Handler*

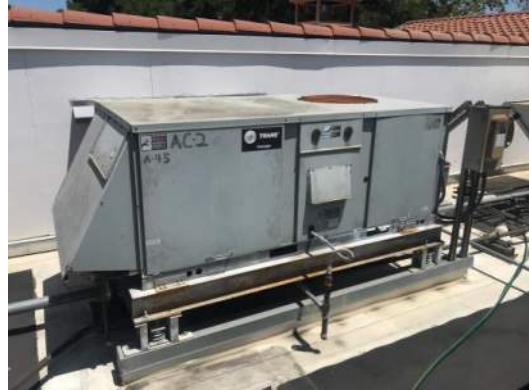
Record ID 448
System D3030 - COOLING SYSTEMS

Item No. D3030.10.018
Floor/Room: Roof
Priority: 2
Quantity/Unit of Measure: 1/EA
Total Deficiency Cost: \$52,230
Deficiency Description: *Packaged AC unit is approaching the end of its expected useful life.*

Comments: *Packaged Unit*

Description of Work: *Provide equipment replacement and installation.*

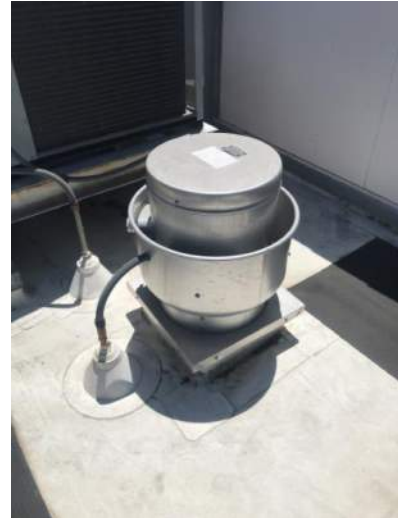
Record ID 449
System D3060 - VENTILATION

Item No. D3060.30.005
Floor/Room: Roof
Priority: 4
Quantity/Unit of Measure: 1/EA
Total Deficiency Cost: \$8,360
Deficiency Description: *Roof exhaust fan is approaching the end of its expected useful life.*

Comments: *Exhaust Fan*

Description of Work: *Provide equipment replacement and installation.*

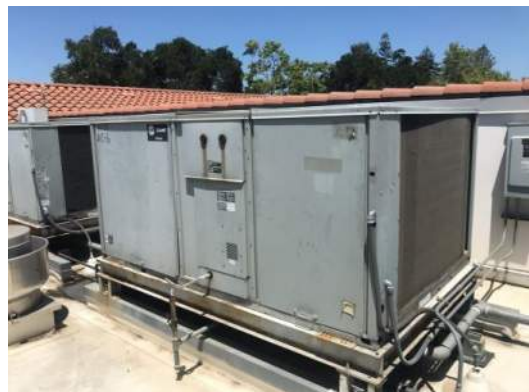
Record ID 450
System D3030 - COOLING SYSTEMS

Item No. D3030.10.019
Floor/Room: Roof
Priority: 2
Quantity/Unit of Measure: 1/EA
Total Deficiency Cost: \$87,030
Deficiency Description: *Packaged AC unit is approaching the end of its expected useful life.*

Comments: *Packaged Unit*

Description of Work: *Provide equipment replacement and installation.*

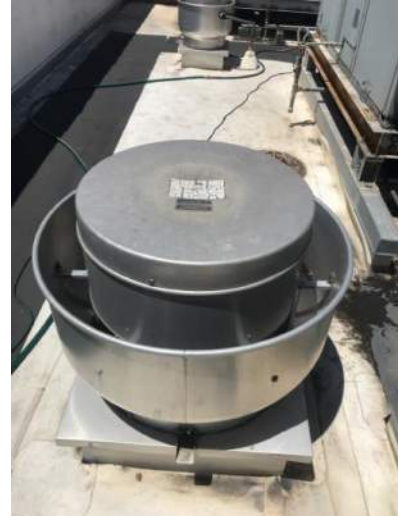
Record ID 451
System D3060 - VENTILATION

Item No. D3060.30.005
Floor/Room: Roof
Priority: 4
Quantity/Unit of Measure: 1/EA
Total Deficiency Cost: \$8,360
Deficiency Description: *Roof exhaust fan is approaching the end of its expected useful life.*

Comments: *Exhaust Fan*

Description of Work: *Provide equipment replacement and installation.*

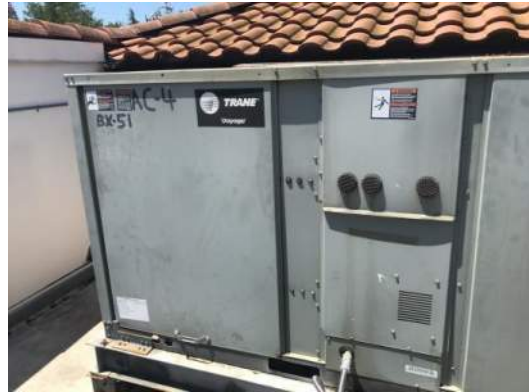
Record ID 454
System D3030 - COOLING SYSTEMS

Item No. D3030.10.019
Floor/Room: Roof
Priority: 2
Quantity/Unit of Measure: 1/EA
Total Deficiency Cost: \$87,030
Deficiency Description: *Packaged AC unit is approaching the end of its expected useful life.*

Comments: *Packaged Unit*

Description of Work: *Provide equipment replacement and installation.*

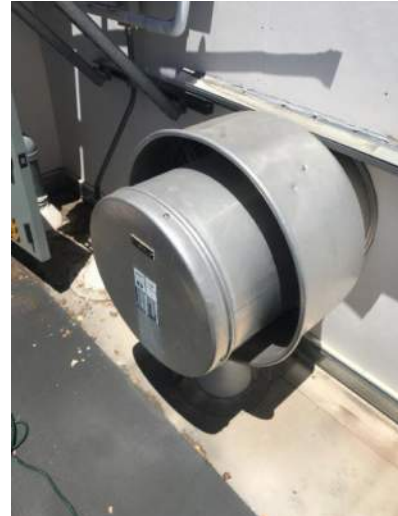
Record ID 455
System D3060 - VENTILATION

Item No. D3060.30.005
Floor/Room: Roof
Priority: 4
Quantity/Unit of Measure: 1/EA
Total Deficiency Cost: \$8,360
Deficiency Description: *Roof exhaust fan is approaching the end of its expected useful life.*

Comments: *Exhaust Fan*

Description of Work: *Provide equipment replacement and installation.*

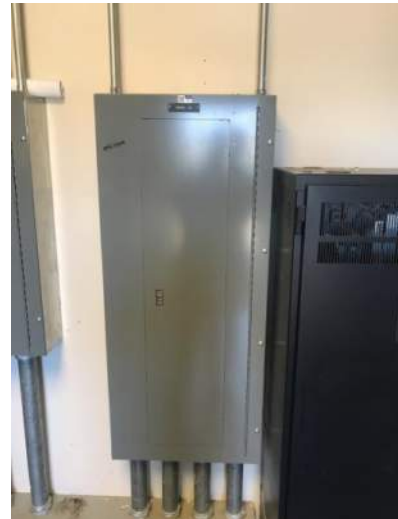
Record ID 461
System D5020 - ELECTRICAL SERVICE AND DISTRIBUTION
Item No. D5020.30.1008
Floor/Room: 1
Priority: 3
Quantity/Unit of Measure: 1/EA
Total Deficiency Cost: \$21,020
Deficiency Description: *The 225A (120/208, 3P) panelboard is past its expected useful life.*

Comments: *Panelboard*

Description of Work: *Replace the existing panelboard with a new panelboard.*

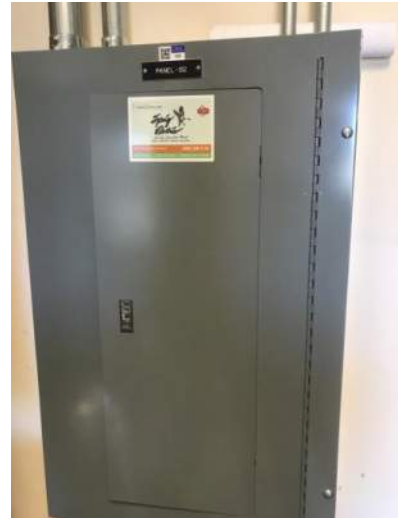
Record ID 462
System D5020 - ELECTRICAL SERVICE AND DISTRIBUTION
Item No. D5020.30.1008
Floor/Room: 1
Priority: 3
Quantity/Unit of Measure: 1/EA
Total Deficiency Cost: \$21,020
Deficiency Description: *The 225A (120/208, 3P) panelboard is past its expected useful life.*

Comments: *Panelboard*

Description of Work: *Replace the existing panelboard with a new panelboard.*

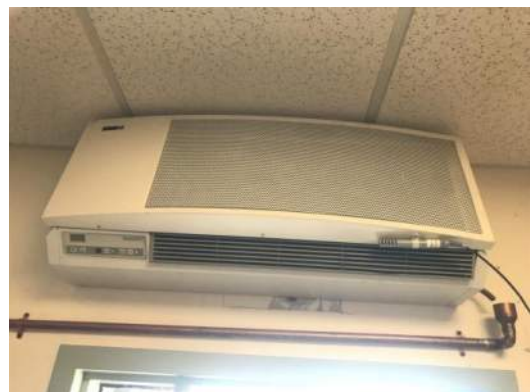
Record ID 464
System D3030 - COOLING SYSTEMS
Item No. D3030.70.043
Floor/Room: 1
Priority: 3
Quantity/Unit of Measure: 1/EA
Total Deficiency Cost: \$30,830
Deficiency Description: *Split system with fan coil and outdoor condensing unit is approaching the end of its expected useful life.*

Comments: *Mini Split*

Description of Work: *Provide equipment replacement and installation.*

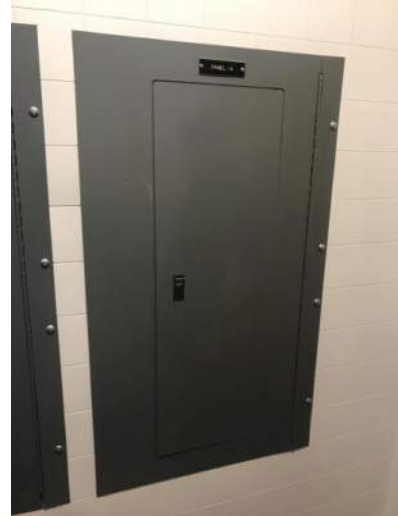
Record ID 476
System D5020 - ELECTRICAL SERVICE AND DISTRIBUTION
Item No. D5020.30.1008
Floor/Room: 1 / Kitchen
Priority: 3
Quantity/Unit of Measure: 1/EA
Total Deficiency Cost: \$21,020
Deficiency Description: *The 225A (120/208, 3P) panelboard is past its expected useful life.*

Comments: *Panelboard*

Description of Work: *Replace the existing panelboard with a new panelboard.*
