# Cupertino City Hall Alternates Study Structural Evaluation:

10300 Torre Avenue, Cupertino, CA 95014-3202

September 29, 2014

## Executive Summary

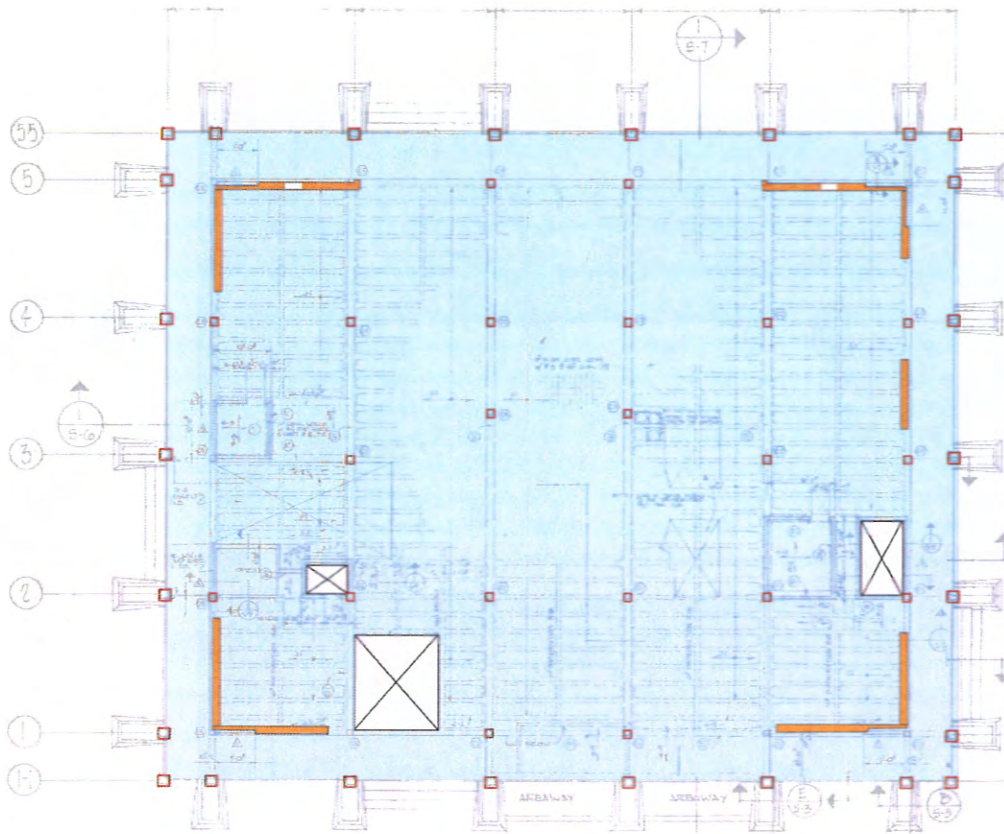
The concrete columns are connected to all floor levels and to the roof. As such, they will deform as they drift with the rest of the building during an earthquake. Bending moments and shear forces will be induced in these columns as they sway with the building during a seismic event. The long span and inherent flexibility of the wood roof diaphragm will also contribute to the anticipated seismic roof drift making these under-reinforced columns very susceptible to seismic damage. The existing concrete columns have limited confinement reinforcement ties around the longitudinal reinforcements, as noted earlier in this report. Sufficient lateral ties are required in modern building codes to properly confine the longitudinal bars and the concrete core in order for the columns to continue carrying gravity loads when the columns are displaced. The lack of confinement ties is likely to result in limited displacement ductility for the concrete column. The existing columns are to be wrapped and strengthened with fiber reinforced polymer. Wrapping the existing columns will increase the displacement ductility for gravity load carrying capacity.

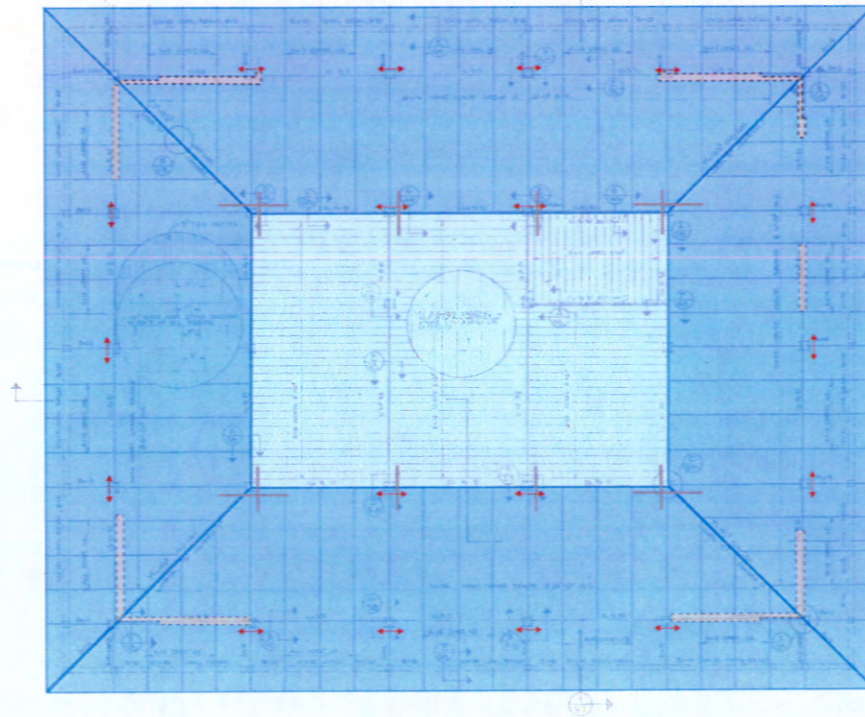
The existing heavy clay roof tiles make up a significant portion of the existing roof's self weight. As the building's seismic force demand is directly proportional to the self weight, it is recommended that the existing clay roof tiles be removed and replaced with a lighter roofing material. Even with the mass of the roof significantly reduced, the force demand on the roof diaphragm is near the capacity limit state for a plywood diaphragm given the shear forces associated with an immediate occupancy performance criteria.

As such, a new High Load Diaphragm will be required for the roof area outboard of the central mechanical well. New 3/4" plywood will be provided over the existing 1/2" plywood and 3x tongue and groove blocking with two rows of 10d nails @ 2 1/2" o.c. along diaphragm boundaries and continuous panel edges, 4" o.c. at other panel edges, and 12" o.c. in field. The existing diaphragm at the central mechanical well will be strengthened with 1 row of 10d nails @ 2" o.c. along diaphragm boundaries and continuous panel edges, 3" o.c. at other panel edge, and 12" o.c. in field. New 4x6 blocking will be added at continuous panel edges perpendicular to joist framing direction.

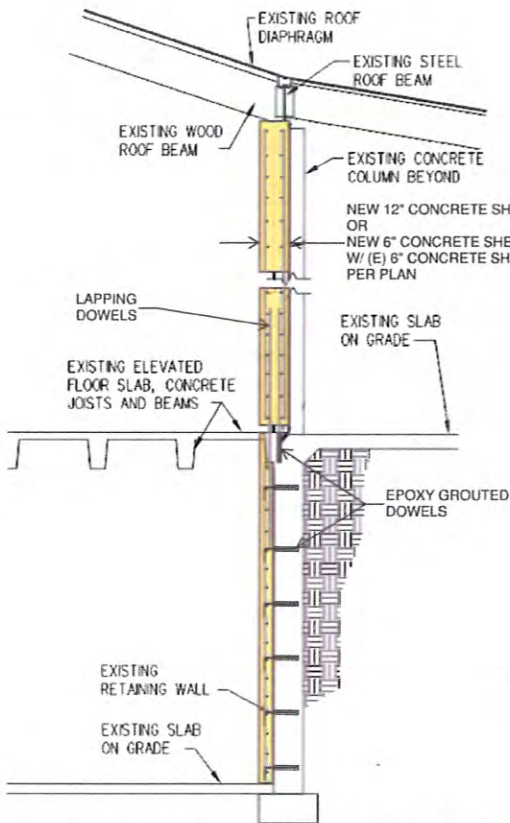
DETAIL 3 - SECTION AT NEW CONCRETE SHEAR WALL

Additional shear walls extending from foundations to roof should be added to provide new/strengthened vertical seismic force resisting elements for the existing structure. The new shear walls will typically be 12" thick concrete walls from the top of existing basement walls to the underside of the roof and 6" thick concrete walls that are overlapped and connected to the face of the existing basement walls with reinforcement dowels, as shown in Detail 3 of Sheet S3. Where the wall length is limited at the north elevation within the basement level, two new new pile caps, with two micro-piles at each cap, should be provided to increase the shear wall overturning resistance along this line and protect the existing very lightly reinforced foundation from associate seismic damage.

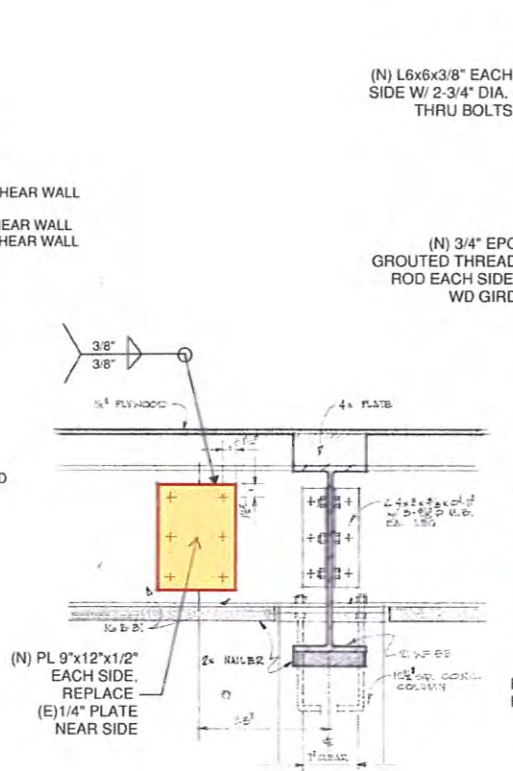
DETAIL 2 - STEEL TO STEEL COLLECTOR SPLICE

There are several types of collector connections at the roof level, all of which require strengthening to increase their load carrying capacity. Where the existing roof diaphragm collectors are wide flange steel roof beams, they are currently spliced to each other with machine bolts. These splices will need to be strengthened with additional new splice plates and new welding as shown in on Sheet S3, Detail 2, of the attached building retrofit drawings. Where existing roof collectors occur at steel wide flange to wood girder locations, additional horizontal Simpson Holdowns or CMST straps are required to strengthen the existing steel beam to timber girder connections, as shown in Detail 1 of Sheet S3. The porch colonnade on the exterior perimeter of the building is constructed of concrete beams and columns. The anchorage connections between these
