Cupertino City Hall Essential Services Facility Analysis

Final Report, Revision 1
March 27, 2012

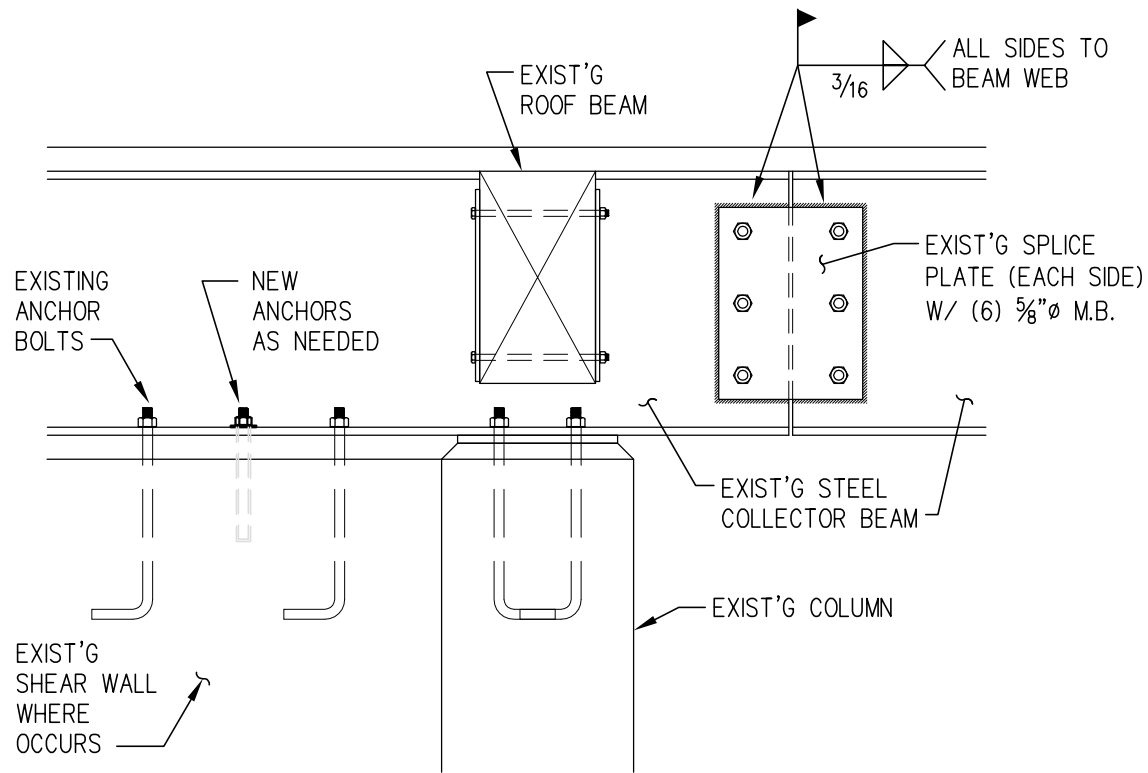
Figure 3.F: ELEVATION: EXISTING STEEL BEAM AT COLUMN AND SHEAR WALL

The existing roof diaphragm collectors consist of steel roof beams around the perimeter of the structure, and are aligned parallel to and above the upper-level concrete shear walls. These elements collect the seismic forces within the roof diaphragm and deliver the forces to the shear walls. Where splices occur in the lines of steel beams at approximately ten (10) locations, the connectors are currently not adequate to transfer the required seismic collector forces. Our recommendation to address this deficiency would be to provide welding around the splice plates to the beams at the splice connections. See Fig. 3.F.

The collector beams mentioned in the previous section are connected to the top of the concrete shear walls with anchor bolts embedded in the walls and extending through the steel beam flange. This is the means through which the seismic forces are transferred from the roof to the shear walls. The current anchor bolts are insufficient to transfer the prescribed forces to the shear walls, even with added shear walls. Our recommendation is to provide adequate anchor bolts to any new walls and provide additional anchor bolts through the existing beams, between the existing anchor bolts, to strengthen the shear-transfer connections sufficiently. See Fig. 3.F.

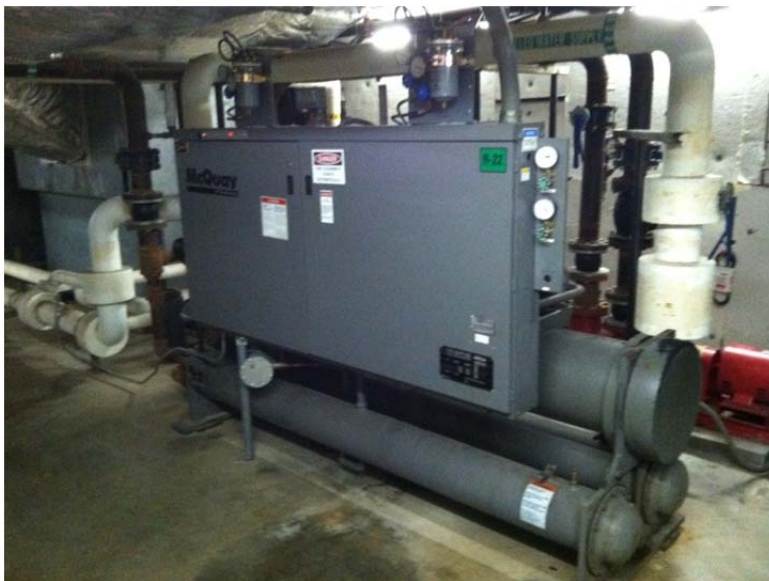
Figure 5B (Water-cooled 70 Ton Chiller)

In the lower level mechanical room, maintenance clearances and an exit pathway may not exist throughout the space. In addition, the combination of chiller, gas boiler, electrical gear, and generator equipment do not meet today's code

requirement to have separate rooms for each of these pieces of equipment. The room is also not equipped with a refrigerant detection and exhaust systems currently required for chiller rooms, and the combustion air ducts in the boiler room need to be routed to an outdoor location.

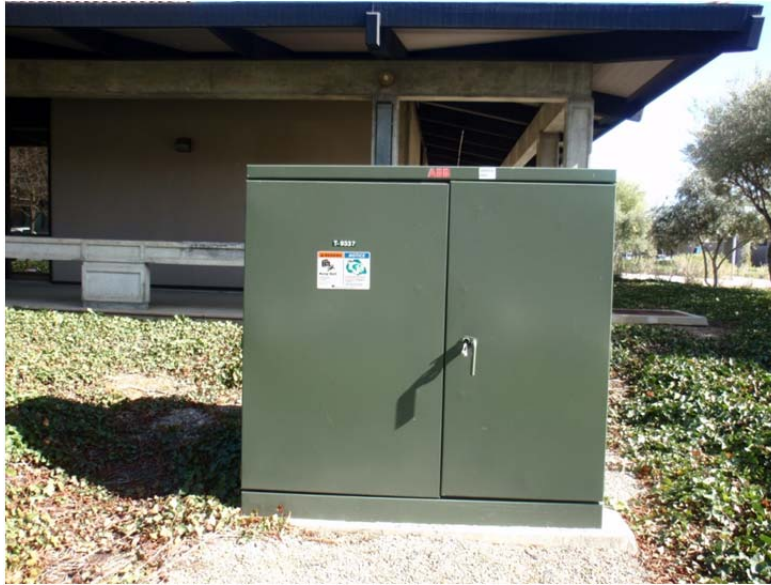
Figure 1E (PG&E Transformer)

The transformer belongs to PG&E and was recently upgraded. It appears to be in good working condition.

Alt #4 Replacement: Transformer was recently upgraded.

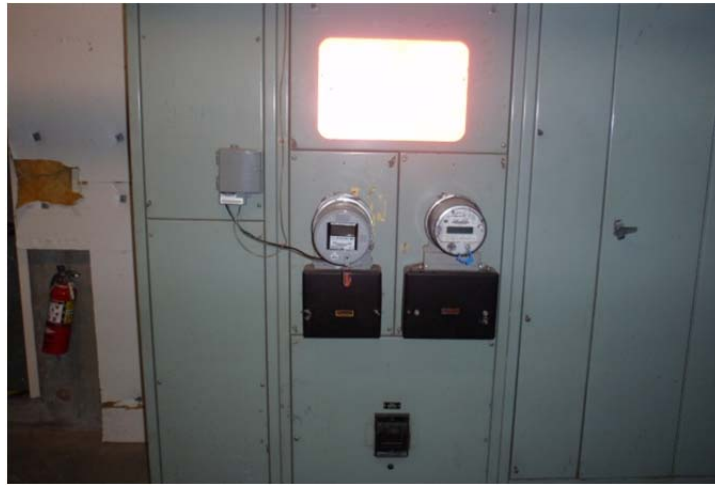
Figure 5F (Main Switchboard)

The main switchboard appears to be of the original construction and in working condition, although past its useful life. In general, the switchboard is adequately sized to support the existing loads.

Alt #2 Min Seismic Upgrade: Provide adequate support suitable for the seismic and earthquake condition.

Alt #4 Replacement: In order to ensure reliable power distribution to the building and reduce service needs in the future, we recommend the main switchboard be replaced with a new model.
