Cupertino City Hall Essential Services Facility Analysis

Final Report, Revision 1
March 27, 2012

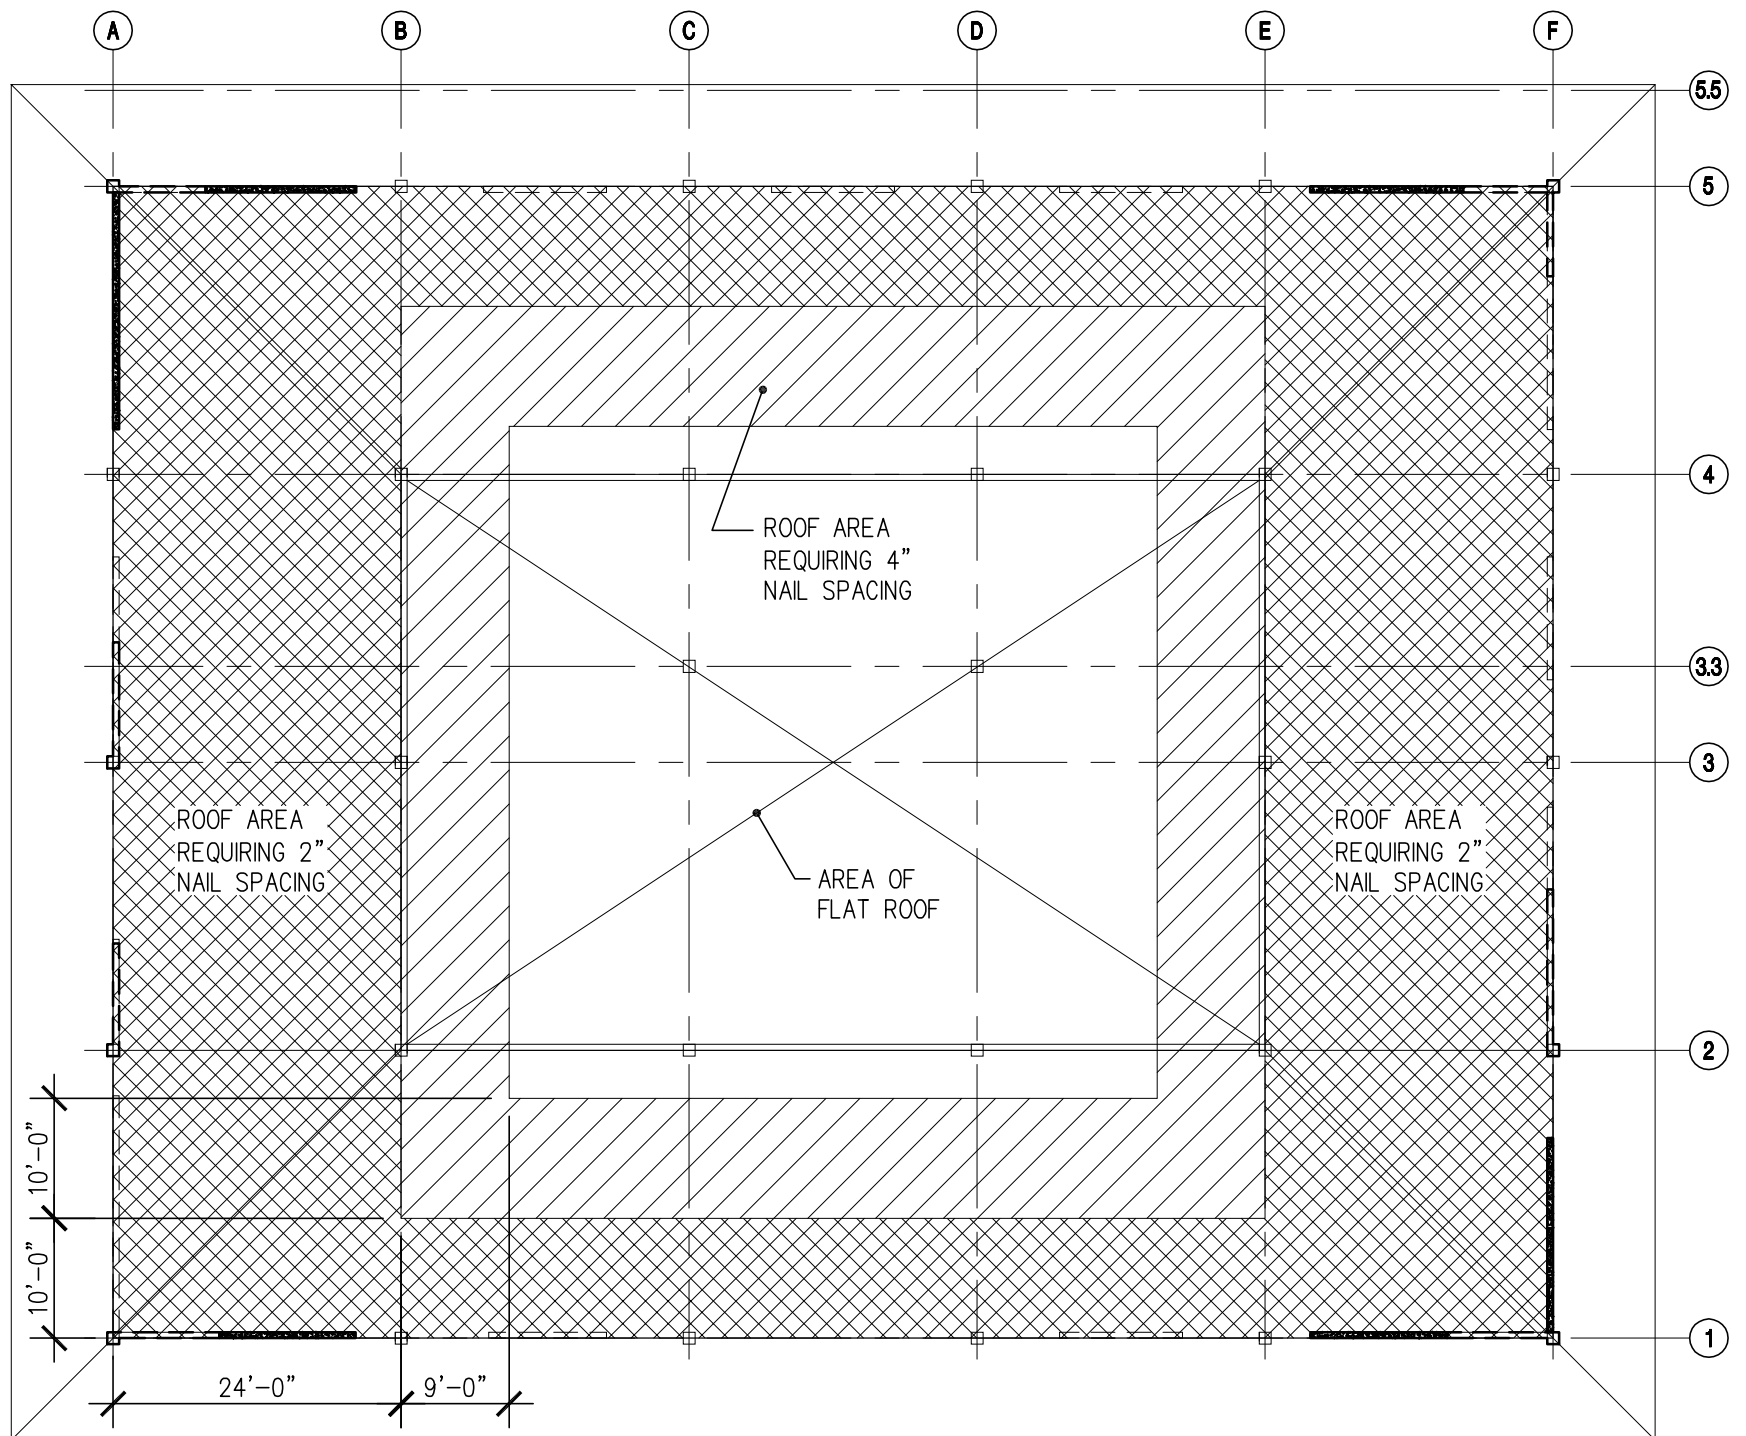
Figure 3.B: KEY ROOF PLAN
(MAIN FLOOR WALLS SHOWN DASHED)

The existing roof diaphragm is comprised of plywood sheathing with specific nailing along its panel edges to common framing members. Its shear capacity is affected by the type and thickness of plywood used, and the size and spacing of nailing used. The existing roof diaphragm shear capacity is exceeded even if the existing roof tile were to be removed and replaced with a lighter roofing material. The roof diaphragm forces would be reduced significantly with the replacement of the heavy clay roof tiles, although the calculated diaphragm shears would still exceed the diaphragm near the building's perimeter, which is where the diaphragm shear forces are highest. The plywood diaphragm can be strengthened as needed with added panel edge nailing near the perimeter of the building. This added nailing would be installed while the roofing is being replaced. See Figures 3.B and 3.G.

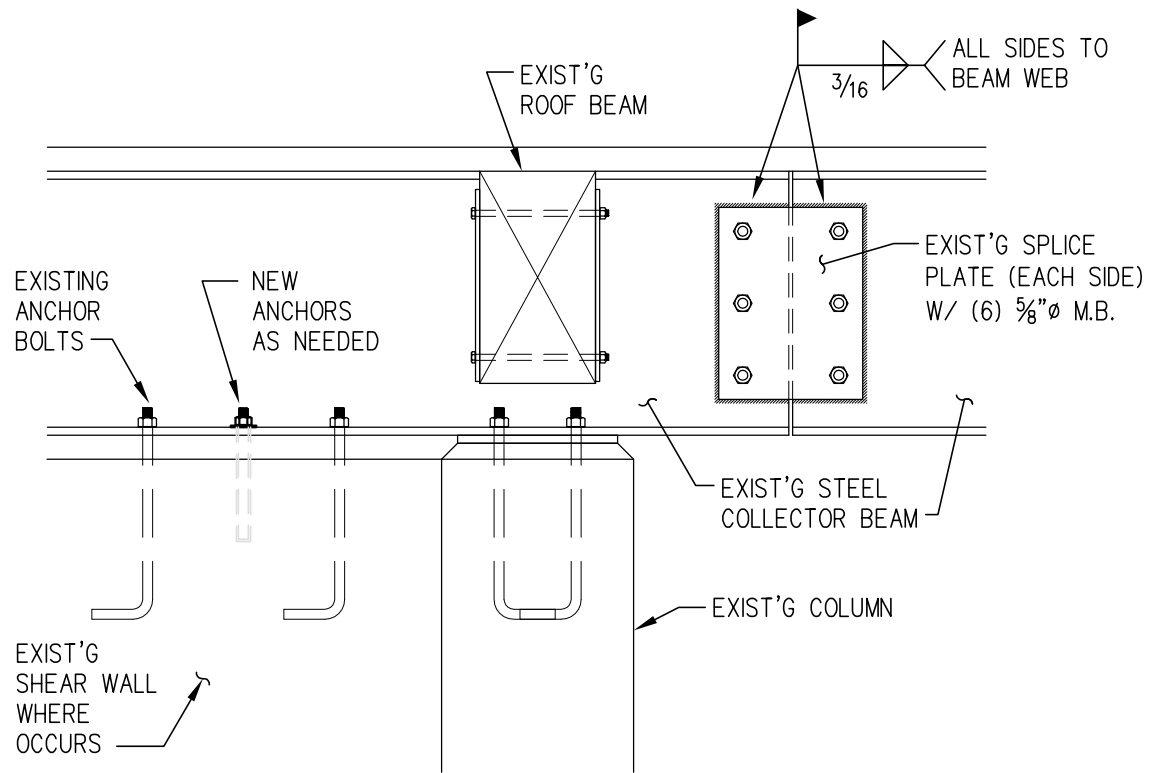
Figure 3.F: ELEVATION: EXISTING STEEL BEAM AT COLUMN AND SHEAR WALL

The existing roof diaphragm collectors consist of steel roof beams around the perimeter of the structure, and are aligned parallel to and above the upper-level concrete shear walls. These elements collect the seismic forces within the roof diaphragm and deliver the forces to the shear walls. Where splices occur in the lines of steel beams at approximately ten (10) locations, the connectors are currently not adequate to transfer the required seismic collector forces. Our recommendation to address this deficiency would be to provide welding around the splice plates to the beams at the splice connections. See Fig. 3.F.

The collector beams mentioned in the previous section are connected to the top of the concrete shear walls with anchor bolts embedded in the walls and extending through the steel beam flange. This is the means through which the seismic forces are transferred from the roof to the shear walls. The current anchor bolts are insufficient to transfer the prescribed forces to the shear walls, even with added shear walls. Our recommendation is to provide adequate anchor bolts to any new walls and provide additional anchor bolts through the existing beams, between the existing anchor bolts, to strengthen the shear-transfer connections sufficiently. See Fig. 3.F.

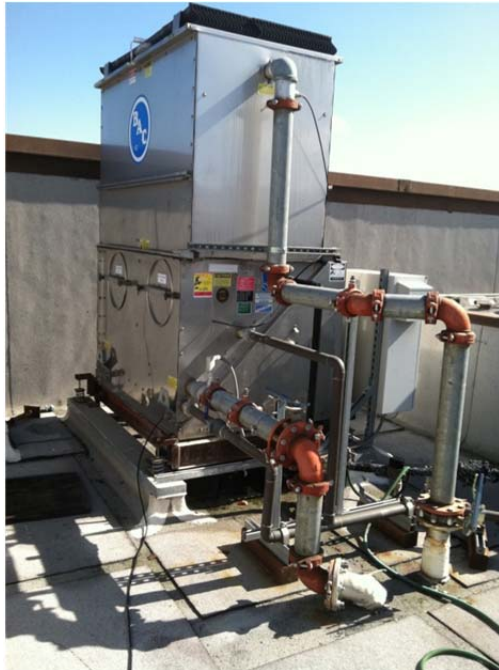
Figure 5A (Closed-Circuit 70 Ton Cooling Tower)

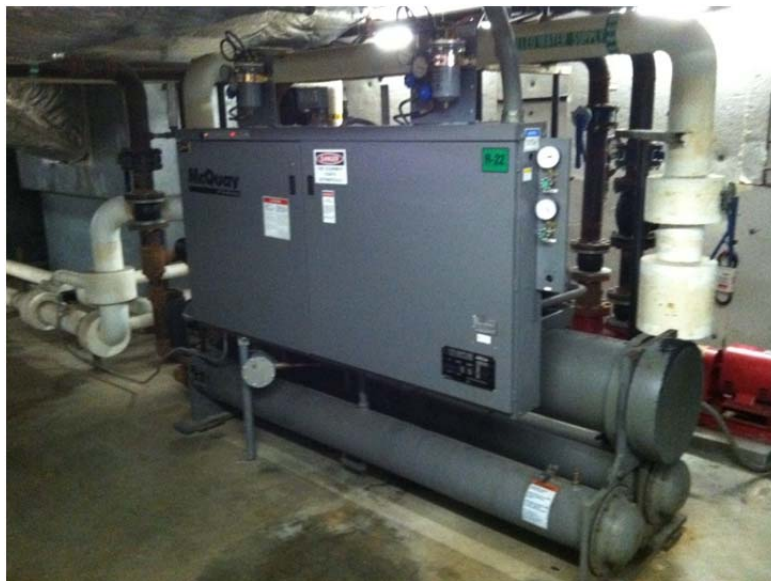
Figure 5B (Water-cooled 70 Ton Chiller)

In the lower level mechanical room, maintenance clearances and an exit pathway may not exist throughout the space. In addition, the combination of chiller, gas boiler, electrical gear, and generator equipment do not meet today's code

requirement to have separate rooms for each of these pieces of equipment. The room is also not equipped with a refrigerant detection and exhaust systems currently required for chiller rooms, and the combustion air ducts in the boiler room need to be routed to an outdoor location.

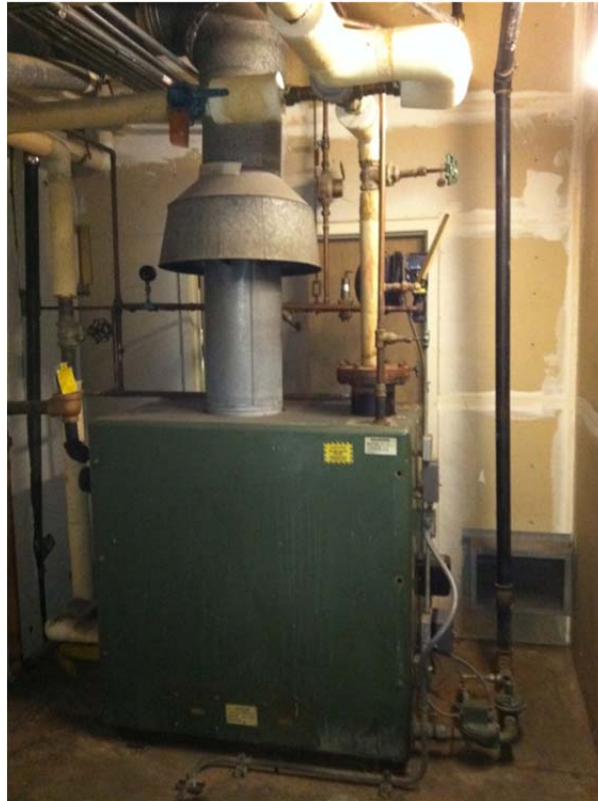
Figure 5C (Gas Fired Boiler)

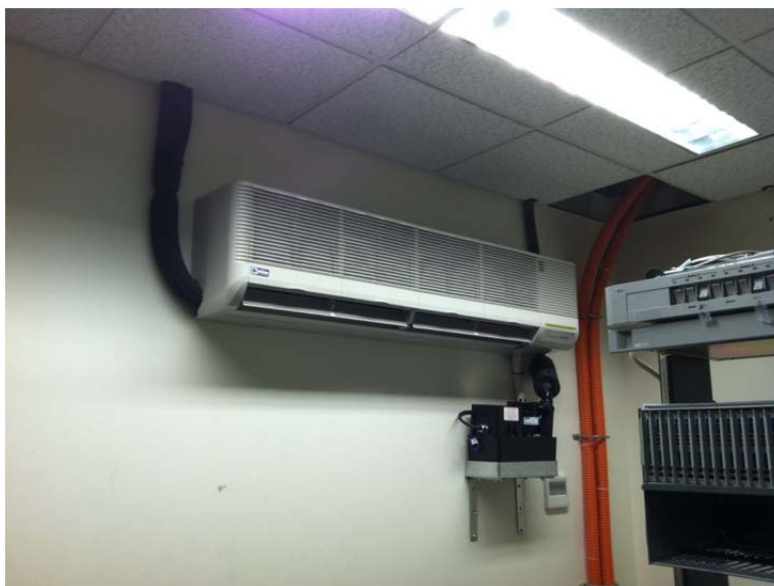
The Cupertino City Hall has a small server room that is cooled by split system AC units, with air-cooled condensers located on the roof. The AC units for the server room appear to have been installed more recently than the rest of the HVAC equipment.

Figure 5D (Server room AC unit (1 of 2))

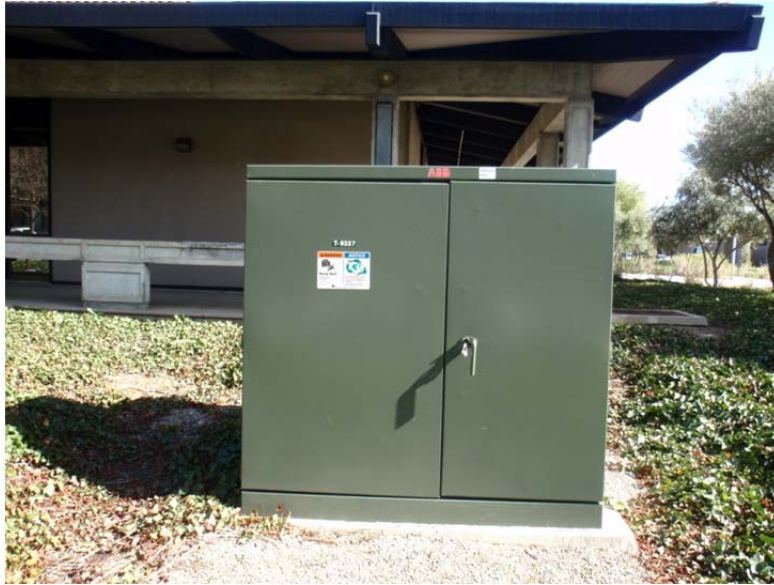
Figure 1E (PG&E Transformer)

The transformer belongs to PG&E and was recently upgraded. It appears to be in good working condition.

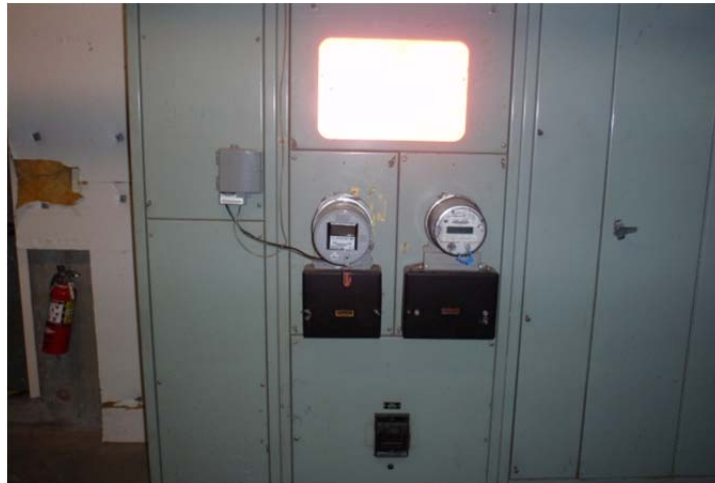
Figure 5F (Main Switchboard)

The main switchboard appears to be of the original construction and in working condition, although past its useful life. In general, the switchboard is adequately sized to support the existing loads.

Alt #2 Min Seismic Upgrade: Provide adequate support suitable for the seismic and earthquake condition.

Alt #4 Replacement: In order to ensure reliable power distribution to the building and reduce service needs in the future, we recommend the main switchboard be replaced with a new model.

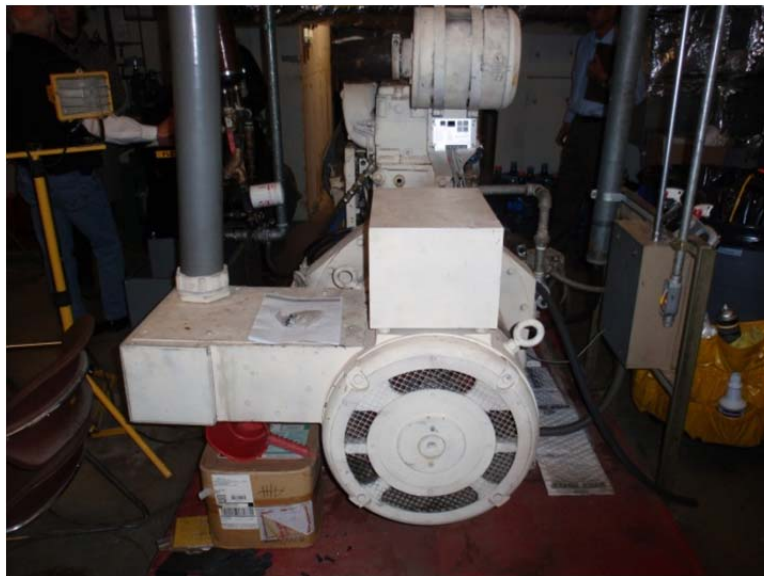
The emergency power system consists of a generator rated at 125KW, 208/120V and is located inside the main electrical room. The fuel tank, with 1000 gallon capacity, is located outside the room. In the event of a power outage, the generator provides power to the panel DP via a 400A automatic transfer switch (ATS) located in the main electrical room. The generator also provides power to the Chiller but the pump must be “jump” to move chilled water. The generator does not serve the existing elevator. or the chiller, as confirmed by discussions with facility personnel.

Figure 5G (Indoor Generator)

Alt #2 Min Seismic Upgrade: Provide adequate support suitable for the seismic and earthquake condition.

Alt #3 Upgrade: The generator should at the minimum be tested per manufacturer's recommendation to confirm its operation, and the batteries tested to confirm capacity and condition as well.

Alt #4 Replacement: The existing generator is currently loaded to its full capacity. In order to increase reliability and provide assurance of operation in the future, it is recommended that the generator be replaced with a new unit. We also recommend upsizing the generator to 175kW or above and its associated automatic transfer switch to 500A or above to provide capacity to serve additional loads such as the elevator and any future loads.
