**Seismic Evaluation - Tier 1  
Cupertino City Hall  
10300 Torre Ave  
Cupertino, California**

MME Job No. 21143.P5

April 19, 2021

**Re: Cupertino City Hall Seismic Evaluation – Tier 1**

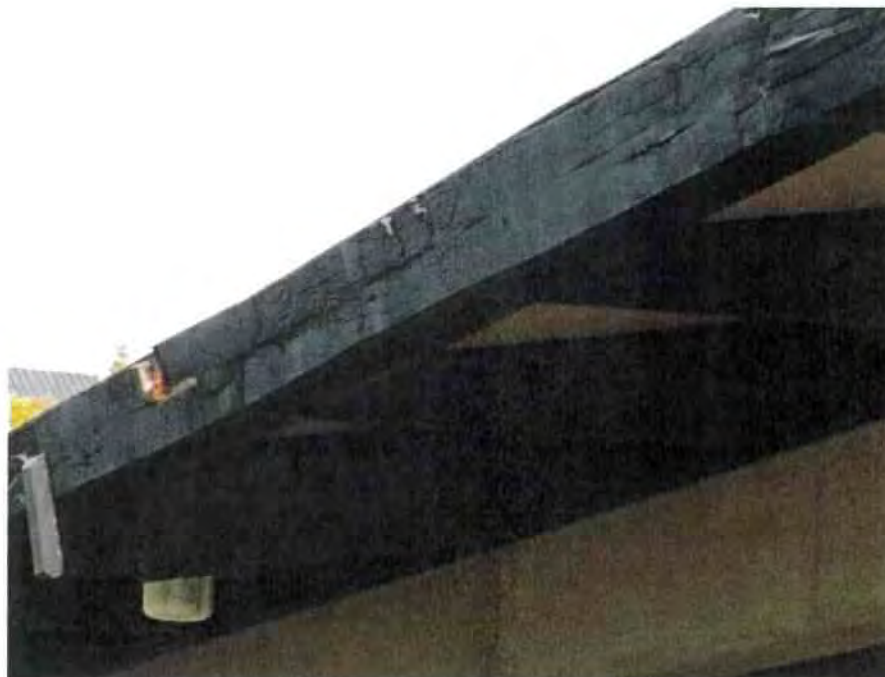
*Photo 3 Damaged Veranda Fascia*

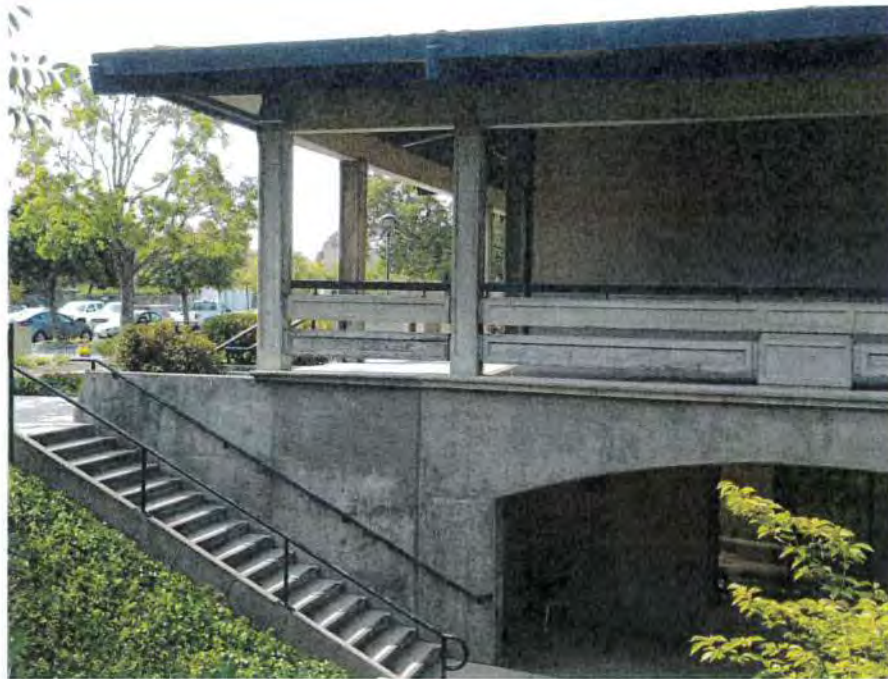
*Photo 4 Veranda*

The veranda fascia on the south elevation has significant wood deterioration, Photo 4. The extent of the deterioration and if it affects the structural members should be investigated during the Tier 2 evaluation.

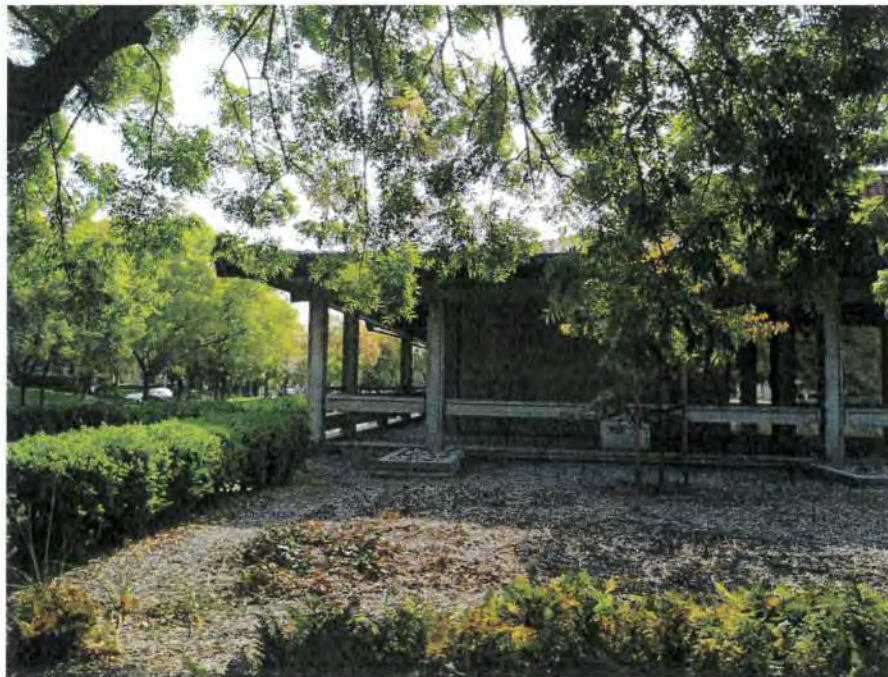
*Photo 5 Veranda*

The veranda slab at the southwest corner has a significant crack and spalling adjacent to the building corner column, Photo 5. The most likely reason is the differential settlement between the building and the slab on grade.

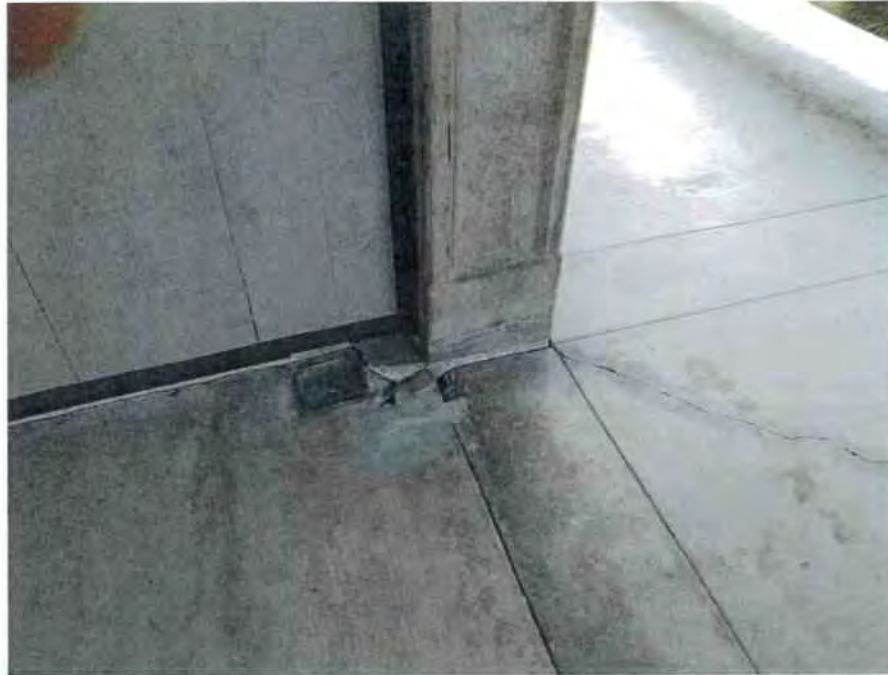
*Photo 6 Veranda Damaged Slab on Grade*
