# **ARBORIST REPORT**

## **HYATT HOUSE HOTEL AT VALLCO PARK**

**WOLFE ROAD & INTERSTATE 280  
CUPERTINO, CALIFORNIA  
(APN 316-20-092)**

July 24, 2014

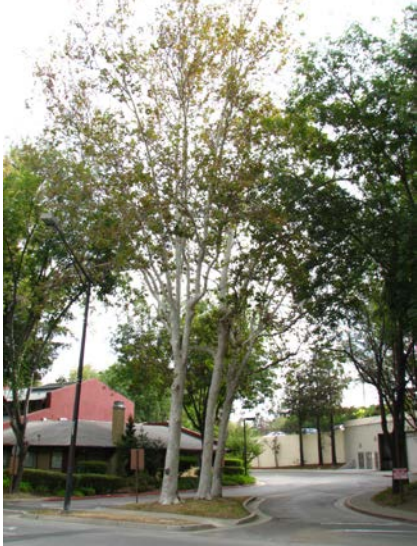
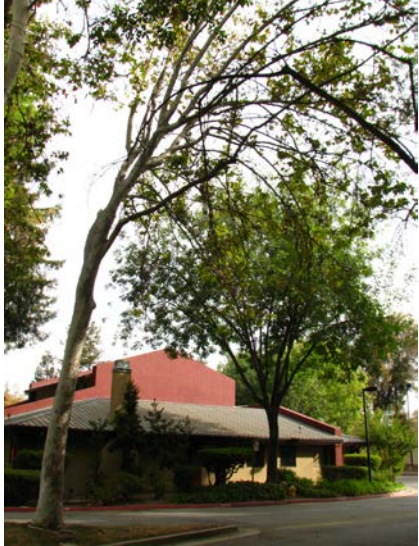
| Tree # | Image | Tree # | Image |
|---|---|---|---|
| 414 and 415<br>to be retained | | 416 initially<br>proposed by<br>the project<br>team to be<br>transplanted<br>(WLCA<br>suggests<br>removal, or<br>redesign the<br>project to<br>work around<br>it) | |

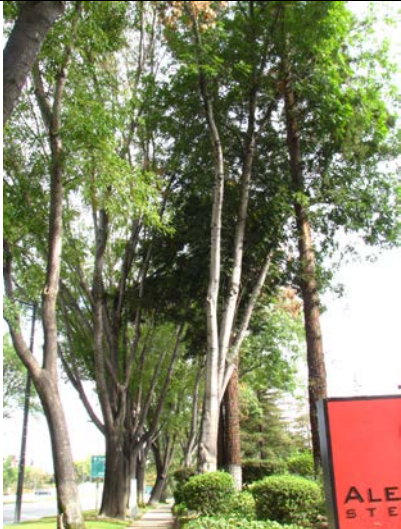
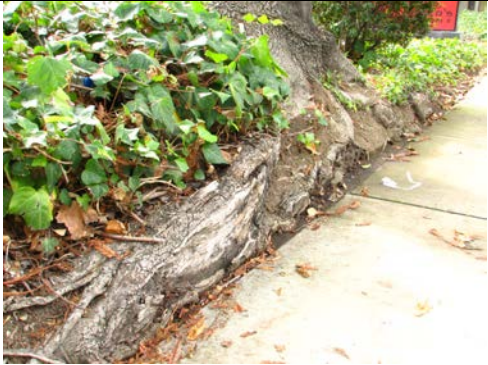
| Tree # | Image | Tree # | Image |
|---|---|---|---|
| 426 to 444<br>along west<br>side of<br>Alexander's<br>Steakhouse<br><br>Some of<br>these trees<br>are to remain,<br>and others<br>are<br>suggested by<br>WLCA to be<br>removed due<br>to safety<br>(risk)<br>concerns | | Close-up of<br>the roots<br>severed<br>along the<br>west side of<br>tree 438,<br>(suggested<br>by WLCA to<br>be<br>removed),<br>during<br>sidewalk<br>replacement. | |

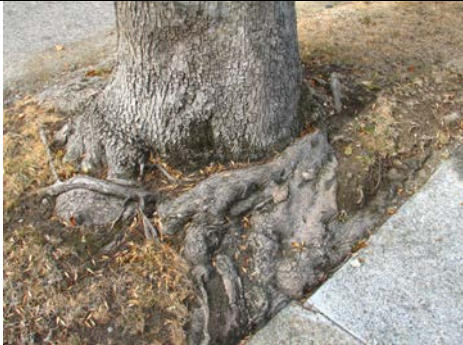
| Tree # | Image | Tree # | Image |
|---|---|---|---|
| Close-up of tree 267 to be removed, which exhibits a severe girdling root issue due to planting strip width which severely restricted normal lateral root extension from the trunk | | Grove of redwoods 204 to 218 to be removed just west of Dynasty Restaurant. | |

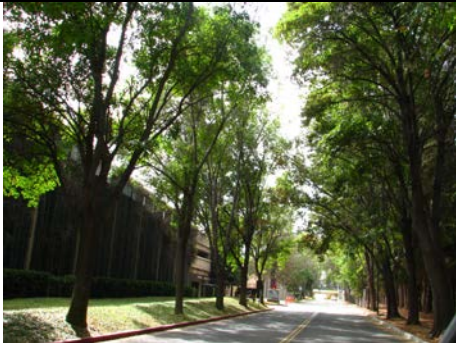
| Tree # | Image | Tree # | Image |
|---|---|---|---|
| Looking south down west perimeter road, at rows starting with tree 240 on left (row to be removed), and 703 at right (row to be retained) | | Redwood specimens along the west side of west perimeter road are suffering severely from soil moisture deficit, and are generally declining or dying | |

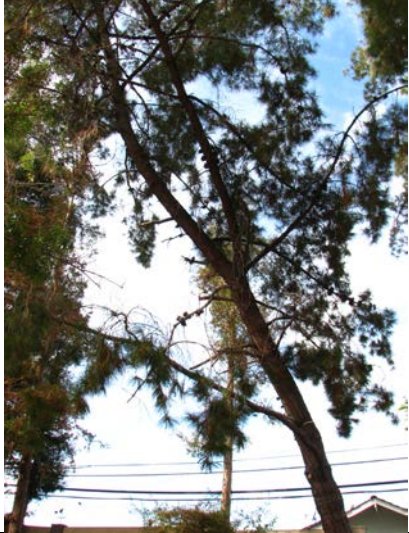
| Tree # | Image | Tree # | Image |
|---|---|---|---|
| Monterey pine 726 rates out with a probable risk of failure due to lean, girdling roots, etc. This tree is in WLCA's suggested removal list. | | Looking south along west perimeter road, again with trees on left to be removed (tree 165 southward), and trees on right to be retained (tree 771 southward) | |

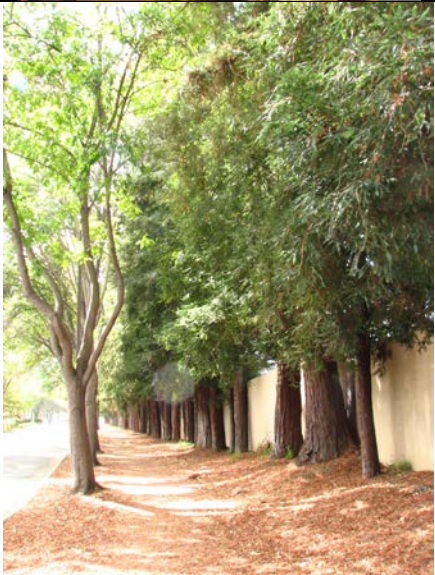
| Tree # | Image | Tree # | Image |
|---|---|---|---|
| The dense screen along the west side of west perimeter road as shown here near tree 771 is in danger of dying due to soil moisture deficit. Replacement of these high water use trees with drought tolerant evergreen species is a viable option. | | | <p>Looking south along west perimeter road.</p> <p>The trees at right are trees 752 southward, and 852 southward, and are currently proposed to be retained.</p> <p>Trees along the left side (east side) of west perimeter road are to be removed.</p> |

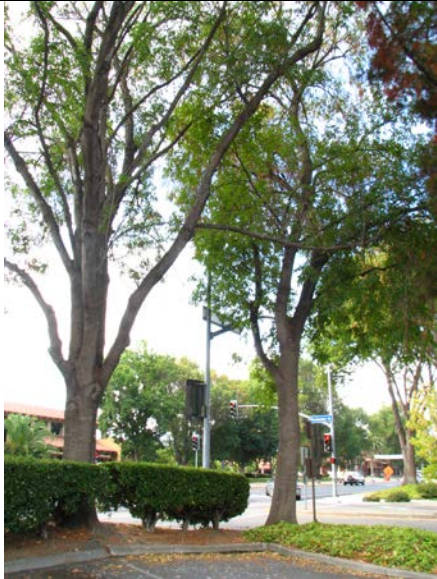
| Tree # | Image | Tree # | Image |
|---|---|---|---|
| Shamel ash trees 8 and 9 to be retained at the southwest corner of the Vallco site.<br><br>Note curb and asphalt displacement from root growth. If this hardscape is removed and replaced, severe root loss and root damage may result, ending in further tree decline or death. | | | <br><br>Shamel ash 9 to 36 to be retained along this south border of the site, looking east. Again, removal of or alternation of existing curb and asphalt materials could cause severe root damage to these already drought-stressed specimens, resulting in further tree decline or death. |

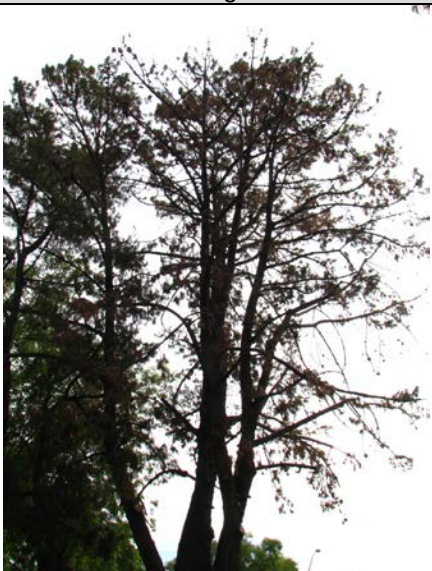
| Tree # | Image | Tree # | Image |
|---|---|---|---|
| Monterey pine 51 at southeast corner of the Vallco site. This tree is dead, and needs to be removed at this time as a high risk of failure and impact to targets. | | Looking north at shamel ash 55, 57, 59, 61, 63, 65 to be retained. | |

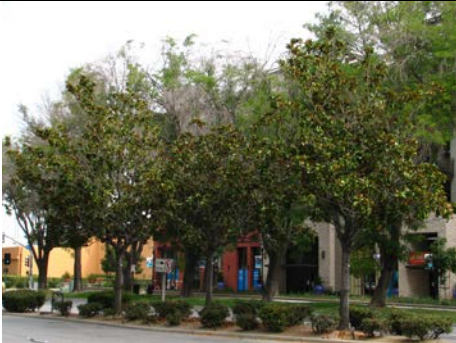
| Tree # | Image | Tree # | Image |
|---|---|---|---|
| Southern magnolias 1106, 1107, 1108 proposed by the project team to be retained, are in decline due to severe soil moisture deficit, and may need to be removed. | | Looking north at shamel ash 102, 103, 104, and 105 to be retained. Note canopy dieback in the form of live twig density decline. | |
