ARBORIST REPORT

HYATT HOUSE HOTEL AT VALLCO PARK

**WOLFE ROAD & INTERSTATE 280
CUPERTINO, CALIFORNIA
(APN 316-20-092)**

July 24, 2014

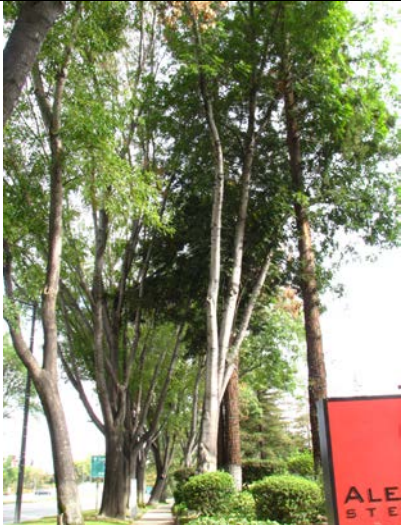
426 to 444 along west side of Alexander's Steakhouse Some of these trees are to remain, and others are suggested by WLCA to be removed due to safety (risk) concerns

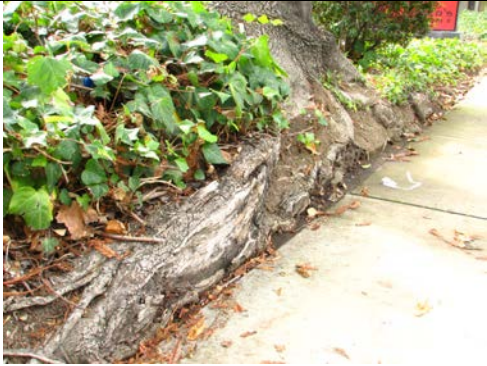
Close-up of the roots severed along the west side of tree 438, (suggested by WLCA to be removed), during sidewalk replacement.

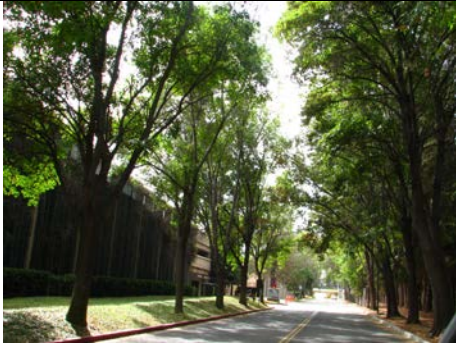
Looking south down west perimeter road, at rows starting with tree 240 on left (row to be removed), and 703 at right (row to be retained)

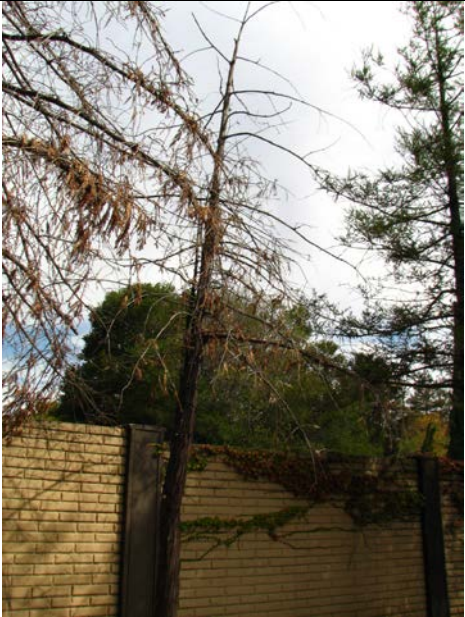
Redwood specimens along the west side of west perimeter road are suffering severely from soil moisture deficit, and are generally declining or dying

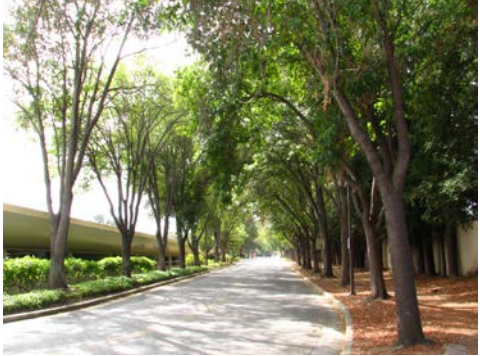
Looking south along west perimeter road, again with trees on left to be removed (tree 165 southward), and trees on right to be retained (tree 771 southward)

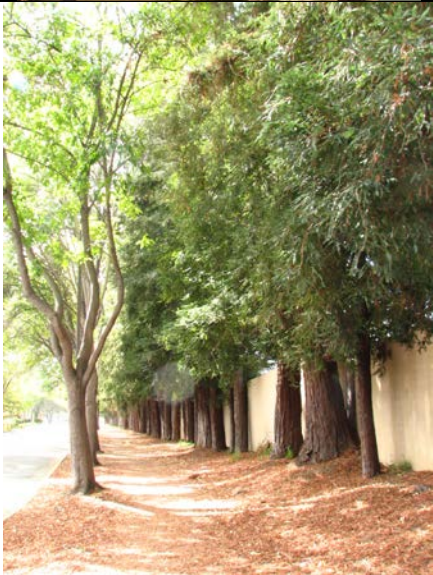
The dense screen along the west side of west perimeter road as shown here near tree 771 is in danger of dying due to soil moisture deficit. Replacement of these high water use trees with drought tolerant evergreen species is a viable option.

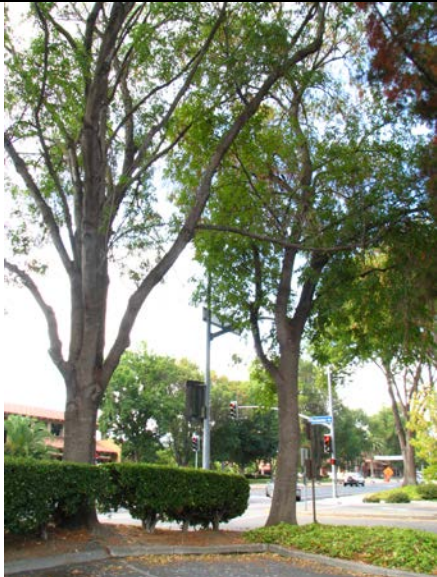
Tree #	Image	Tree #	Image
Shamel ash trees 8 and 9 to be retained at the southwest corner of the Vallco site. Note curb and asphalt displacement from root growth. If this hardscape is removed and replaced, severe root loss and root damage may result, ending in further tree decline or death.

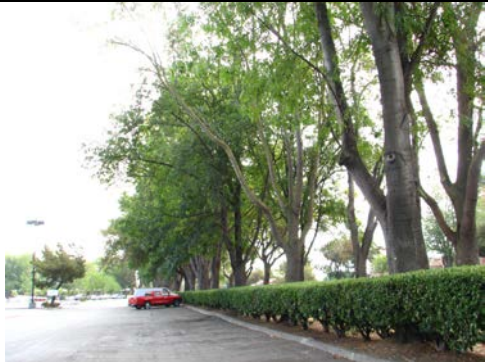
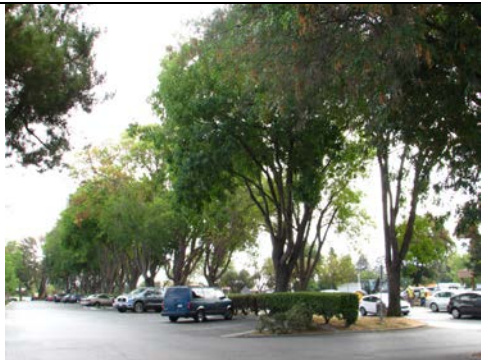
Shamel ash 9 to 36 to be retained along this south border of the site, looking east. Again, removal of or alternation of existing curb and asphalt materials could cause severe root damage to these already drought-stressed specimens, resulting in further tree decline or death.
Shamel ash 23 to 36 to be retained, looking southeast.

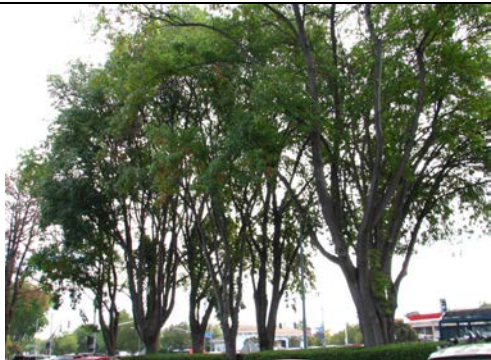
Shamel ash 42 to 50 to be retained along south border. Looking southeast.

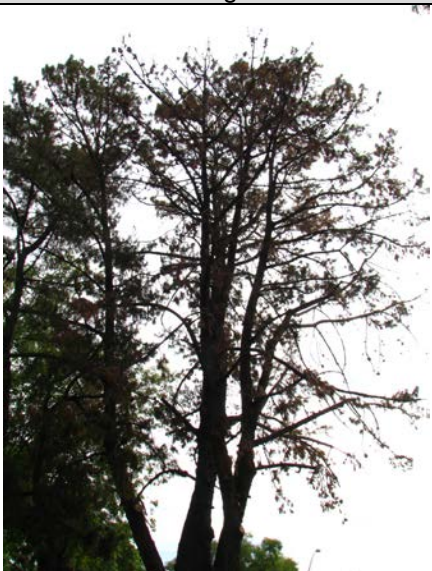
Tree #	Image	Tree #	Image
Monterey pine 51 at southeast corner of the Vallco site. This tree is dead, and needs to be removed at this time as a high risk of failure and impact to targets.

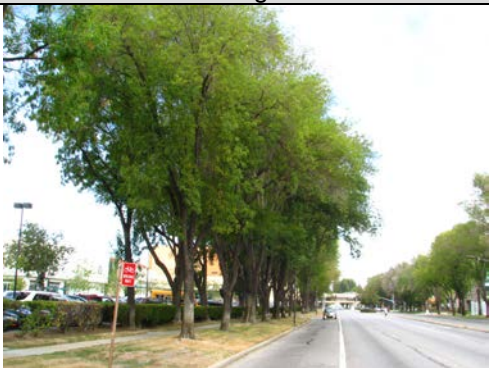
Looking north at shamel ash 55, 57, 59, 61, 63, 65 to be retained.
