ARBORIST REPORT

HYATT HOUSE HOTEL AT VALLCO PARK

**WOLFE ROAD & INTERSTATE 280
CUPERTINO, CALIFORNIA
(APN 316-20-092)**

July 24, 2014

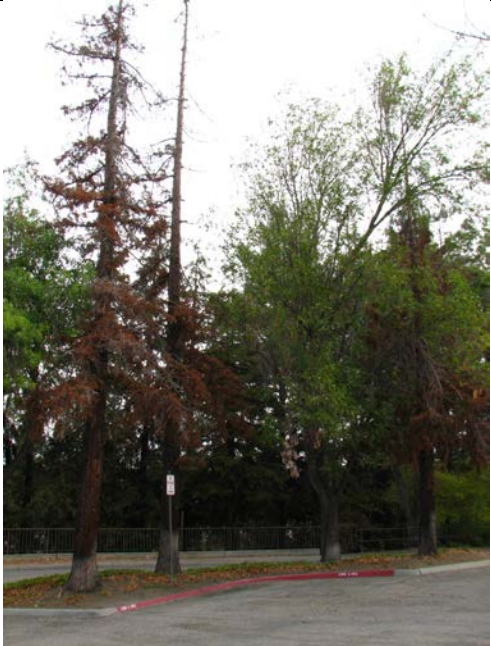
Example of redwoods and ash specimens 332, 333, and 335 in very poor condition due to soil moisture deficit, at the JC Penny parking lot.

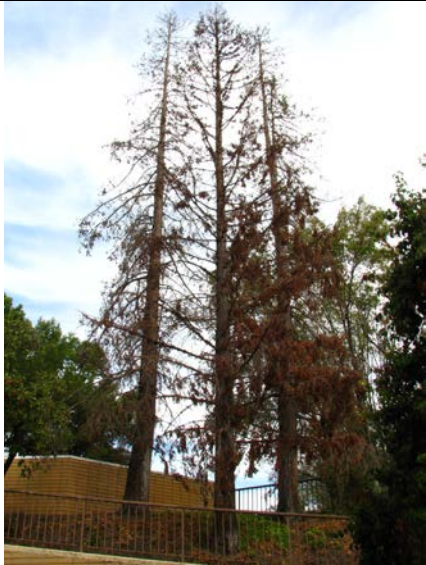
Redwoods 500, 501, and 502 are dead in the southeast corner of the JC Penny parking lot area. These trees are planned to be removed.

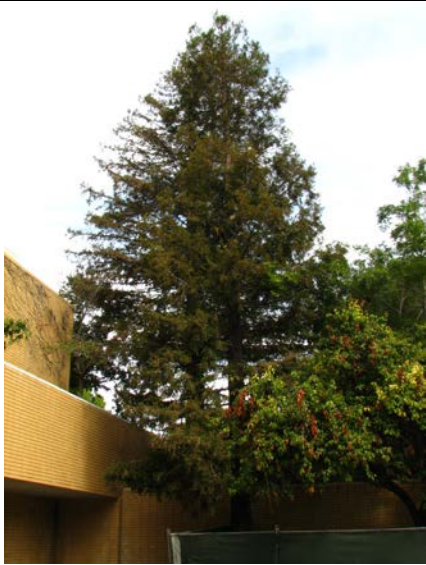
In contrast to dead redwoods 500, 501, and 502 shown in the image at left, redwoods 505 and 510 at right are in decent condition just 30 or 40 feet west. The trees are to be removed.

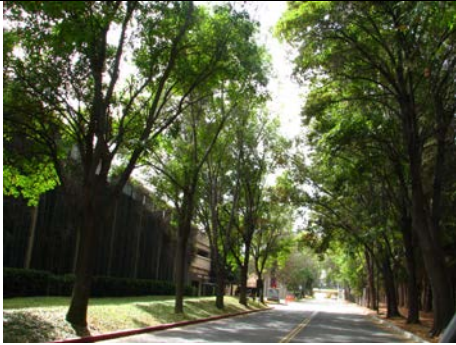
Looking south down west perimeter road, at rows starting with tree 240 on left (row to be removed), and 703 at right (row to be retained)

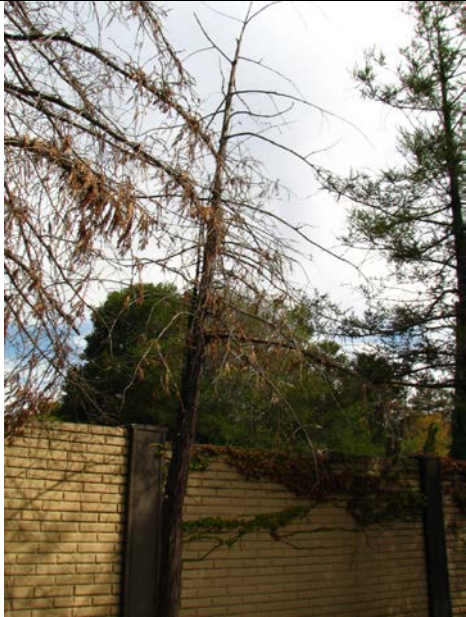
Redwood specimens along the west side of west perimeter road are suffering severely from soil moisture deficit, and are generally declining or dying

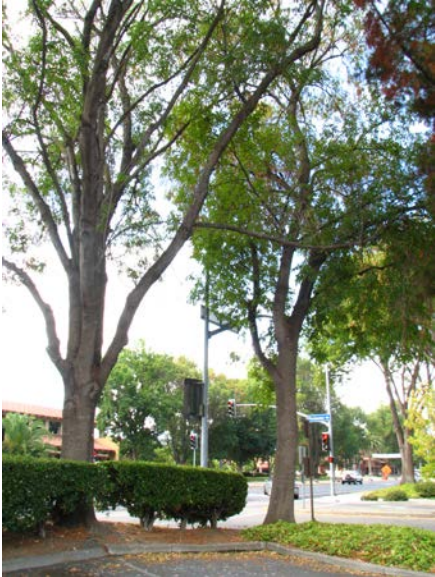
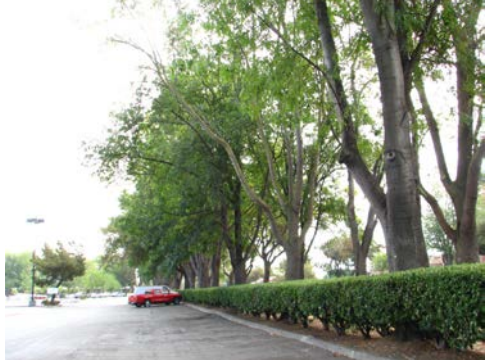
Tree #	Image	Tree #	Image
Shamel ash trees 8 and 9 to be retained at the southwest corner of the Vallco site. Note curb and asphalt displacement from root growth. If this hardscape is removed and replaced, severe root loss and root damage may result, ending in further tree decline or death.

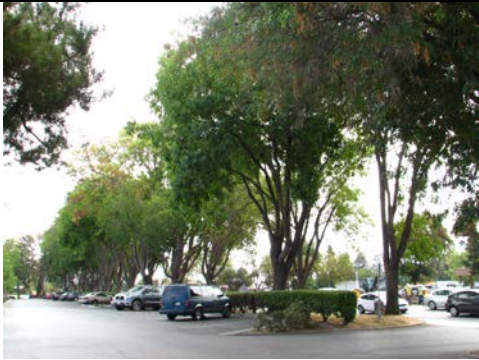
Shamel ash 9 to 36 to be retained along this south border of the site, looking east. Again, removal of or alternation of existing curb and asphalt materials could cause severe root damage to these already drought-stressed specimens, resulting in further tree decline or death.
Shamel ash 23 to 36 to be retained, looking southeast.

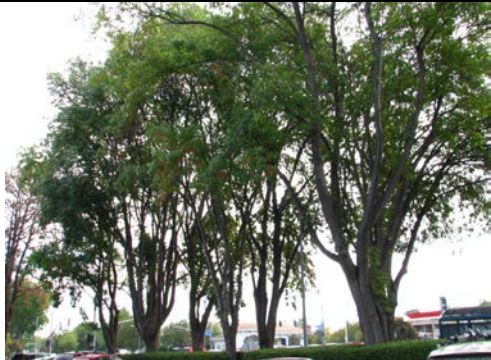
Shamel ash 42 to 50 to be retained along south border. Looking southeast.

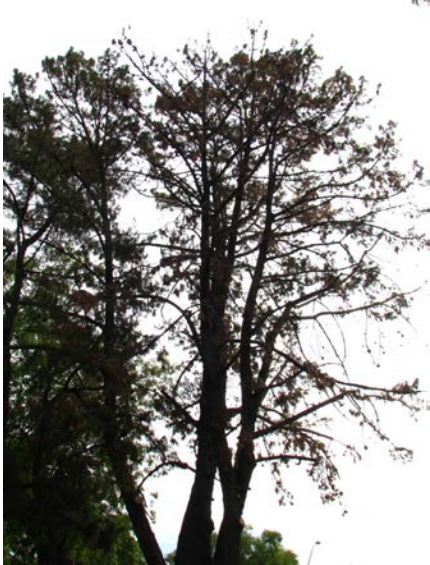
Tree #	Image	Tree #	Image
Monterey pine 51 at southeast corner of the Vallco site. This tree is dead, and needs to be removed at this time as a high risk of failure and impact to targets.

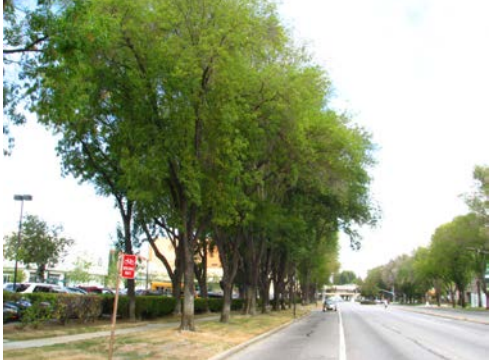
Looking north at shamel ash 55, 57, 59, 61, 63, 65 to be retained.

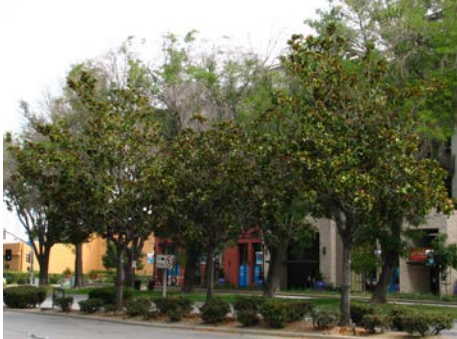
Southern magnolias 1106, 1107, 1108 proposed by the project team to be retained, are in decline due to severe soil moisture deficit, and may need to be removed.
