March 26, 2019

Subject: Closure Plan for Former Sears Automotive Center, Former Vallco Shopping Mall

PHOTOGRAPHIC LOG	
Sand Hill Pro	operties	Former Vallco Mall Cupertino, California	31401588.001
collected along t	ilding, first flo amples will be	019 ars or.

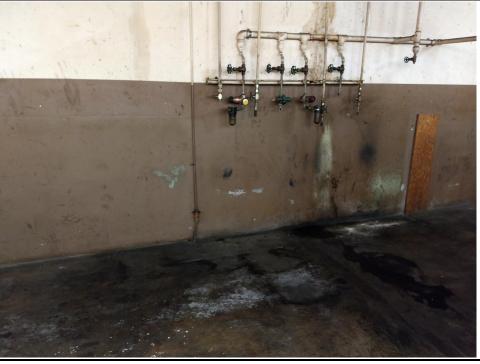
6	March 25, 2019	
Basement level o	of the former Sears	
Automotive Co	enter. Two wipe	111
samples to be co	llected in areas of	
staining on the f	loor and two wipe	1
samples along th	ne wall, above the	1
areas of	staining.	
		1. 47. 4
