RE: Tree Inventory and Arborist Report for Courtyard Hotel in Cupertino, CA

TREE INVENTORY AND ARBORIST REPORT

Courtyard Hotel
10605 N. Wolfe Rd.
Cupertino, CA

September 2019

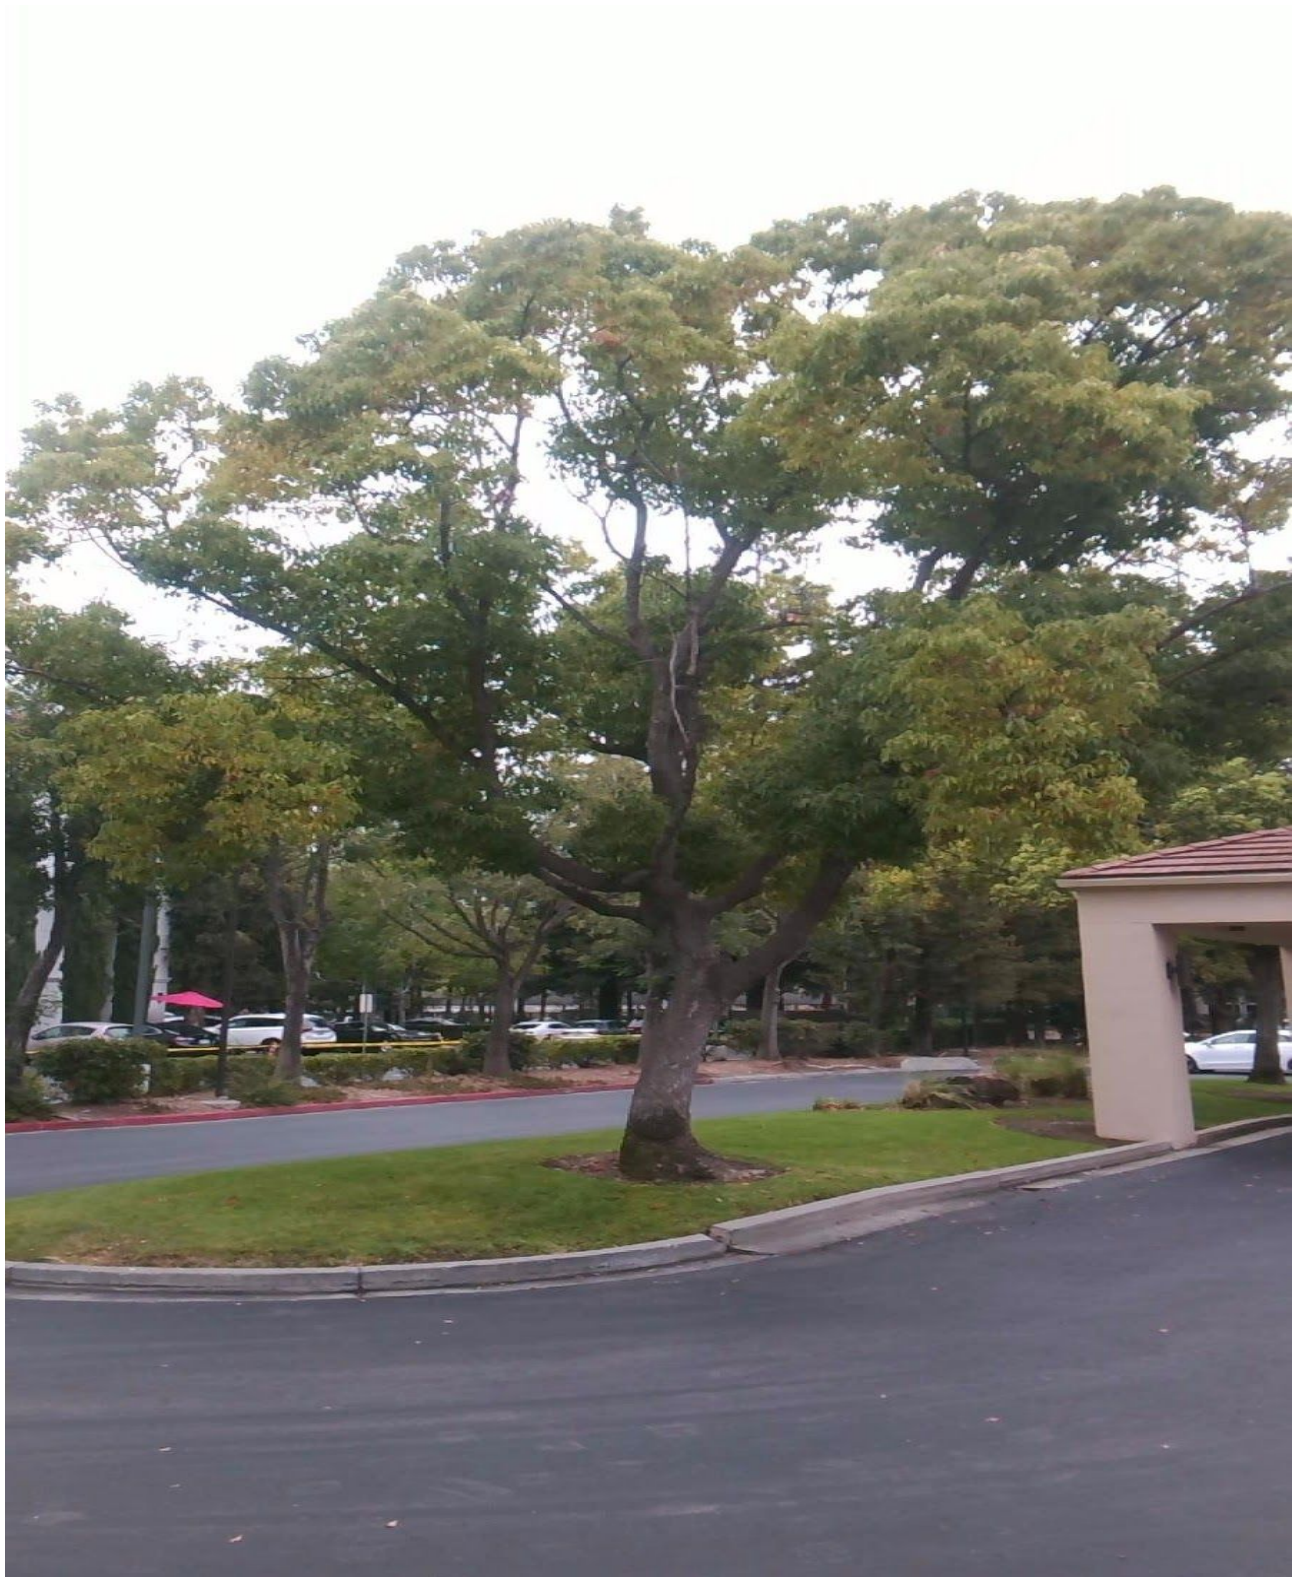
Photo 1. Camphor tree #1 is damaging curb

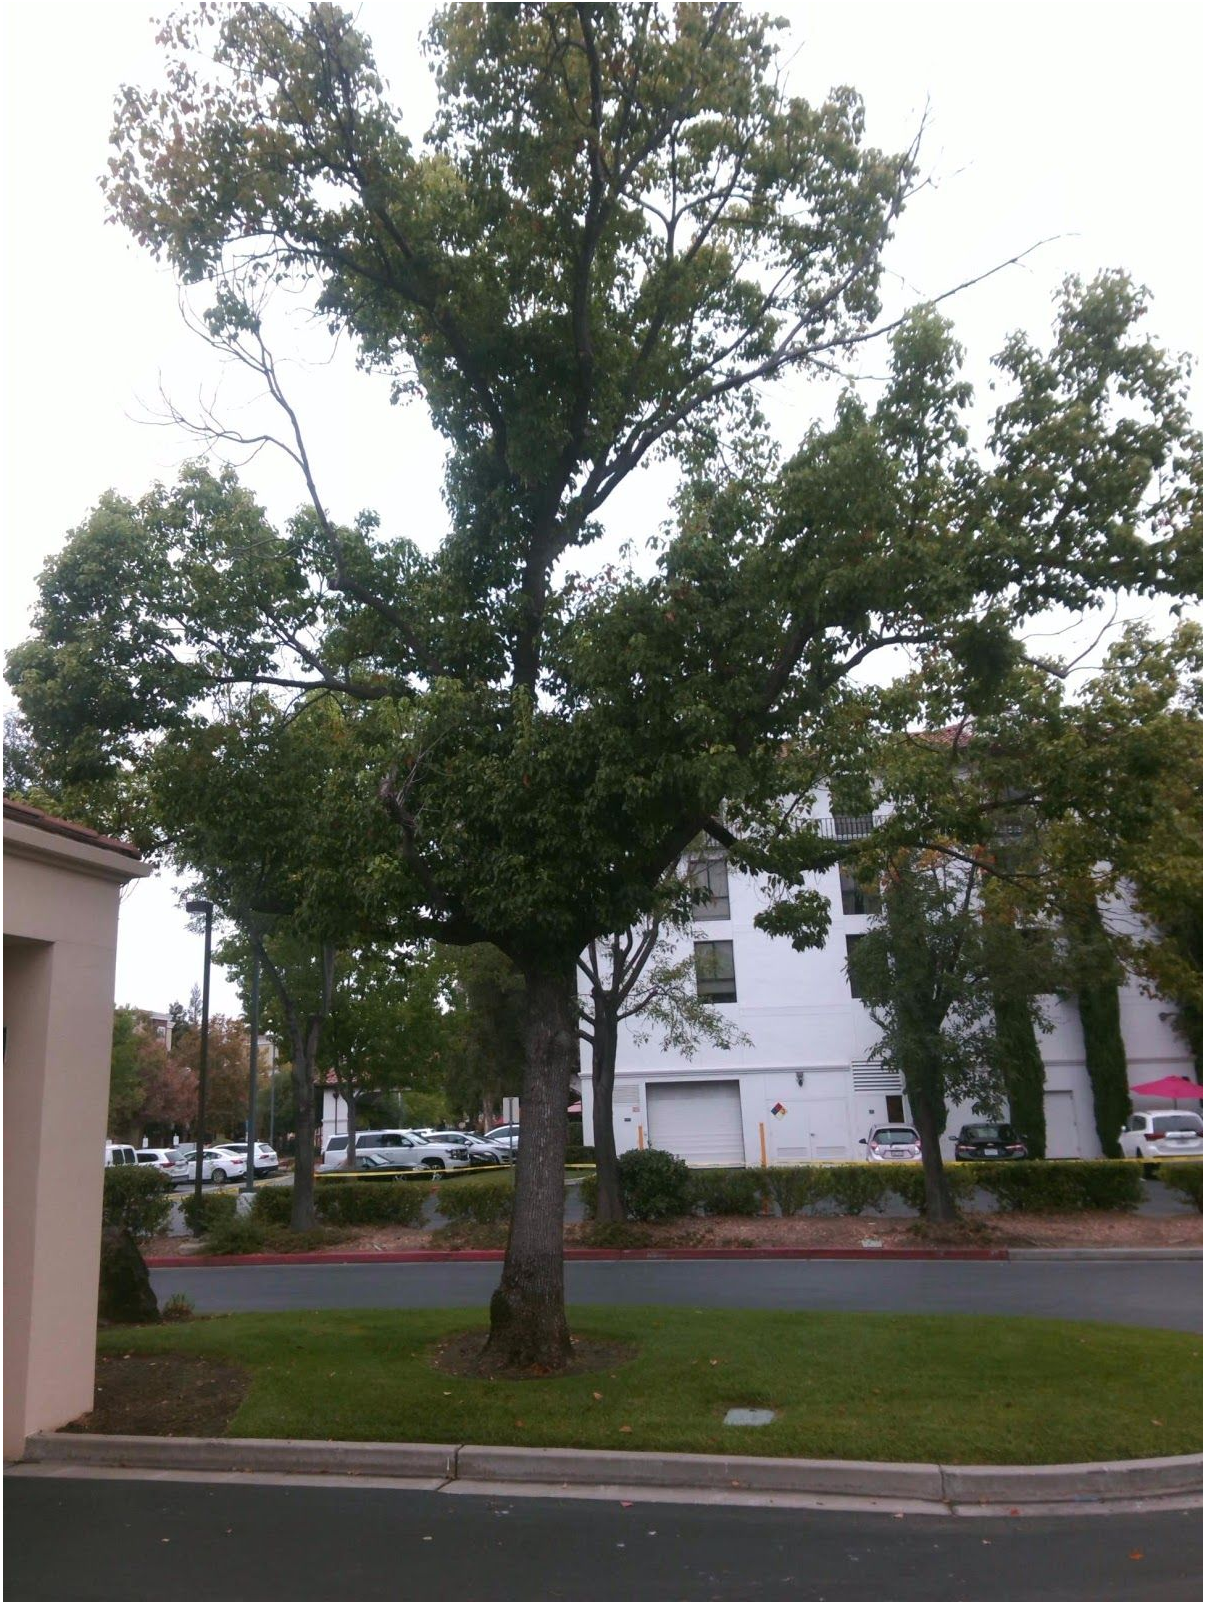
Photo 2. Camphor tree #2 is showing signs of stress

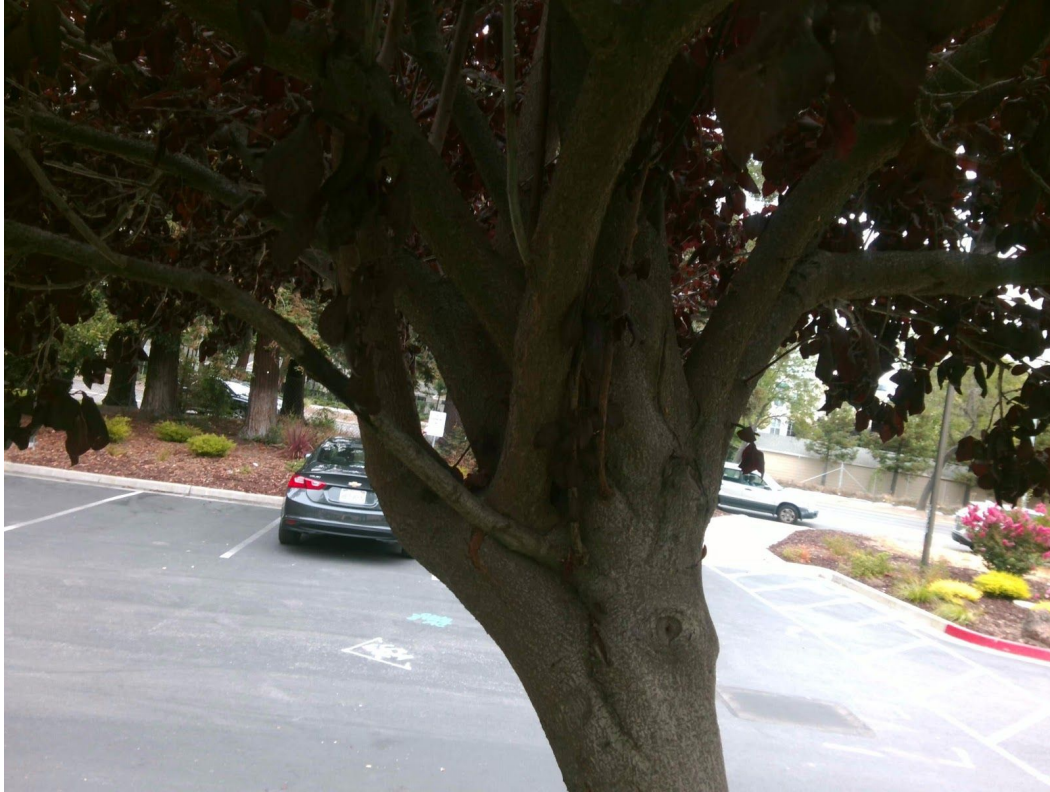
Photo 3. Tree #3 has poor branch structure

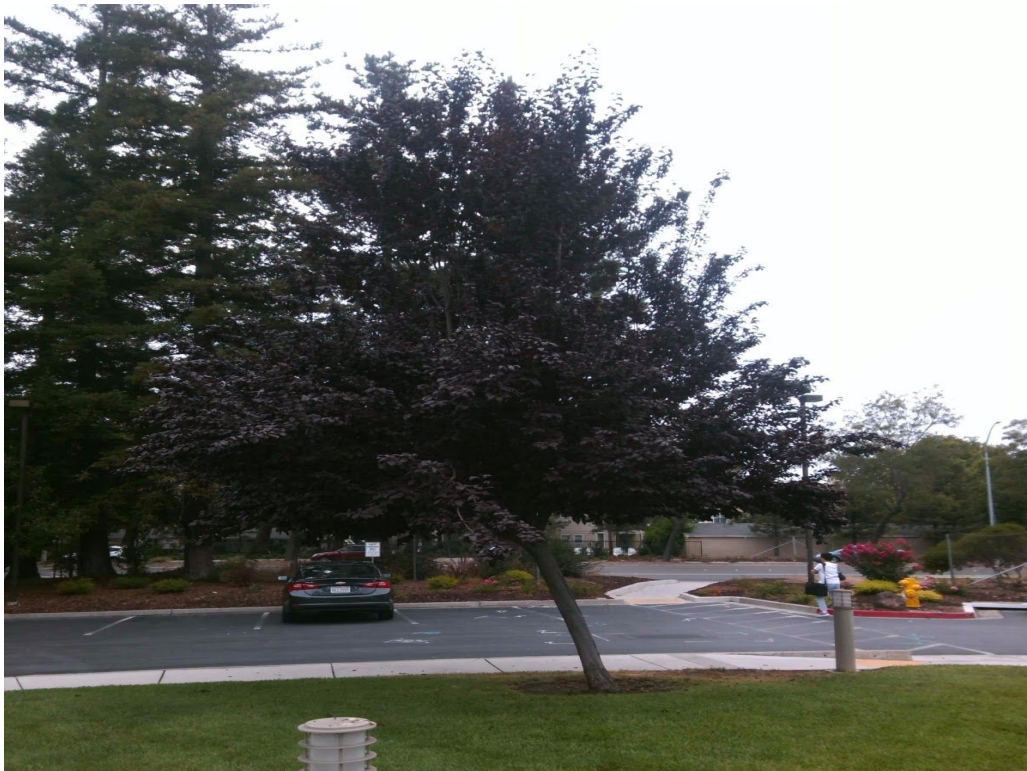
Photo 4. Tree #3 leans

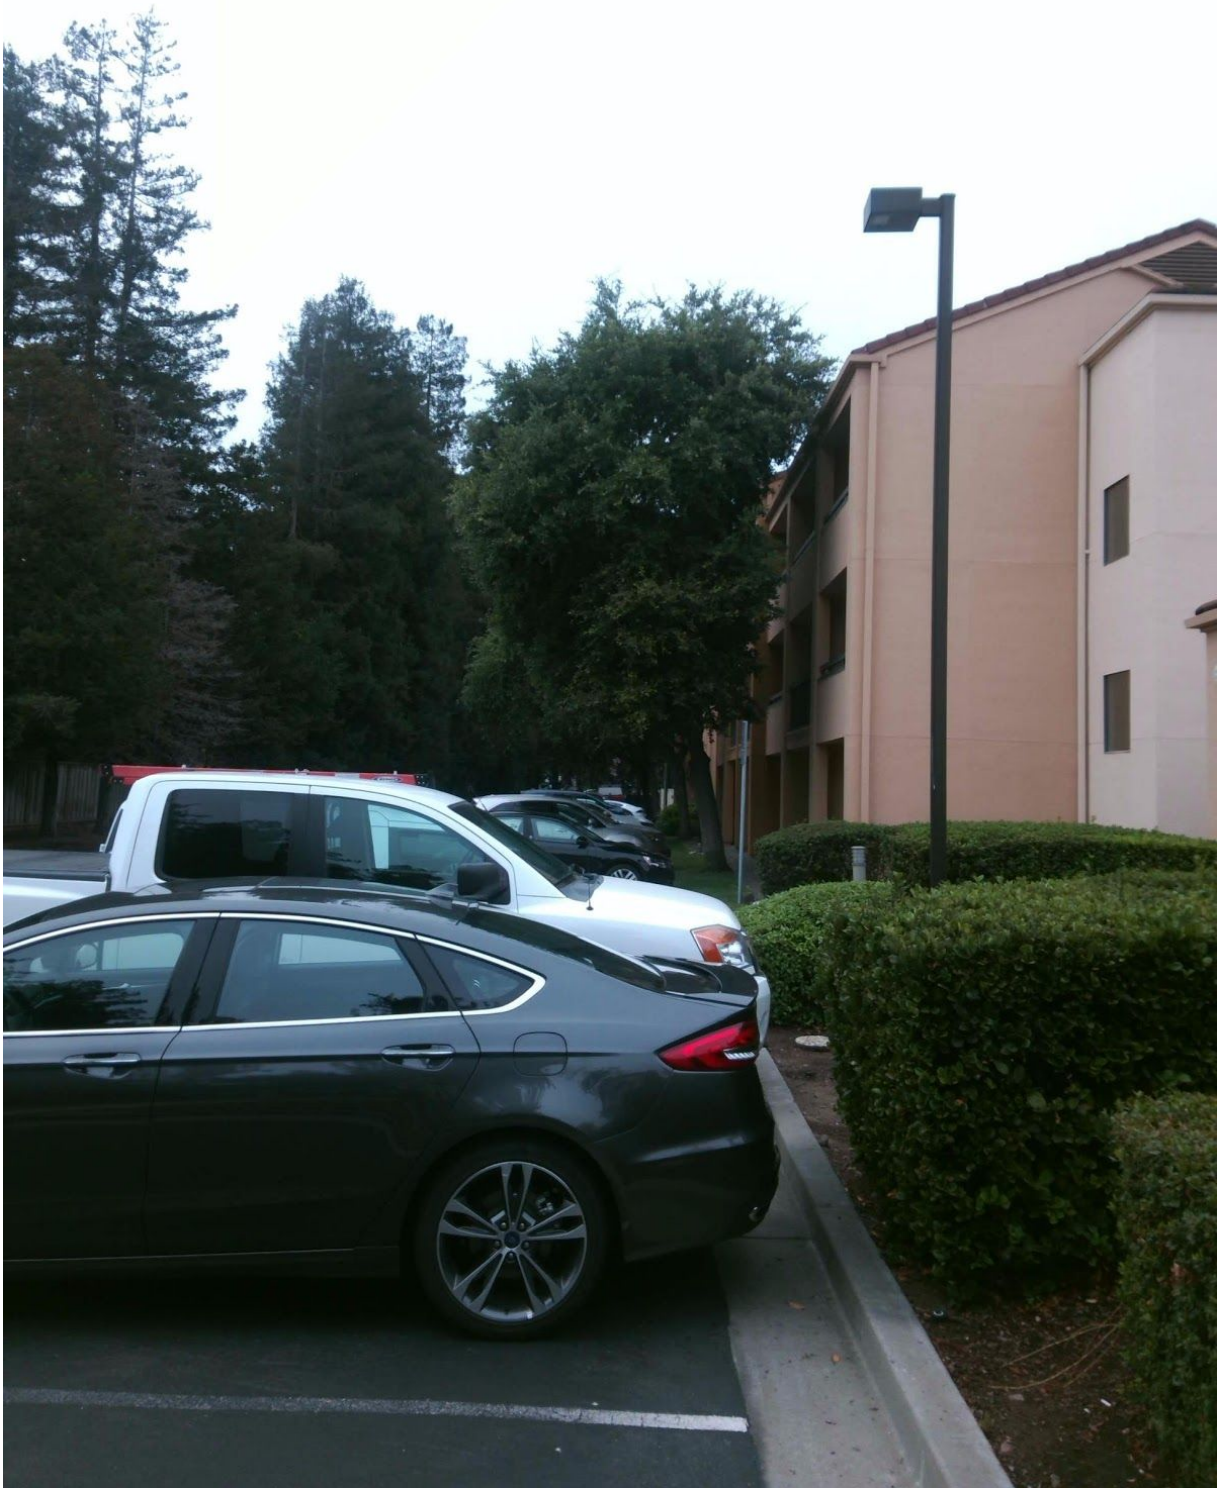
Photo 5. Tree #4 is growing too close to building

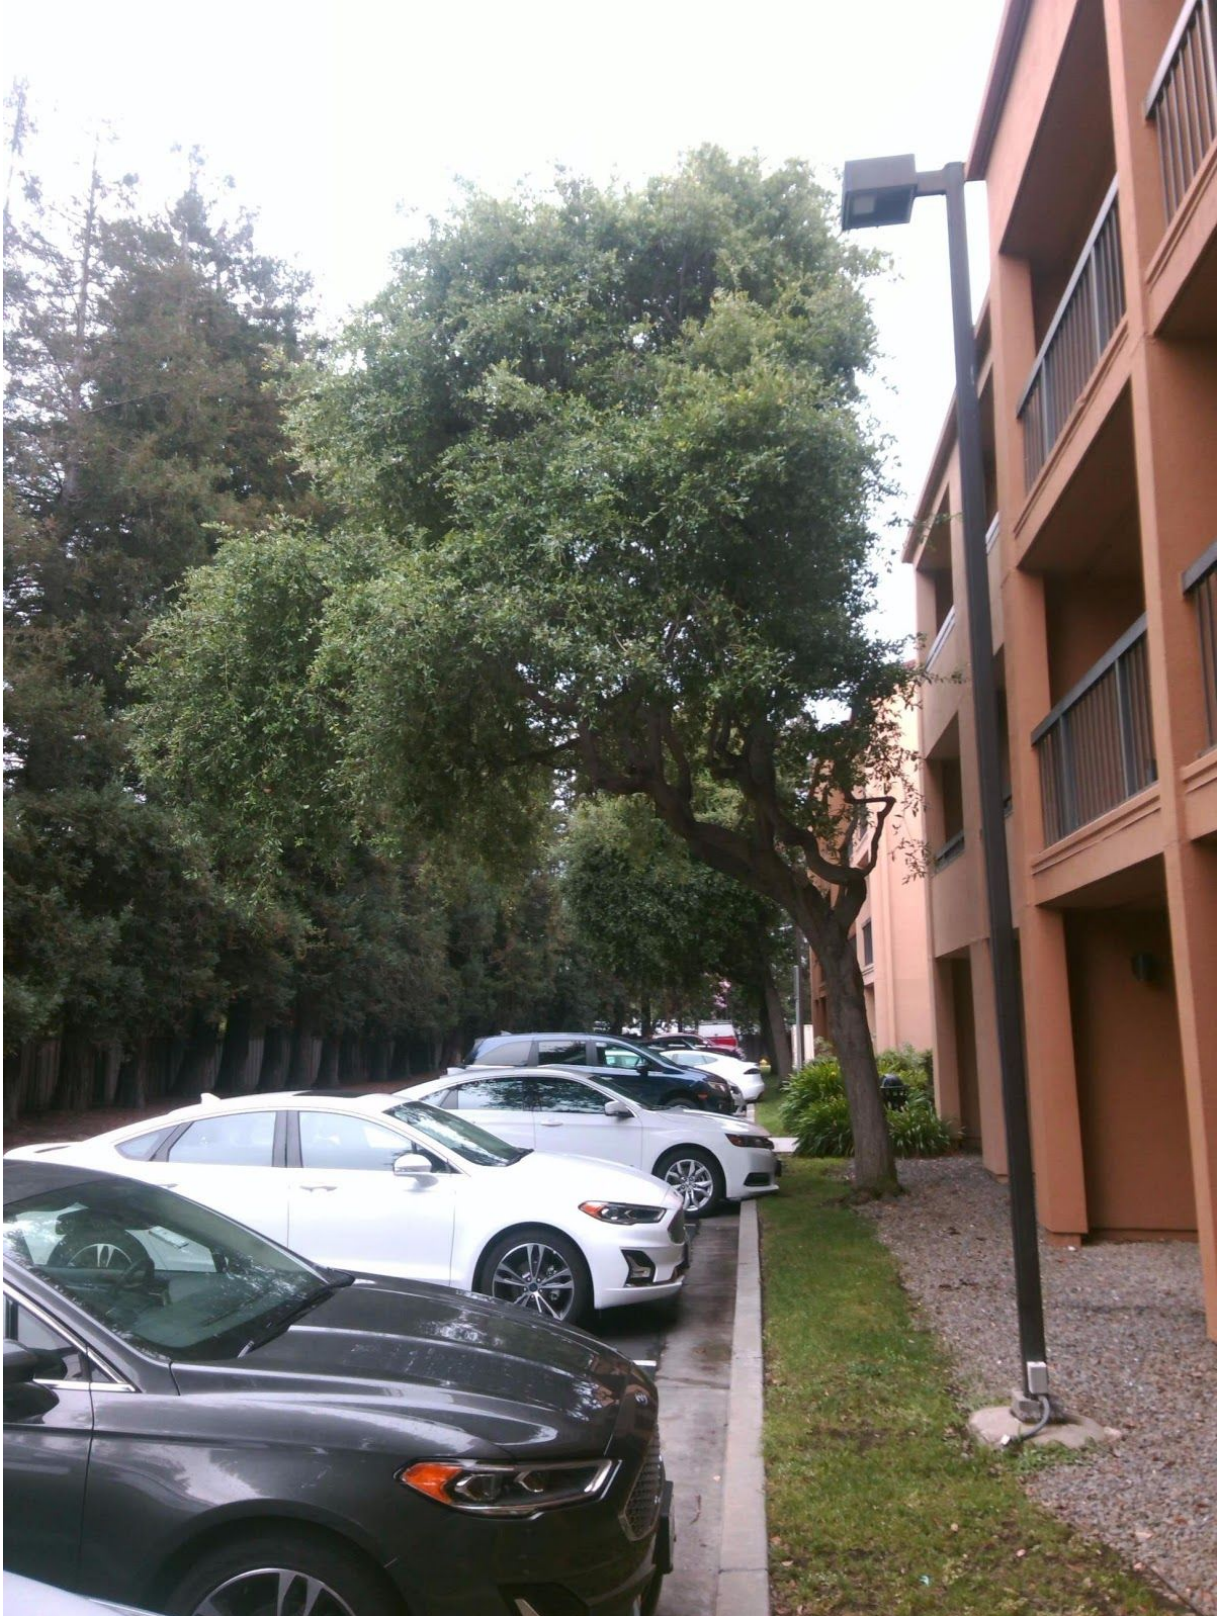
Photo 6. Tree #5 is one sided

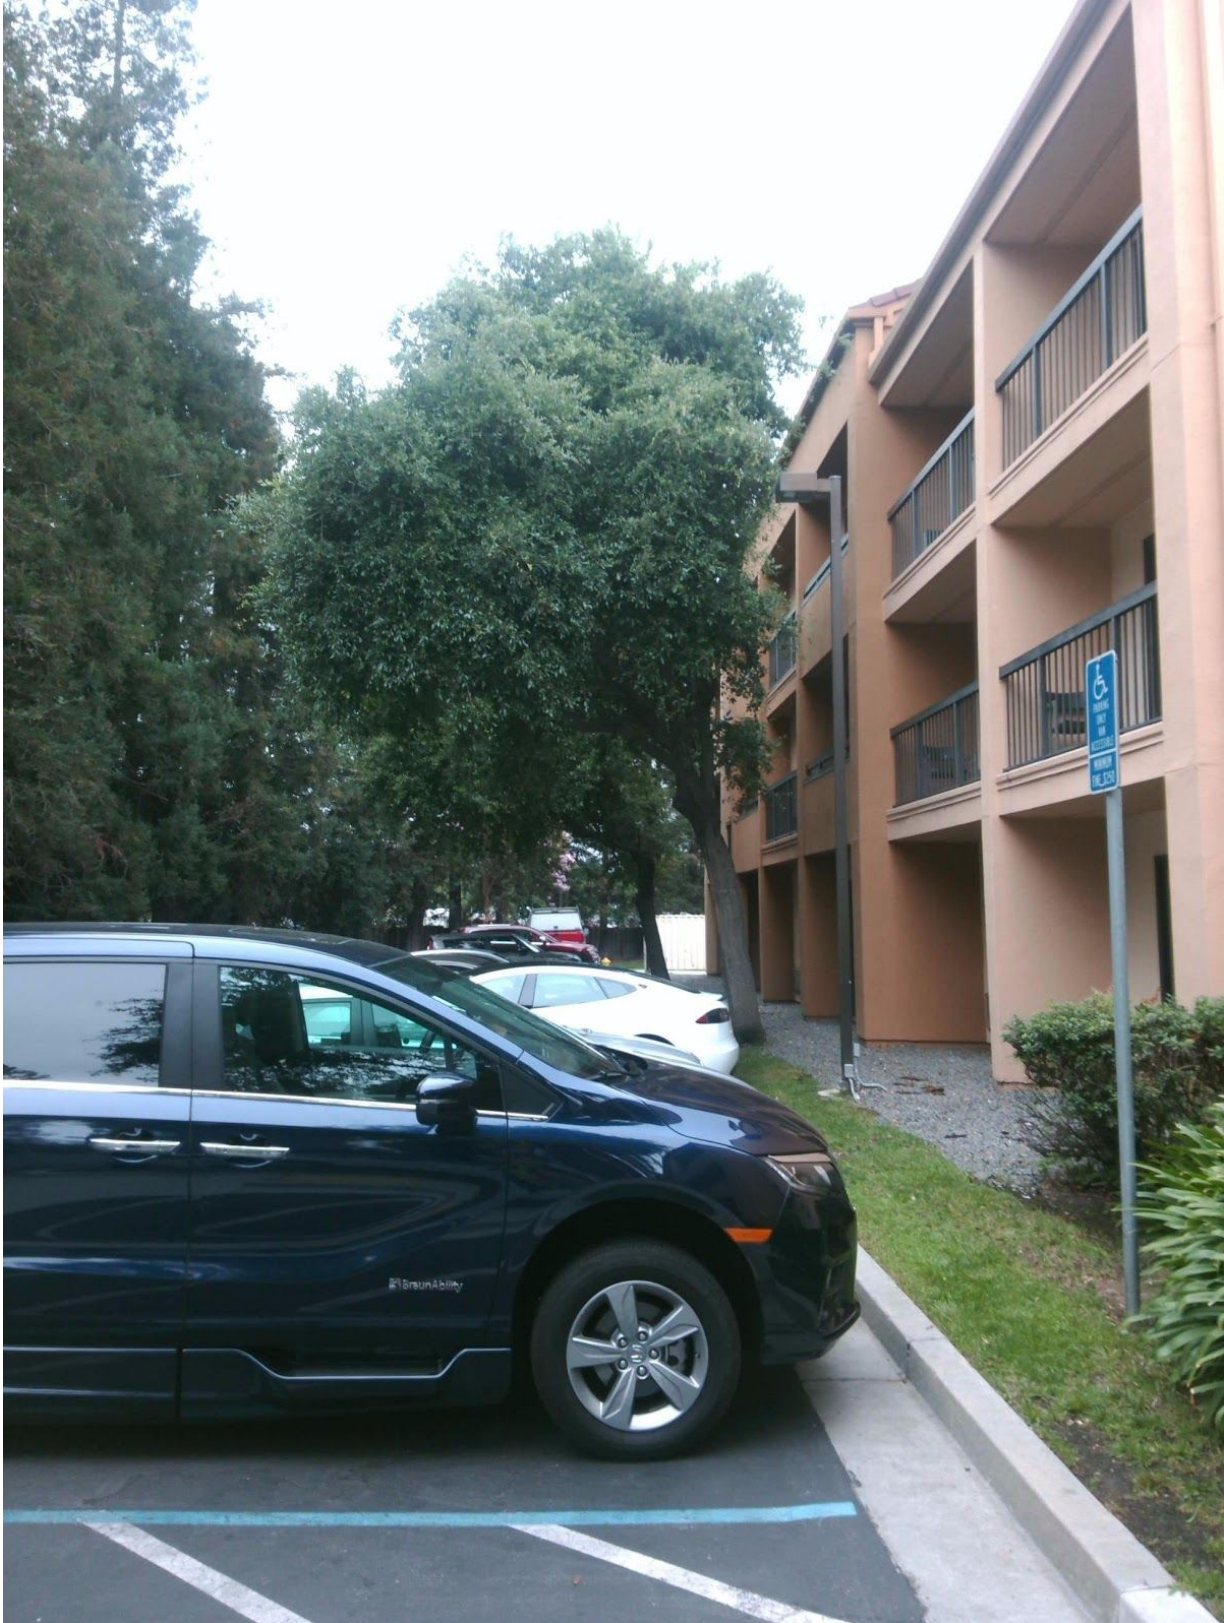
Photo 7. Tree #6 is one sided

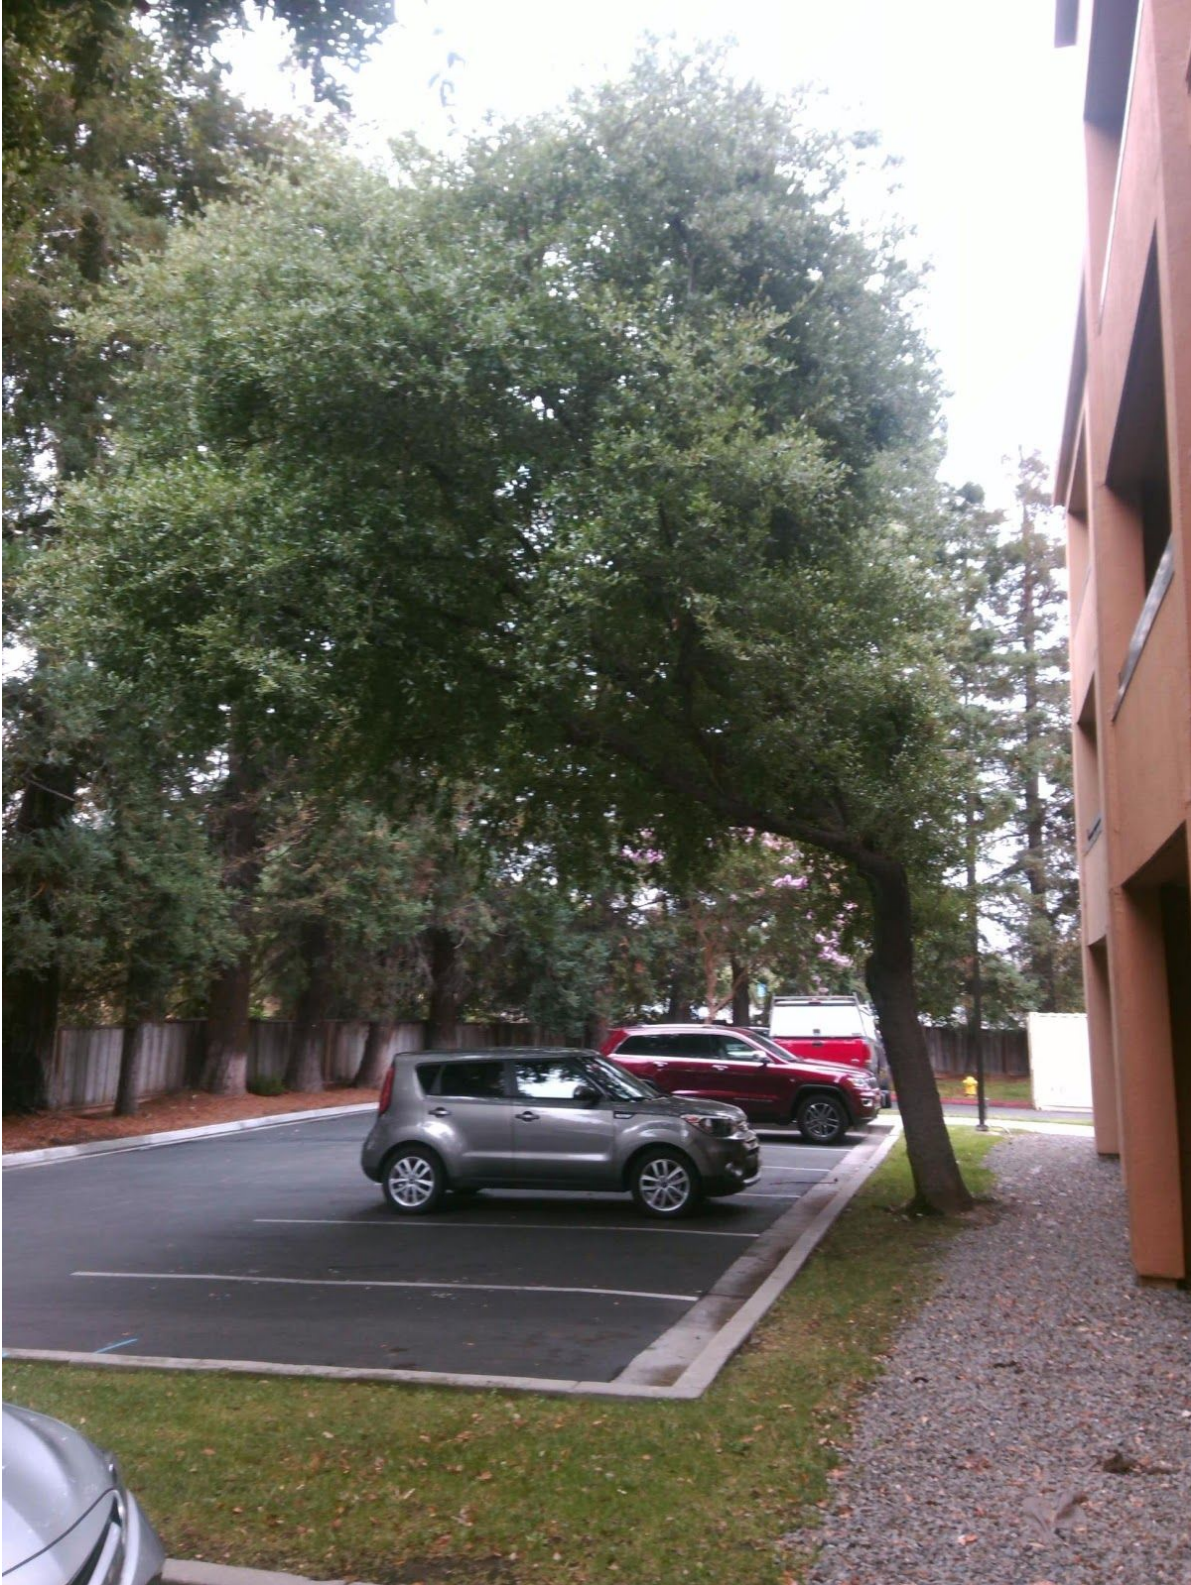
Photo 8. Tree #7 has unbalanced and off-center canopy

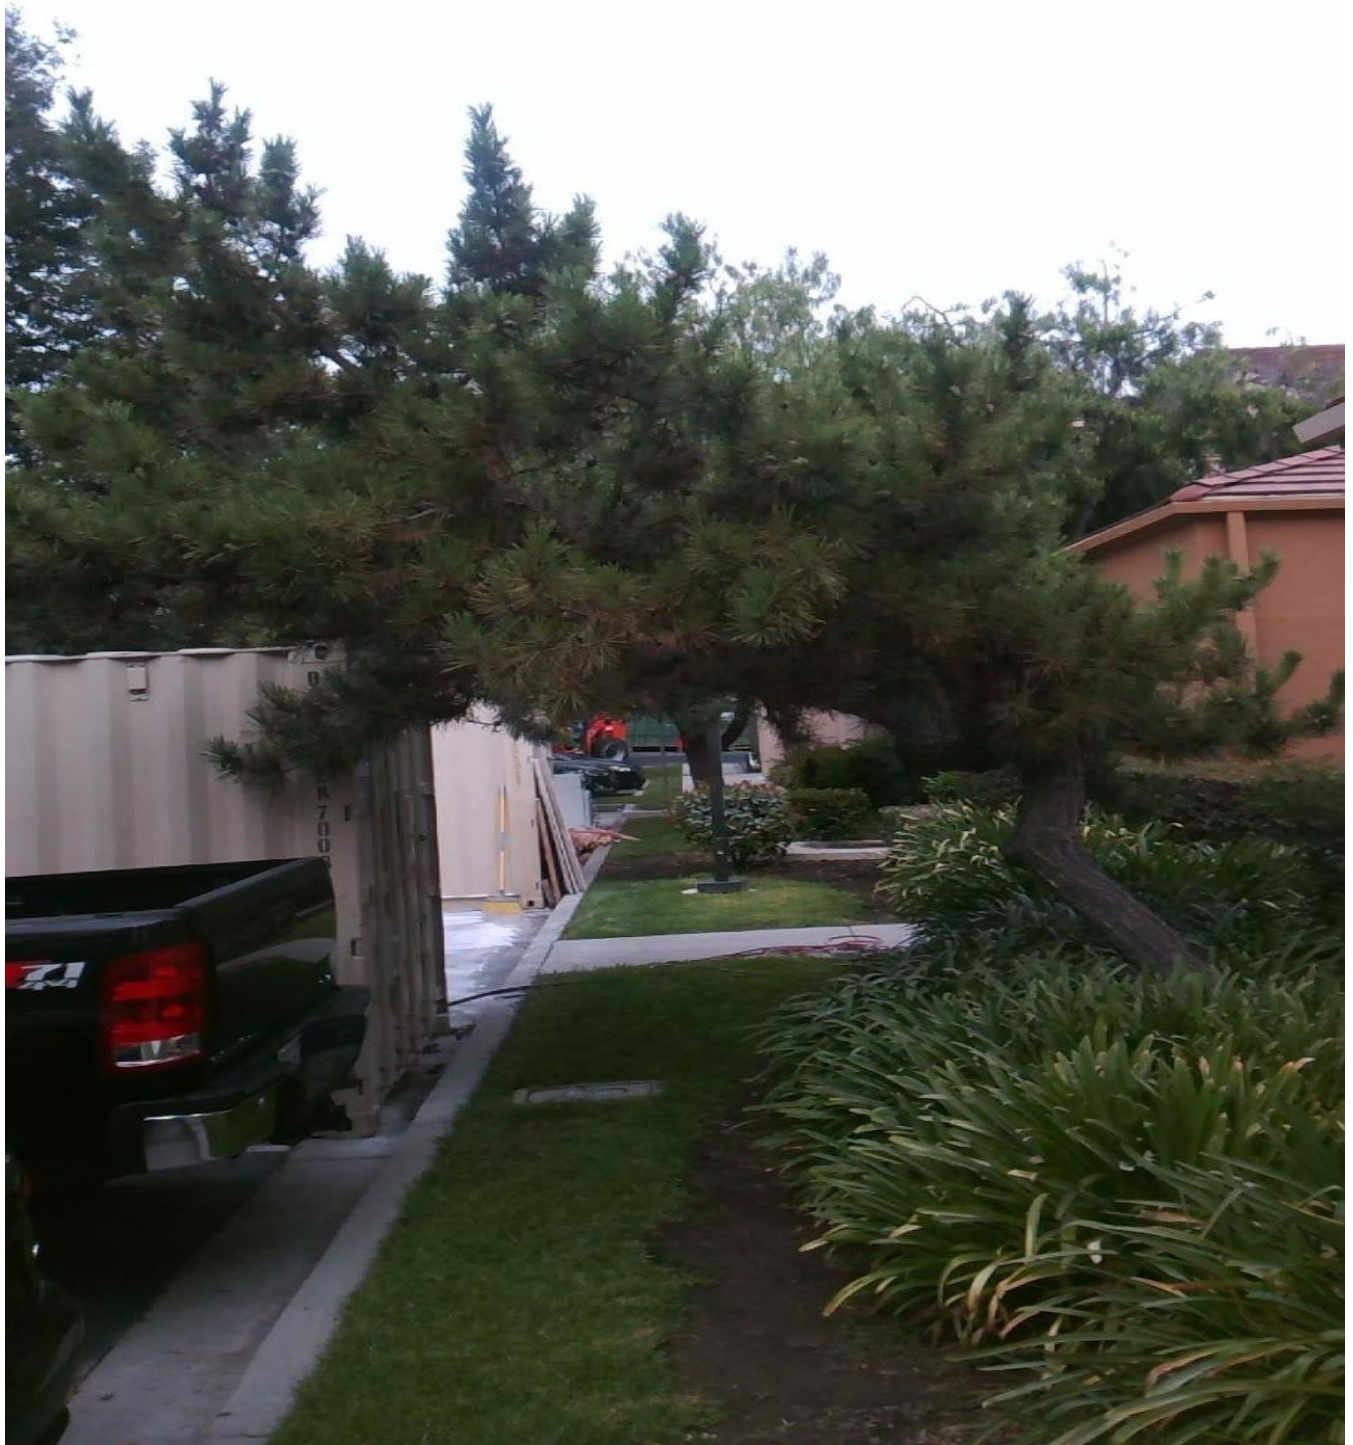
Photo 9. Tree #8 has an excessive lean

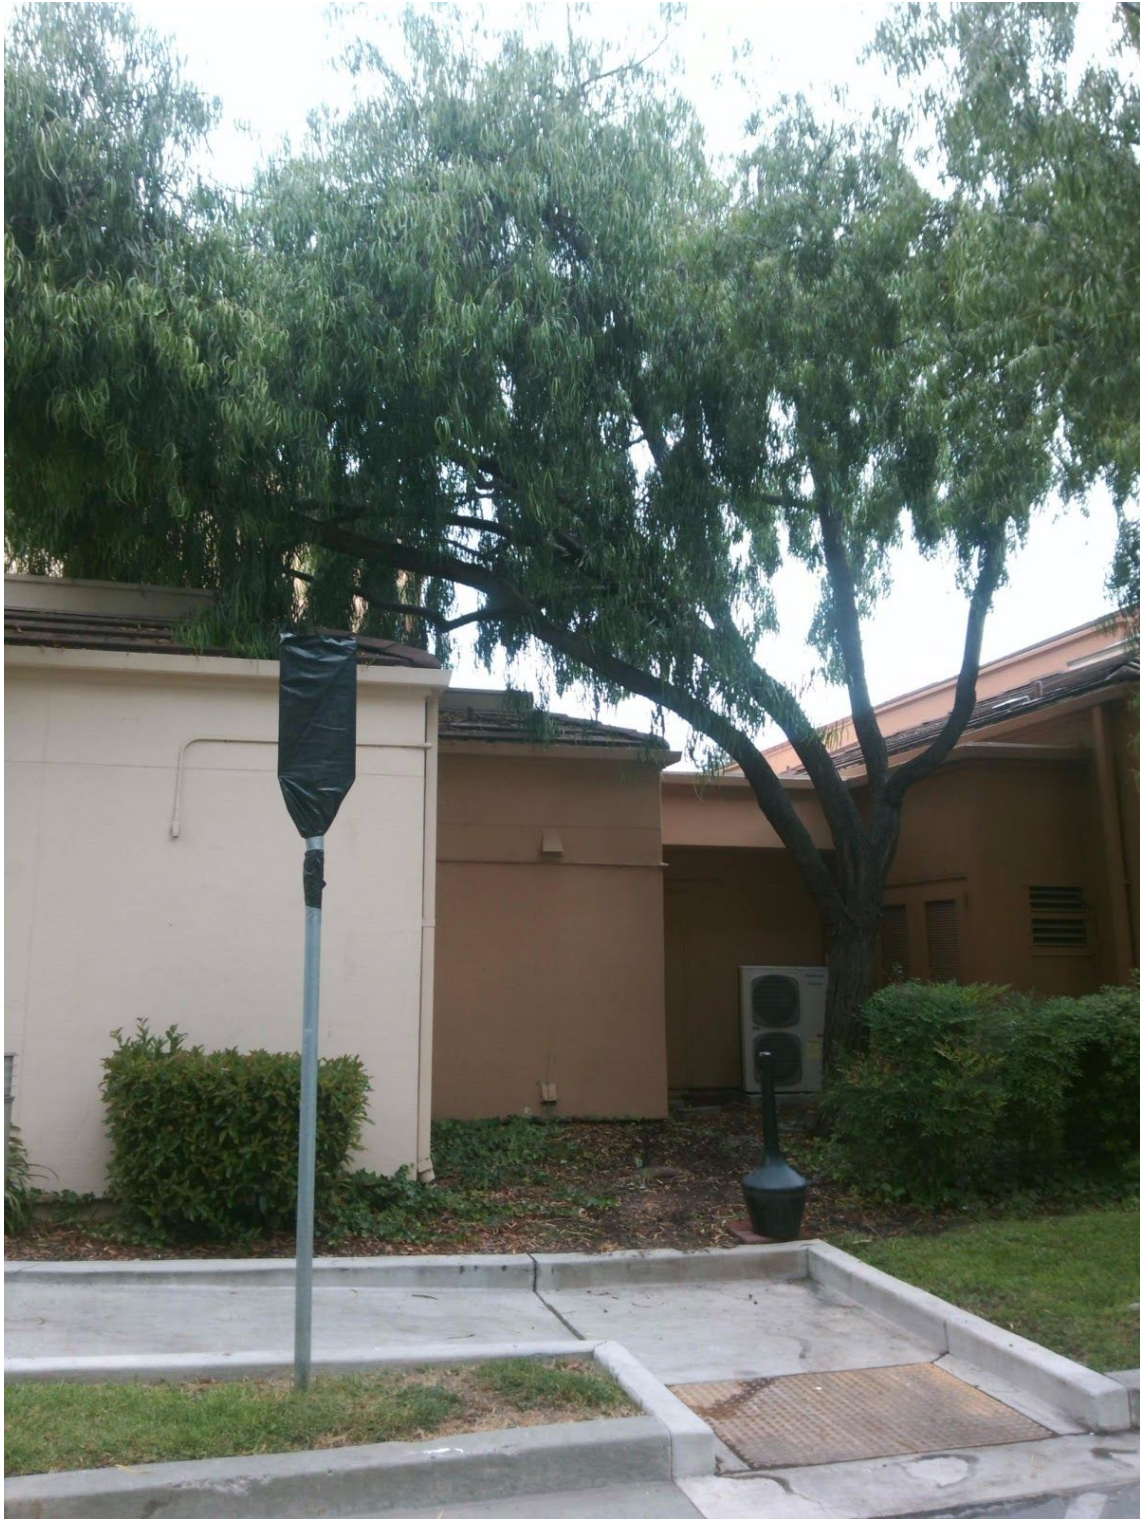
Photo 10. Tree #9 is growing very close to building

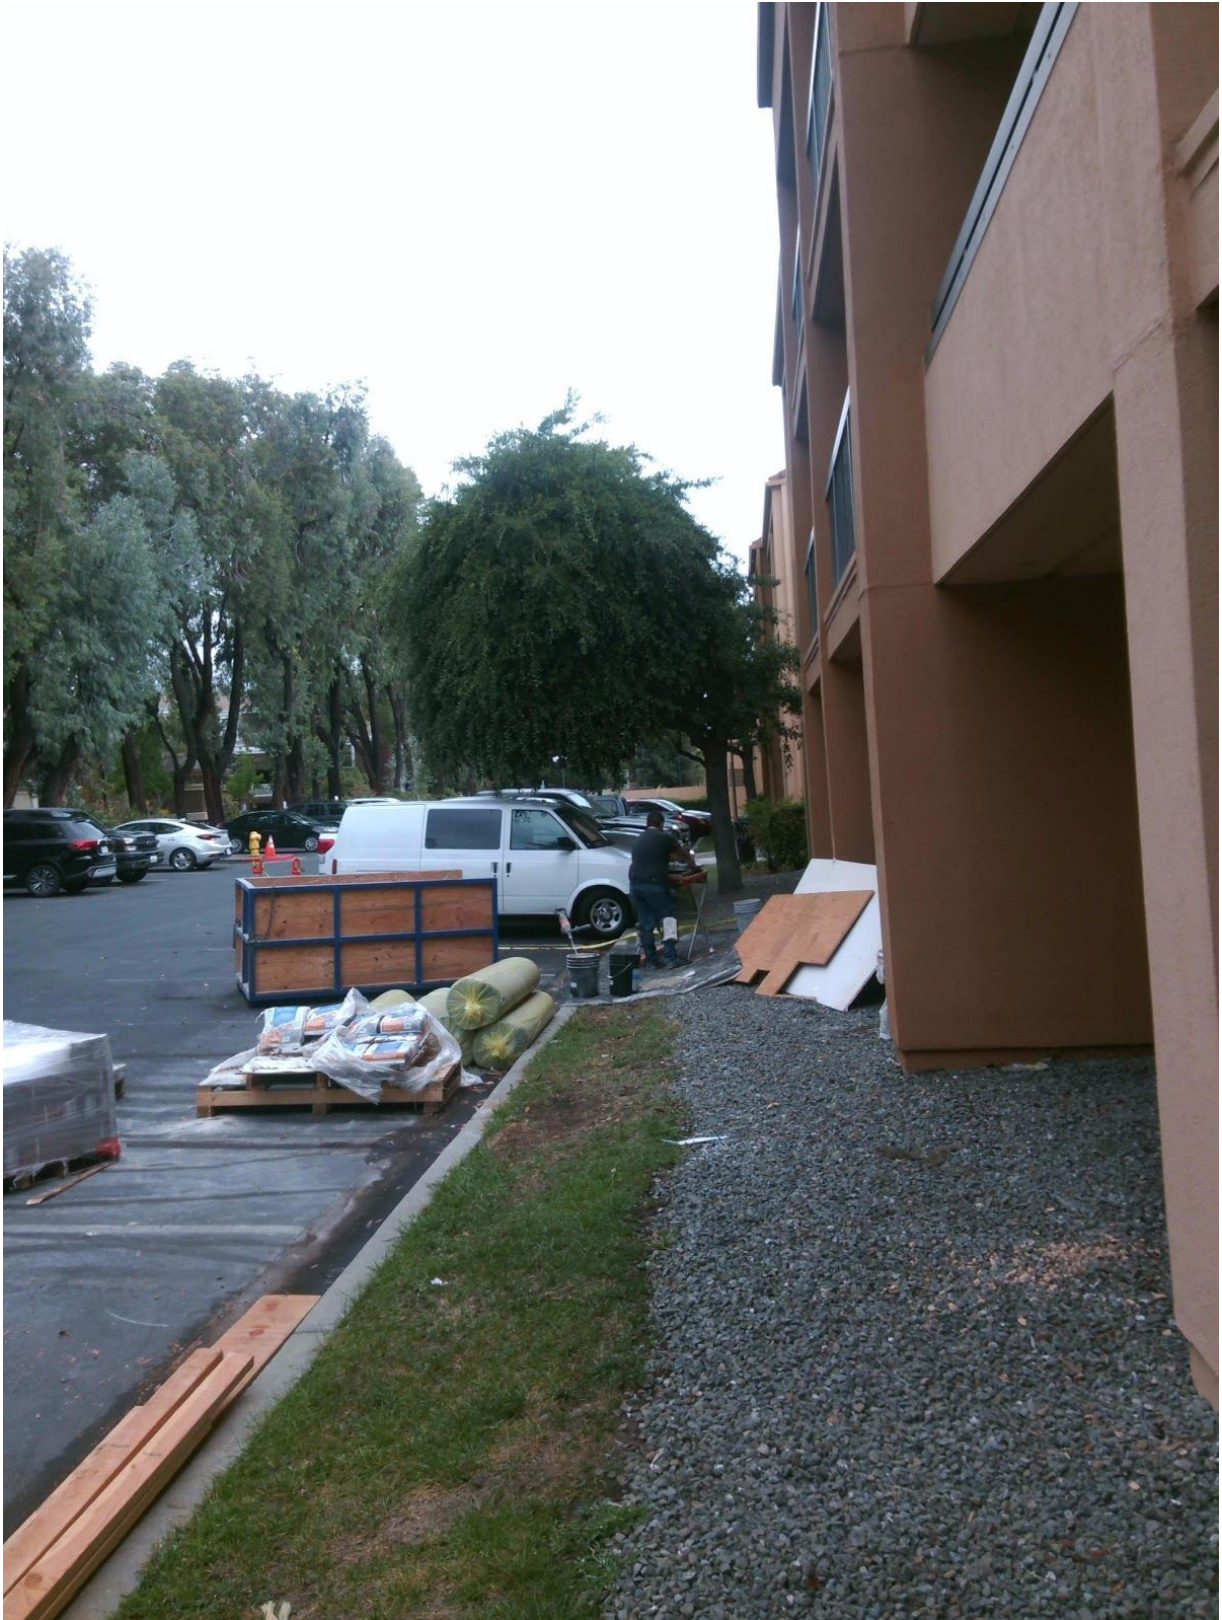
Photo #11. Tree #10 has unbalanced and off-center canopy

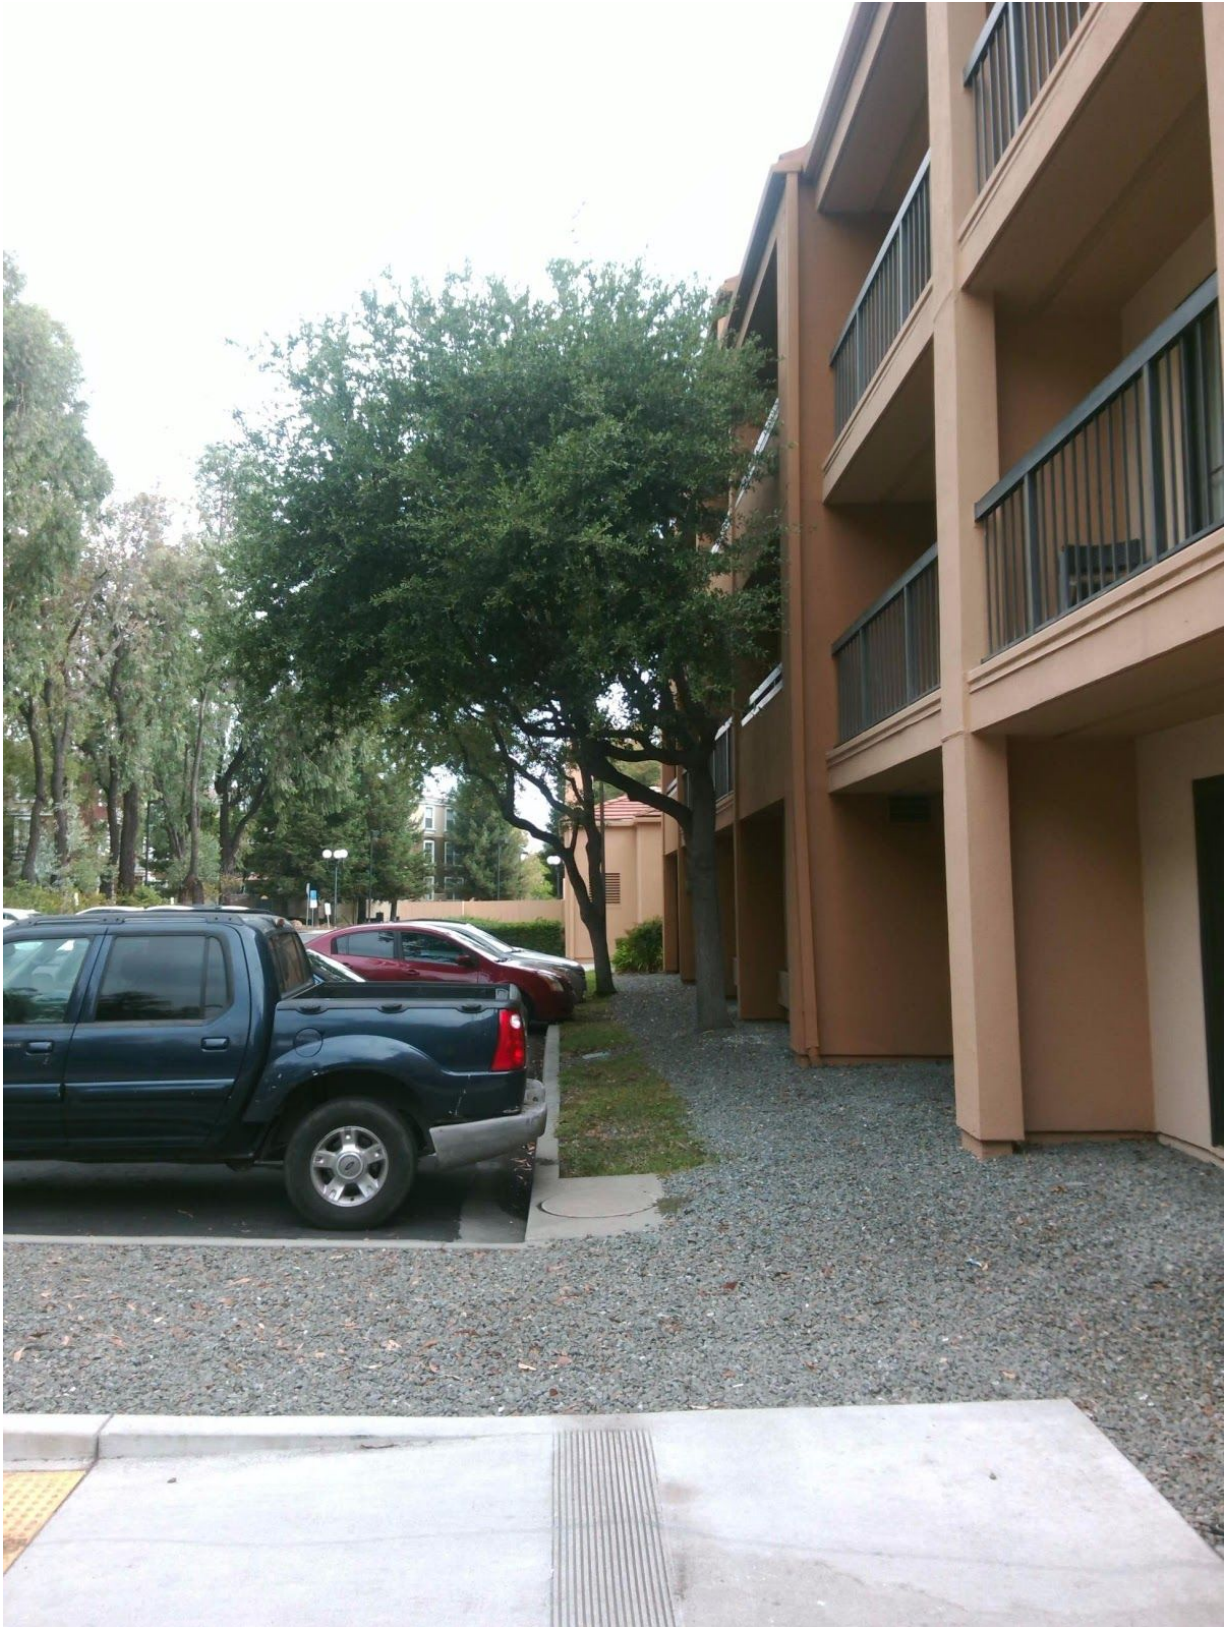
Photo 12. Tree #11 is one-sided

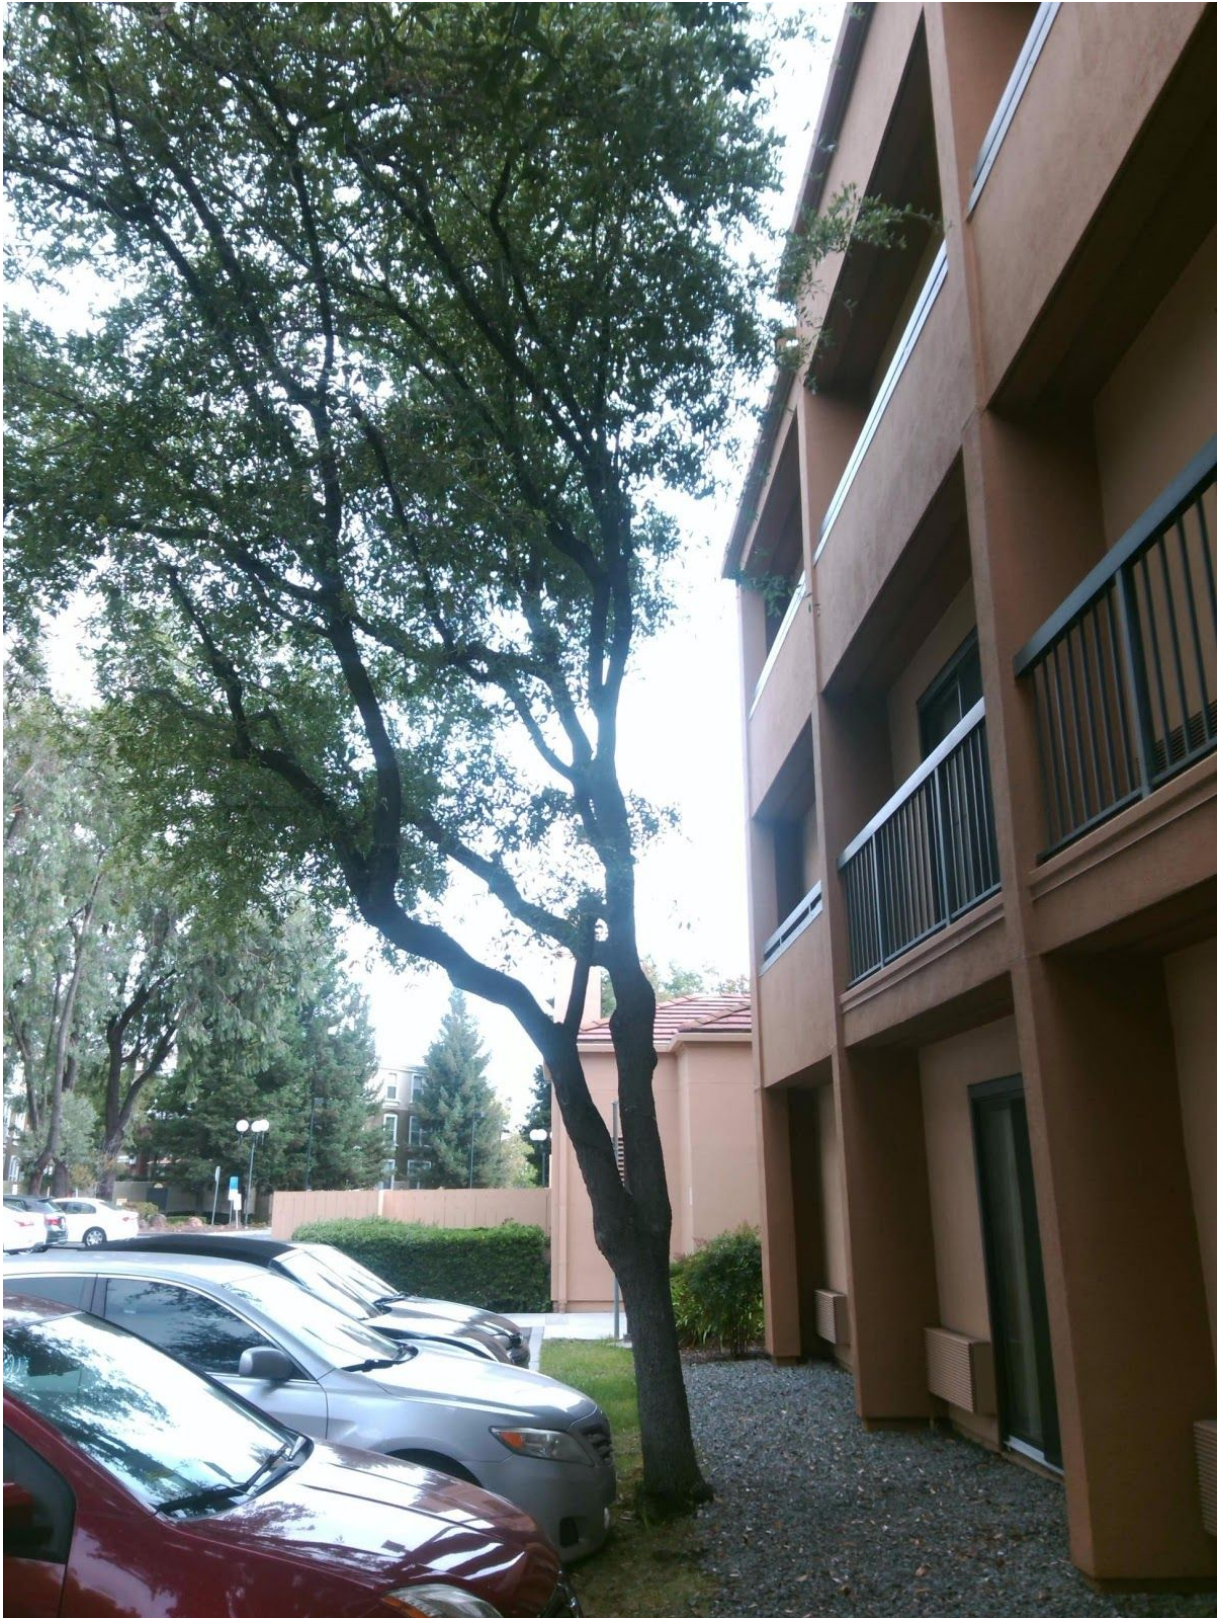
Photo 13. Tree #12 is unbalanced and one-sided
