RE: Tree Inventory and Arborist Report for Courtyard Hotel in Cupertino, CA

TREE INVENTORY AND ARBORIST REPORT

Courtyard Hotel
10605 N. Wolfe Rd.
Cupertino, CA

September 2019

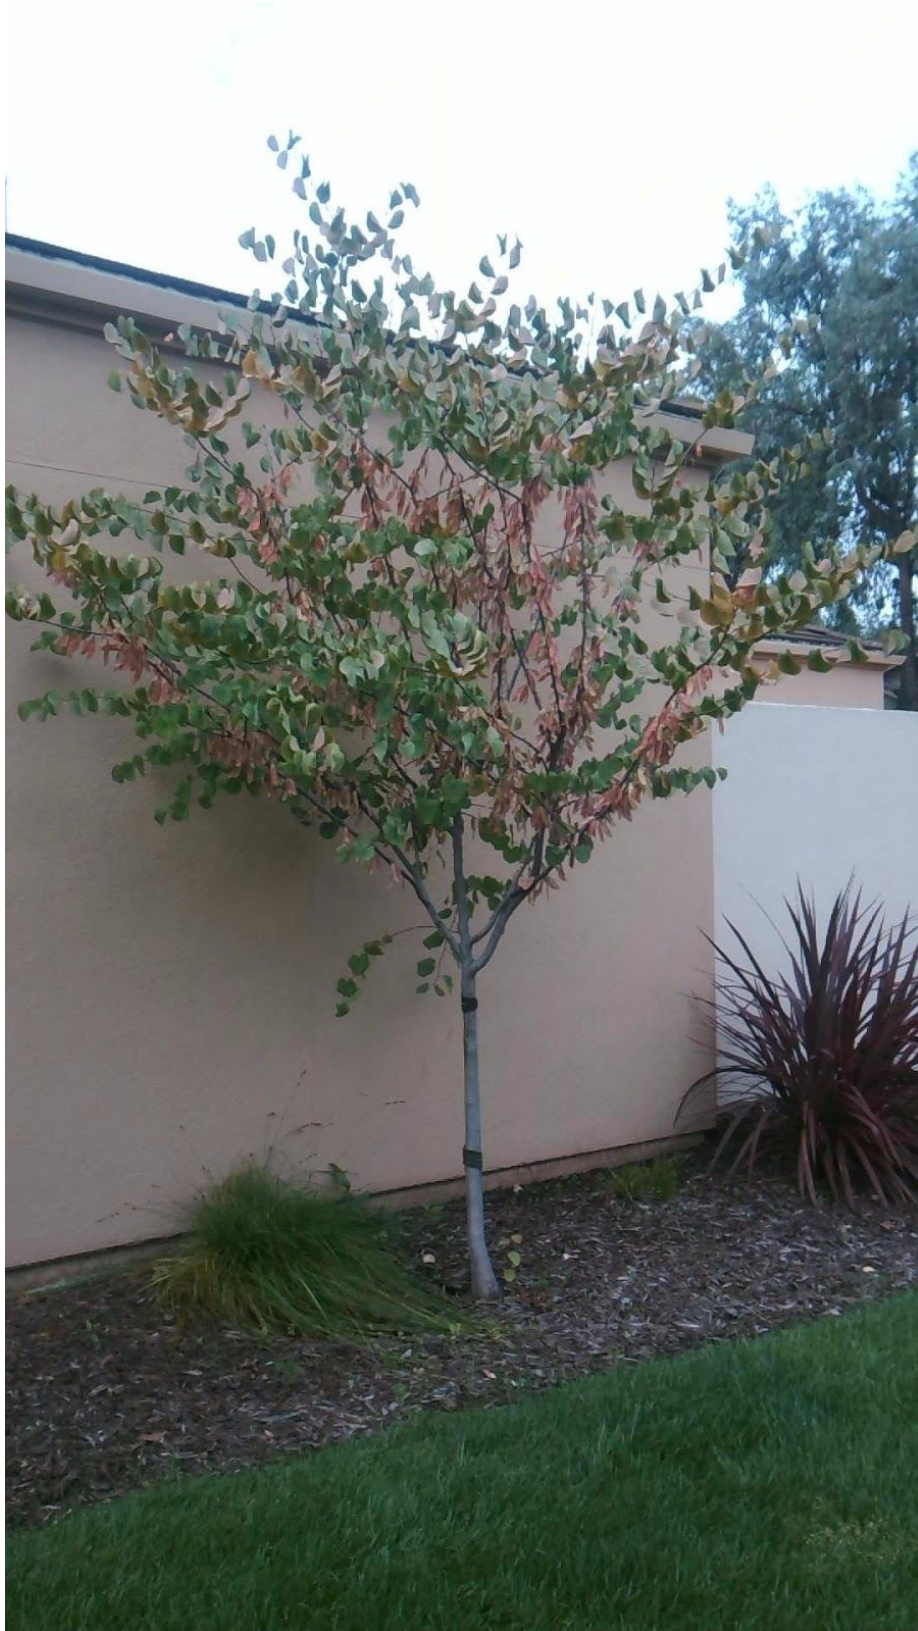
Photo 14. Tree #14 is planned for removal and replacement.

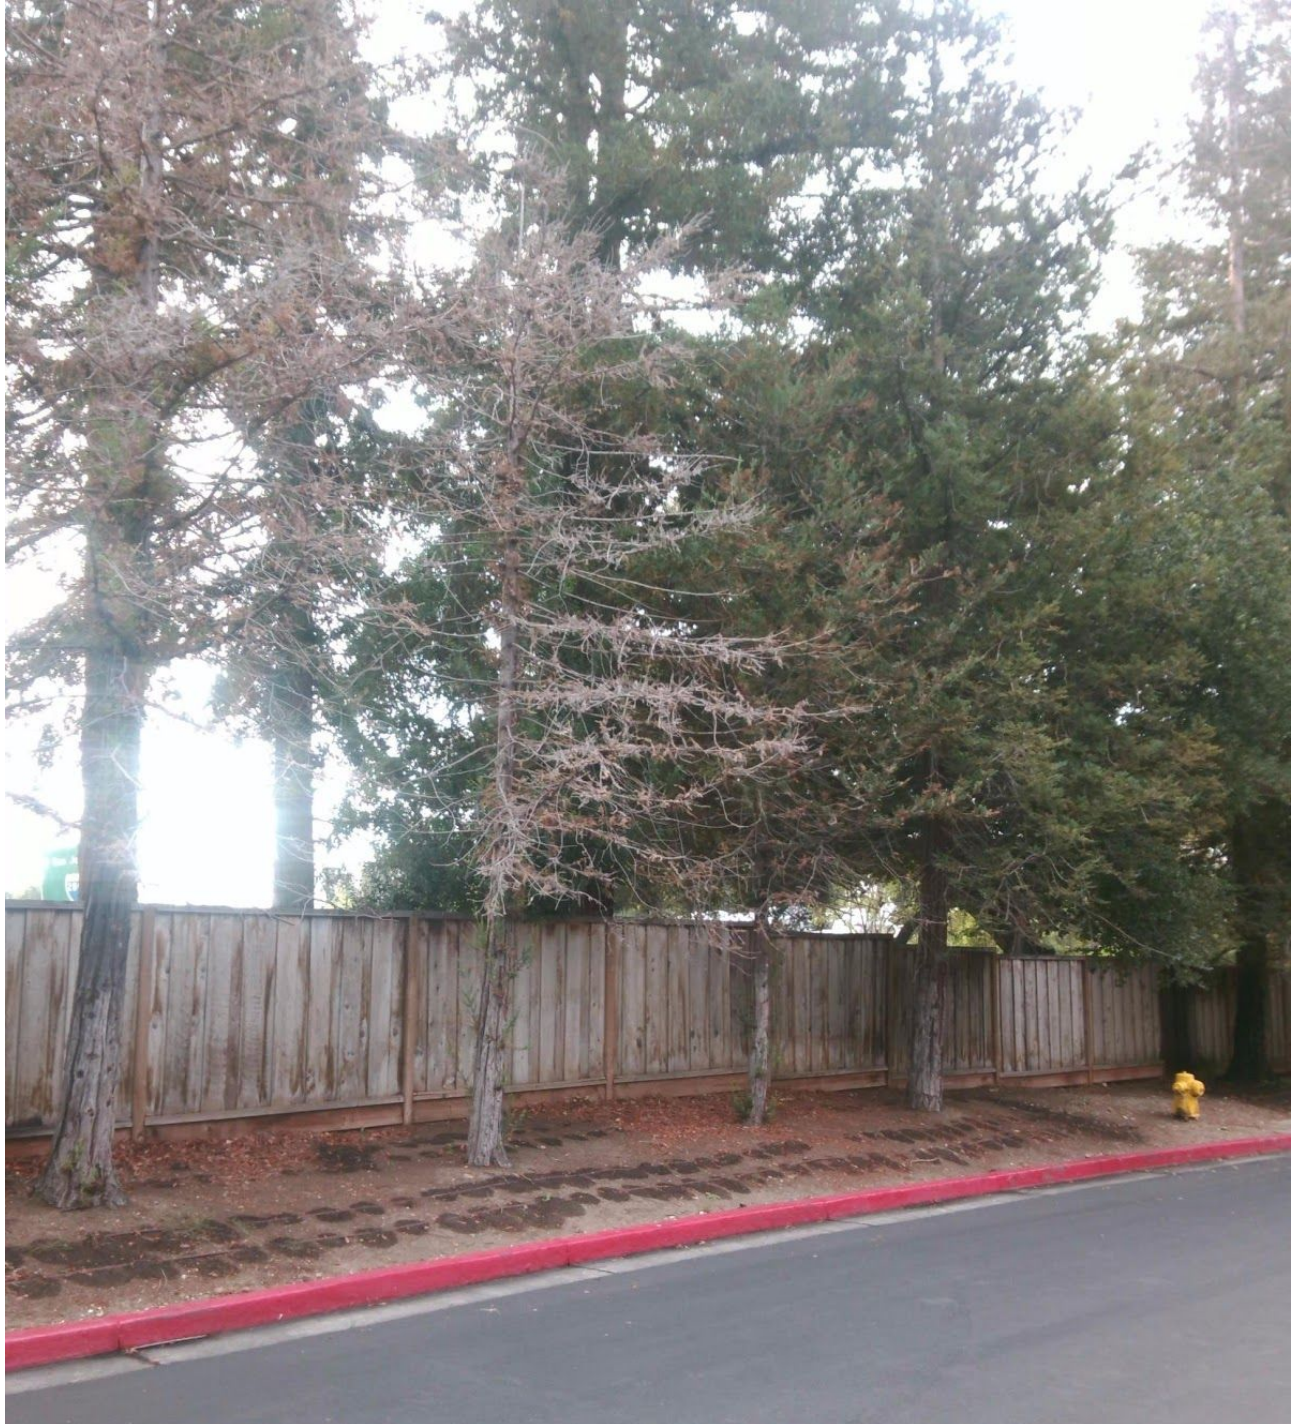
16	7	Coast redwood	Sequoia sempervirens	Critical	25	Serious decline

Photo 15. Trees #15 and #16 are in serious decline.
