Updated Arborist Report

**10200 South De Anza Blvd.
Cupertino, CA 95014**

March 4, 2021

**Updated Arborist Report
10200 South De Anza Blvd.
Cupertino, CA 95014**

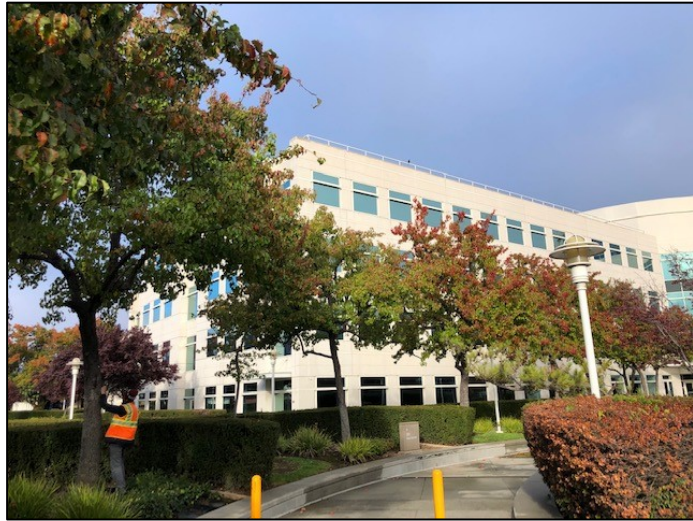
Evergreen pear was the most frequently occurring species. A total of 37 pears (57% of the inventory) were assessed. Twelve (12) evergreen pears grew in a landscaped area east of the existing building (Photo 1). Twenty-two (22) grew along South De Anza Blvd; nine of these were protected street trees. Tree conditions ranged from poor (nine trees) to good (five trees) with 23 trees in fair condition. Trunk diameters ranged from 7" to 20". All of the pears exhibited signs of fire blight bacterial disease, to varying degrees of severity. Fire blight causes dieback and gradual decline in overall condition. It is difficult to effectively manage.

Photo 1 – Twelve (12) evergreen pears grew in a landscaped area east of the existing building

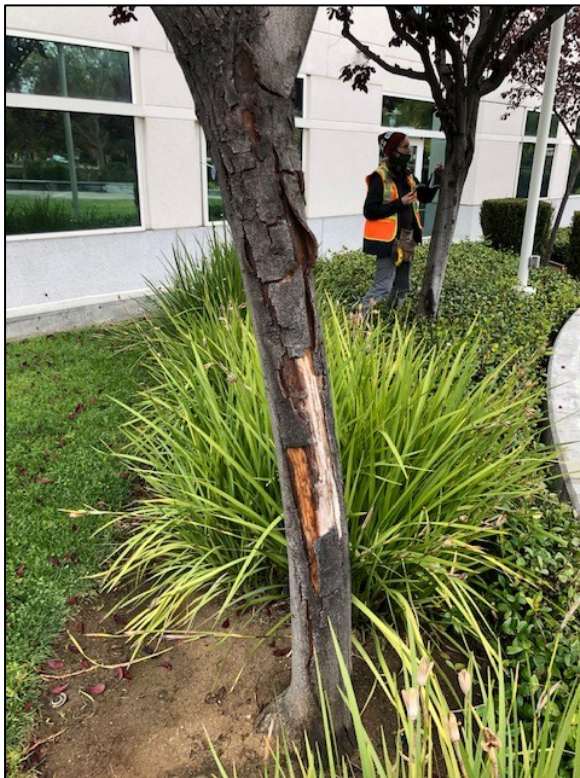
Sixteen (16) purpleleaf plums were also assessed. Tree conditions ranged from poor (six trees) to fair (10 trees). Individual trunk diameters ranged from 5" to 9". Six of the plums were multi-stemmed. Many of the plums also exhibited signs of internal decay, which can compromise health and structural integrity (Photo 2).

Photo 2 – Many of the purpleleaf plums exhibited signs of internal decay, which can compromise health and structural integrity.

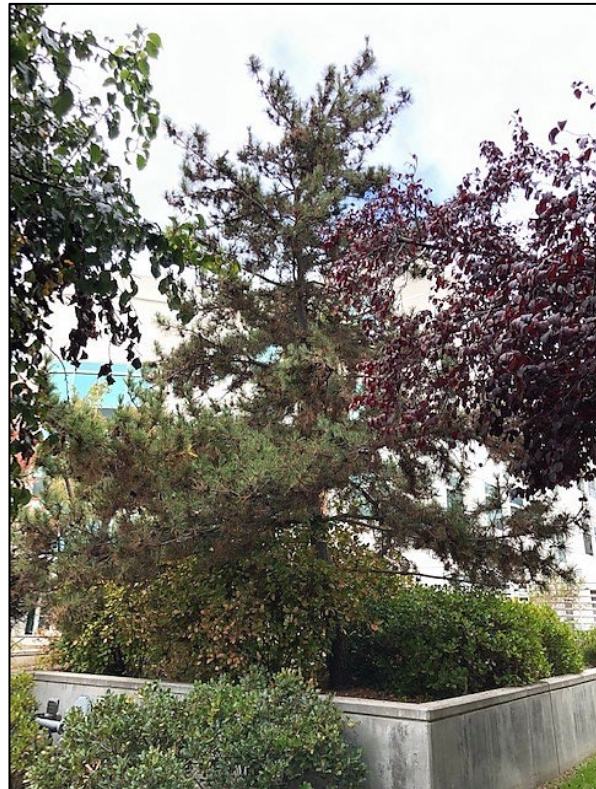
- Japanese black pine #265 was in good condition with typical pyramidal form and structure. Despite its bowed trunk, it had a dense, vigorous crown. The semi-mature 10" tree was growing along the eastern property line.
- Mediterranean fan palm #213 was in fair condition with browning live frond tips, an indicator of stress. The 21" palm was growing adjacent to the existing building.

Photo 3 – Japanese black pine #265 had limited growing space, browning needles, and was located where new landscaping is planned.

- Eighteen (18) on-site trees will be removed due to a combination of their proximity to proposed impactful work and low suitability for preservation. An example of such a tree is Japanese black pine #265 (Photo 3).
 - All are considered *Protected*.

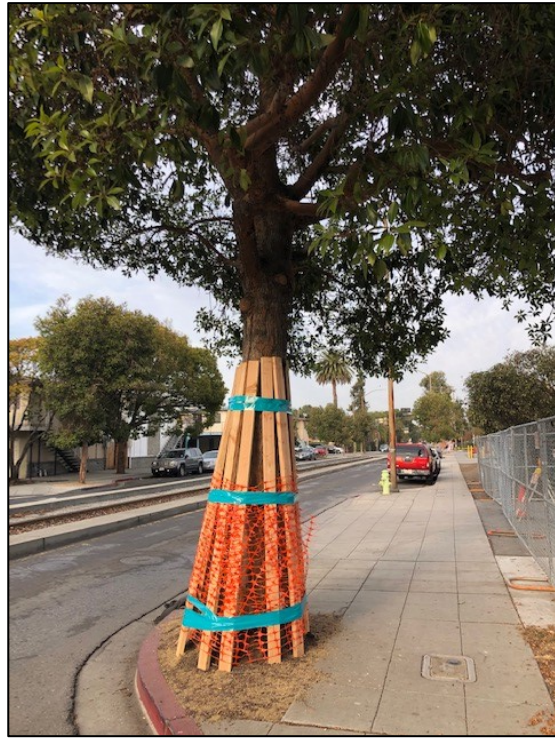
Photo 4 – An example of wood plank trunk protection is pictured above.

- Street trees should have tree protection zone fencing installed around the edges of their planter strips or wood plank trunk protection (Photo 4) installed around their trunks.
