CAPITAL IMPROVEMENT PROGRAMS FISCAL YEAR 2026 - 2027 and 5-YEAR PLAN

PROJECT LISTS from MASTER PLANS

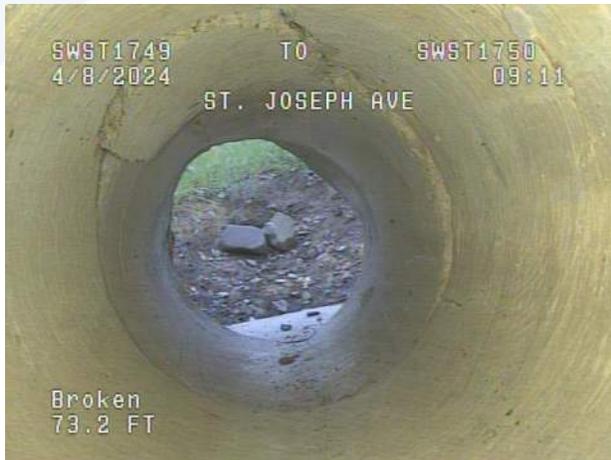
Photo 1. Broken RCP (Grade 4); SWPP724.

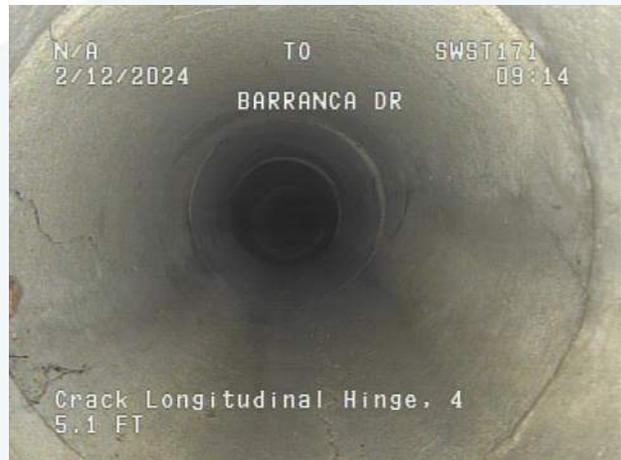
Photo 2. Crack longitudinal hinge on RCP, (Grade 4); SWPP4745.

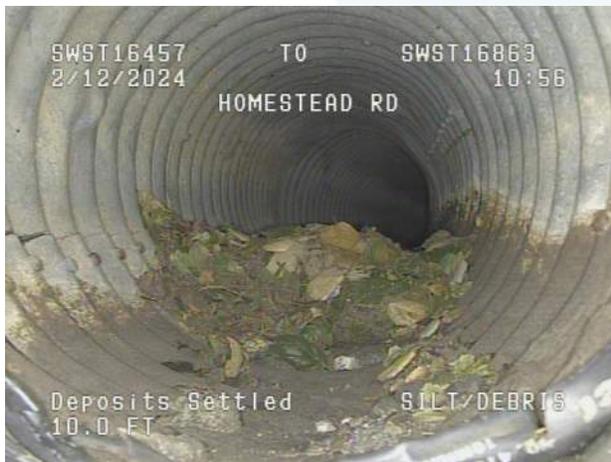
Photo 3. Grade 4 structural defect on CMP; Grade 3 O&M defect (debris); SWPP4896.

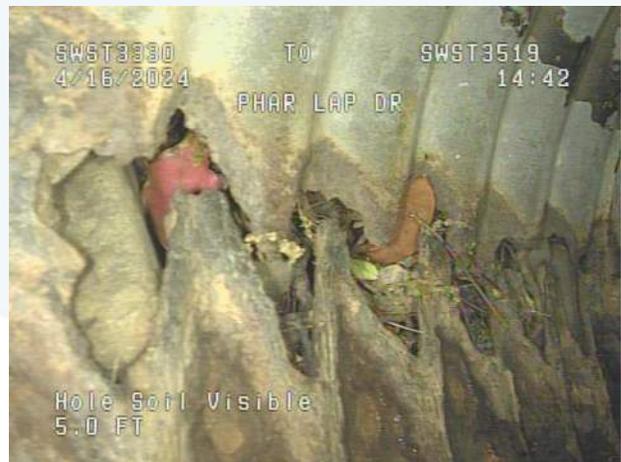
Photo 4. Grade 5 structural defect on CMP (hole); SWPP1698.

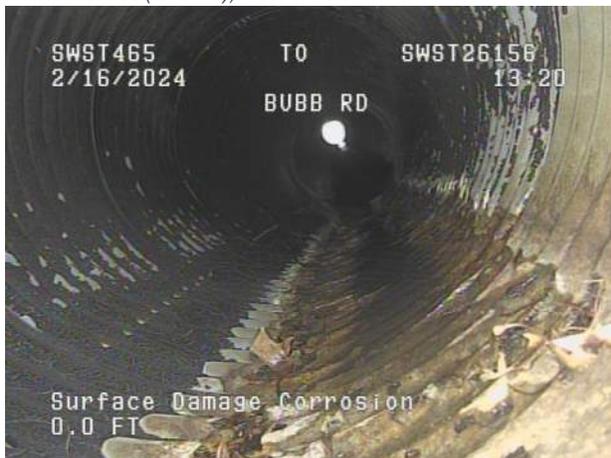
Photo 5. Grade 5 structural defect on CMP (holes at invert); SWPP3232.

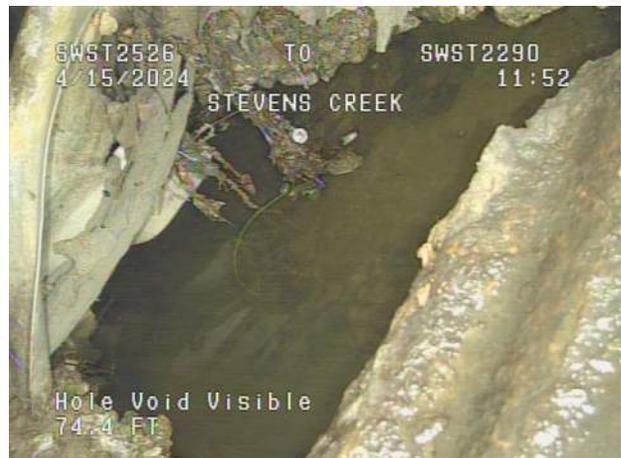
Photo 6. Grade 5 structural defect on CMP (large hole/void); SWPP3360.

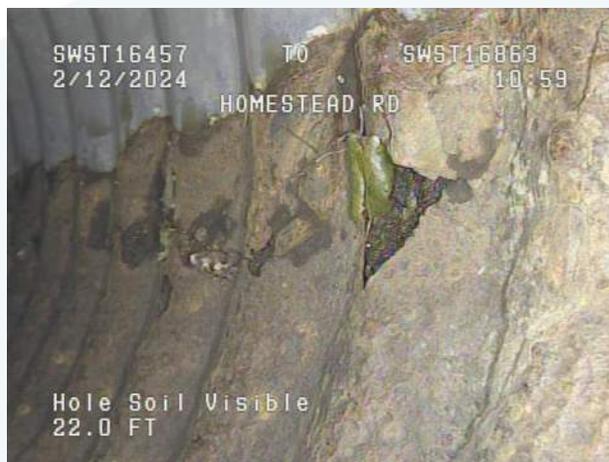
Photo 8. Hole in CMP pipeline due to corrosion (Grade 5); SWPP4896.

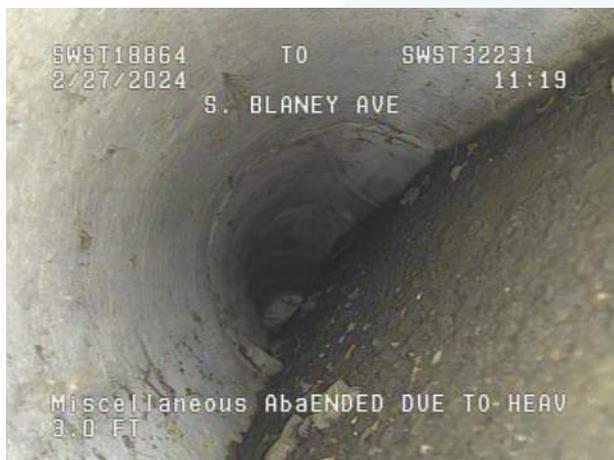
Photo 9. O&M Grade 4 defect due to debris; SWPP4643.

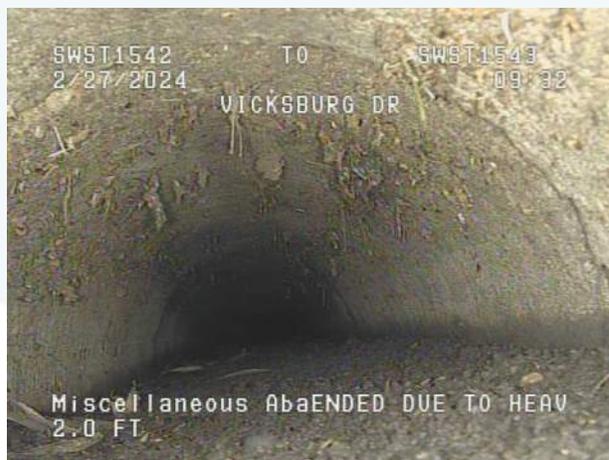
Photo 10. O&M Grade 5 defect due to debris; SWPP3661.

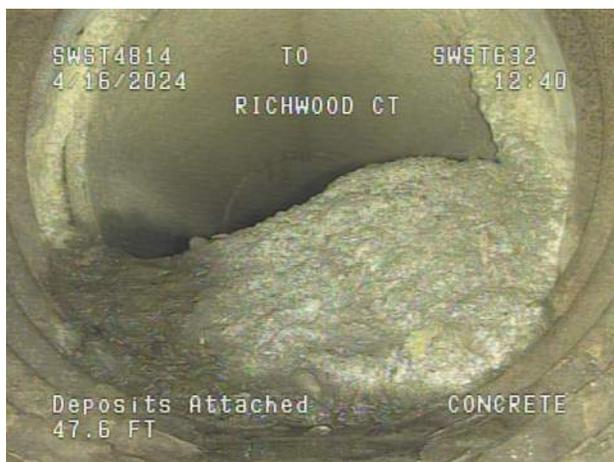
Photo 11. O&M Grade 4 defect due to concrete deposits; SWPP1546

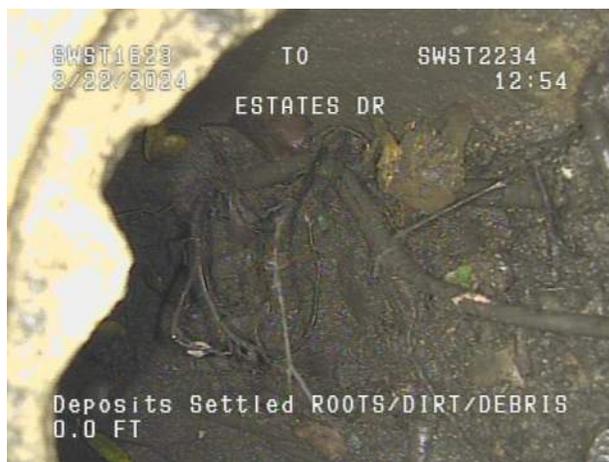
Photo 12. Grade 5 defect due to roots, dirt, and debris; SWPP3283.

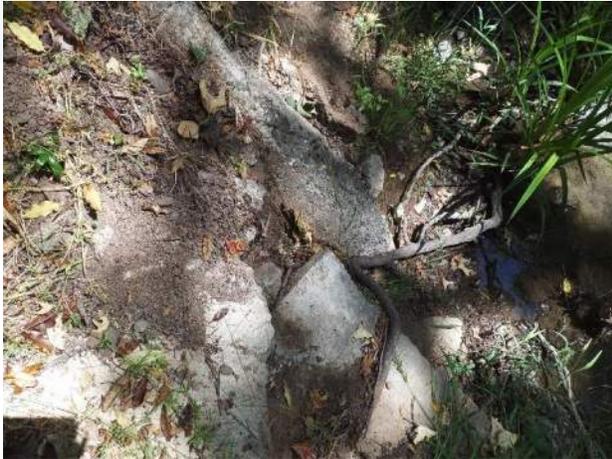
Photo 13. Collapsed outfall structure SWST3548 (VANDA Level 5).

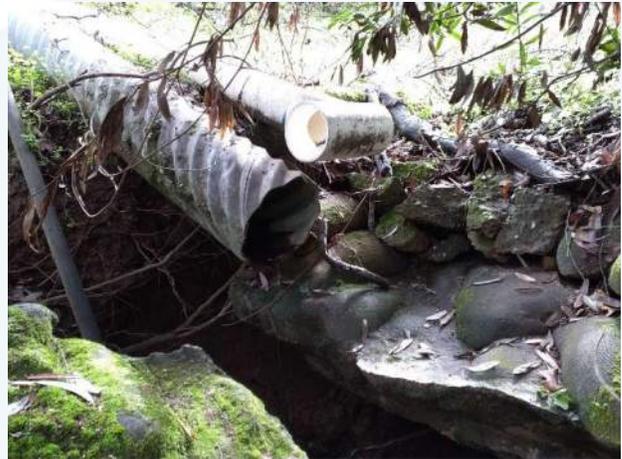
Photo 14. Large cracking of outfall structure; undermining (VANDA Level 5); SWST25337.

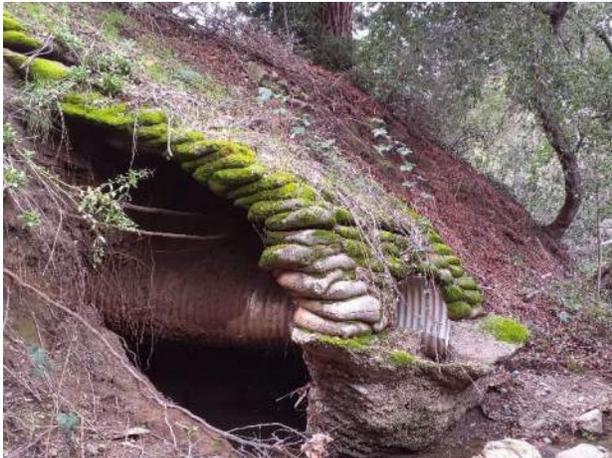
Photo 15. Failure of the headwall and undermining at SWST3786 (VANDA Level 5).

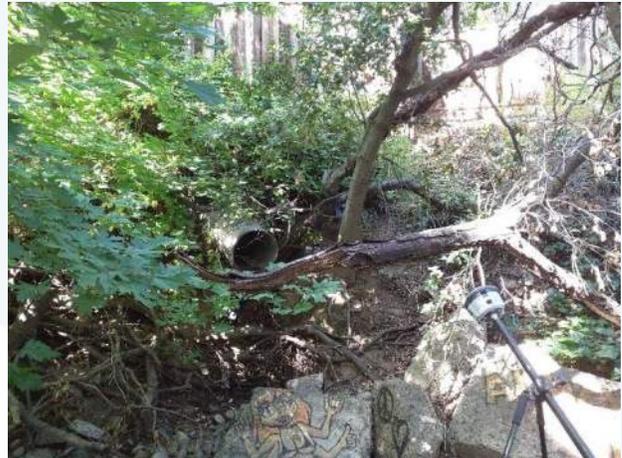
Photo 16. Collapsed outfall structure SWST2041 (VANDA Level 4).

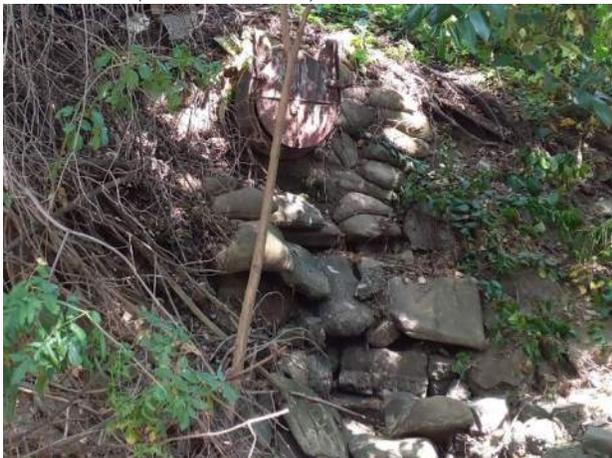
Photo 17. Severe damage to outfall headwall SWST4805 (VANDA Level 4).

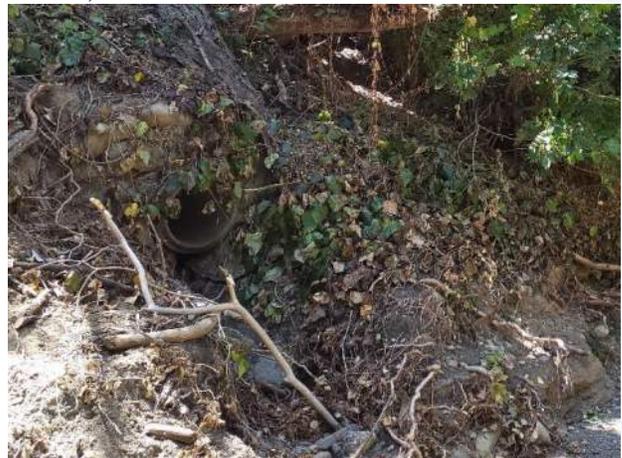
Photo 18. Severe damage to outfall headwall SWST4807 (VANDA Level 4).

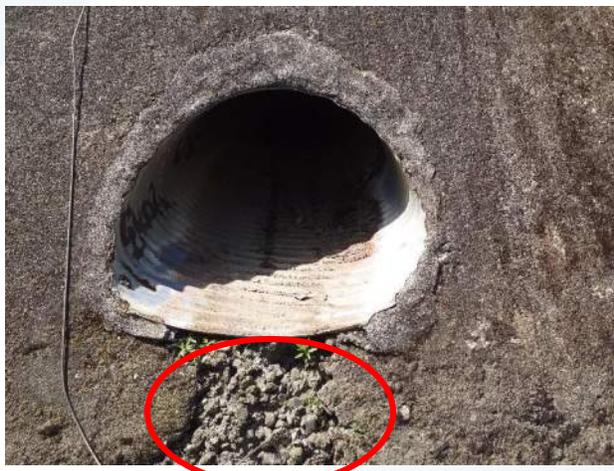
Photo 19. Spalling of outfall structure SWST26153 (VANDA Level 3).

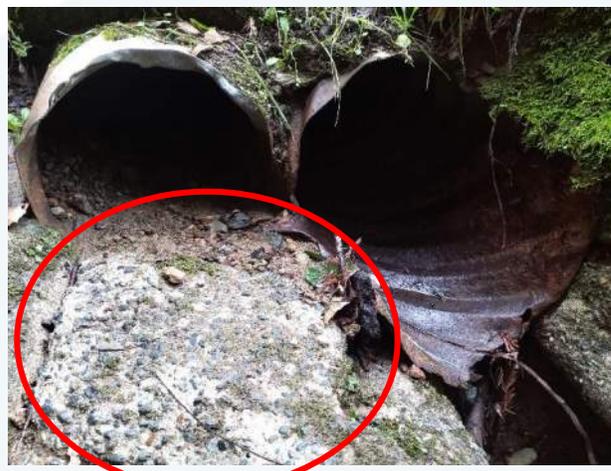
Photo 20. Moderate surface damage on outfall structure SWST25297 (VANDA Level 3).

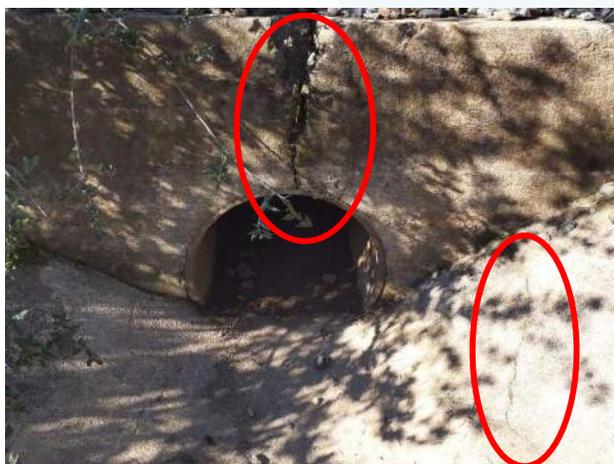
Photo 21. Moderate cracking of outfall structure SWST26153 (VANDA Level 3).

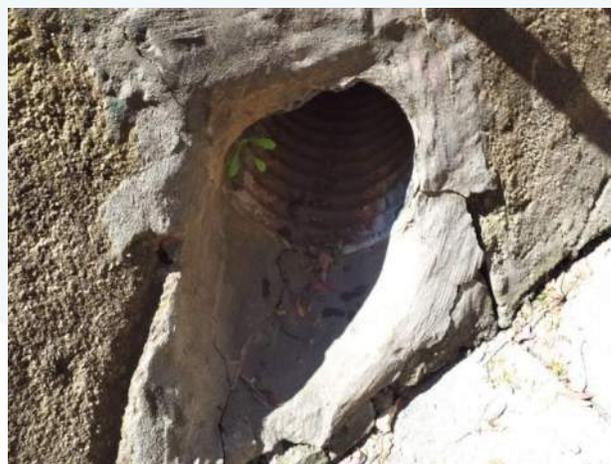
Photo 22. Moderate surface damage and cracking of outfall structure SWST3528 (VANDA Level 3).

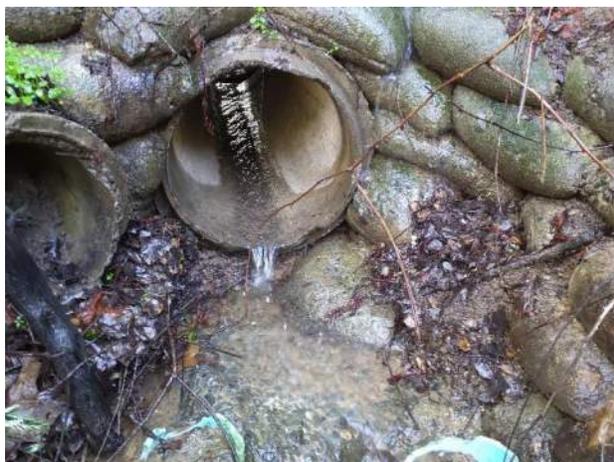
Photo 23. Minor surface damage to outfall structure SWST433 (VANDA Level 2).

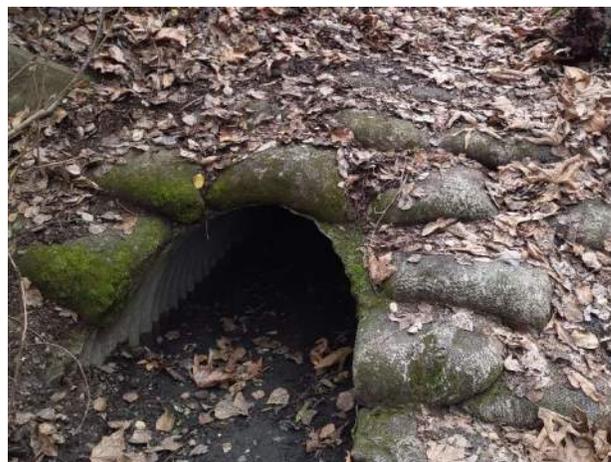
Photo 24. Minor surface damage to outfall structure SWST3549 (VANDA Level 2).

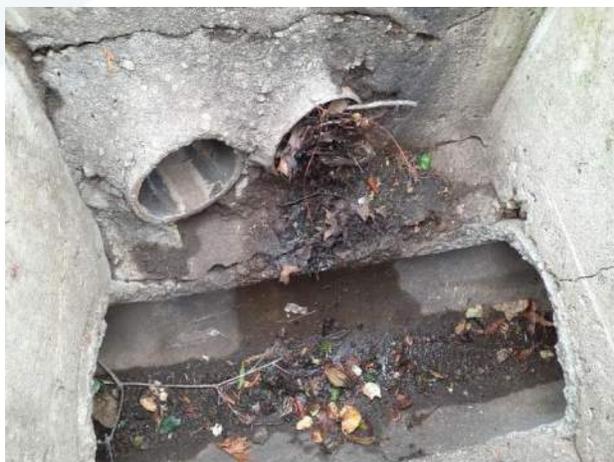
Photo 25. Frequent cracking along catch basin SWST24885 (VANDA Level 4).

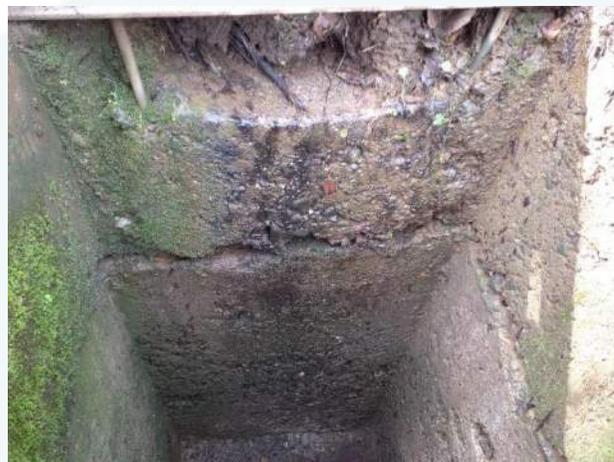
Photo 26. Moderate surface damage and voids in SWST10461 (VANDA Level 4).

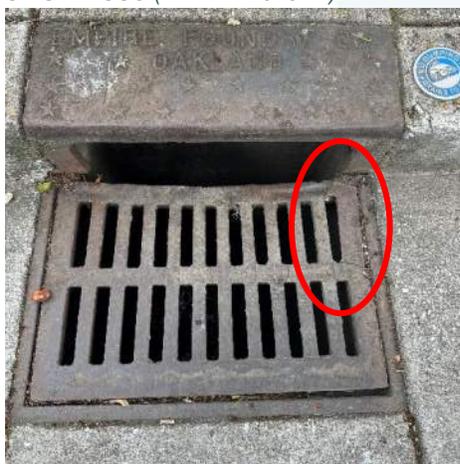
Photo 27. Broken catch basin cover; SWST2015 (VANDA Level 4).

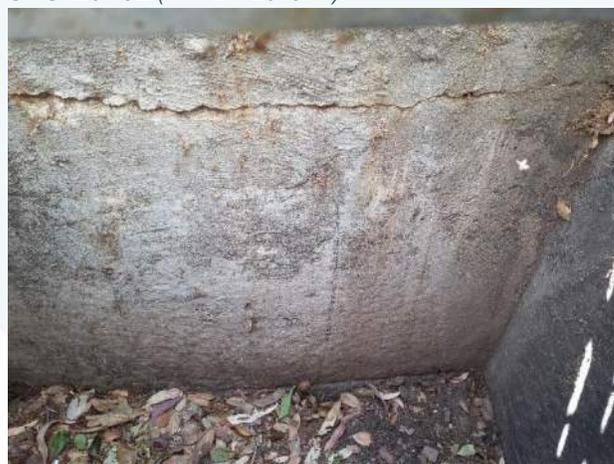
Photo 28. Moderate crack in structure SWST3066 (VANDA Level 3).

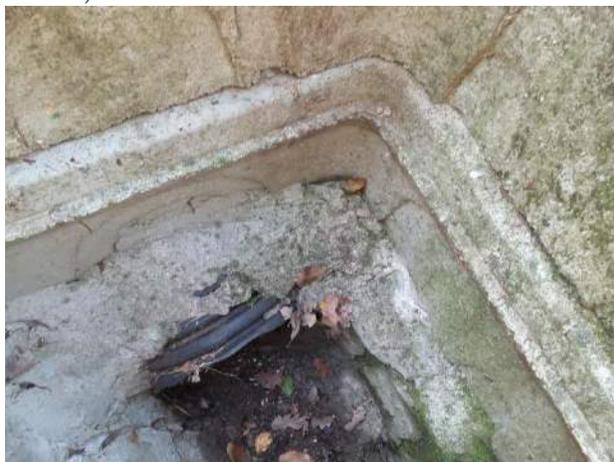
Photo 29. Moderate surface damage in SWST434 (VANDA Level 3).

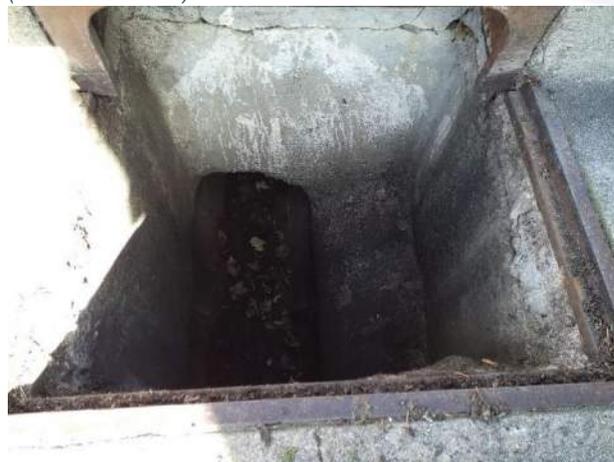
Photo 30. Moderate cracking of SWST1411 (VANDA Level 3).

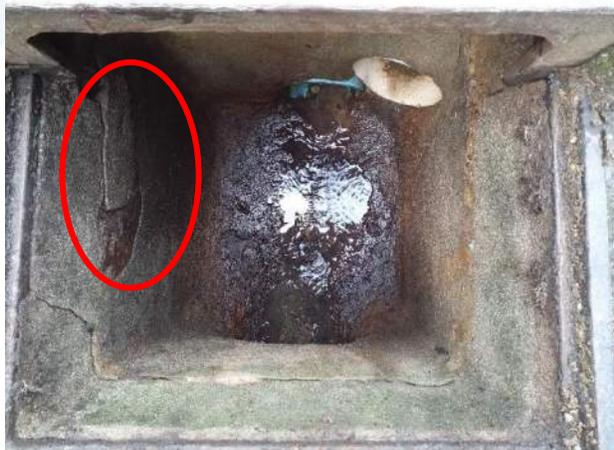
Photo 31. Concrete spalling and moderate cracking of SWST4473 (VANDA Level 3).

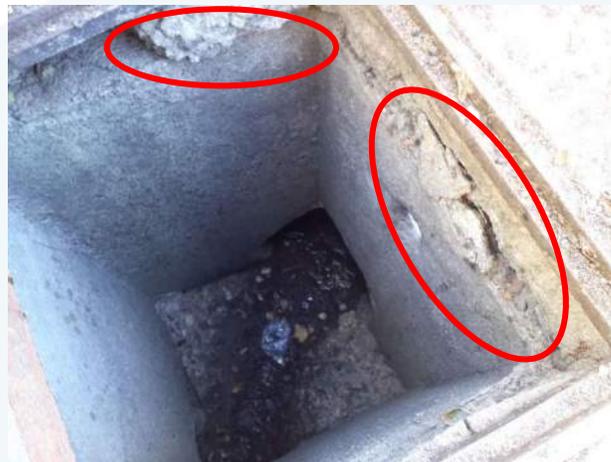
Photo 32. Deterioration of concrete under cover frame in SWST2156 (VANDA Level 3).

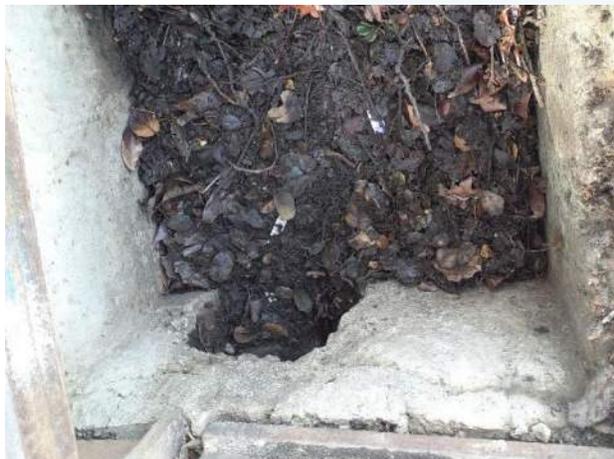
Photo 33. Moderate surface damage of SWST15657 SWST26153 (VANDA Level 3).

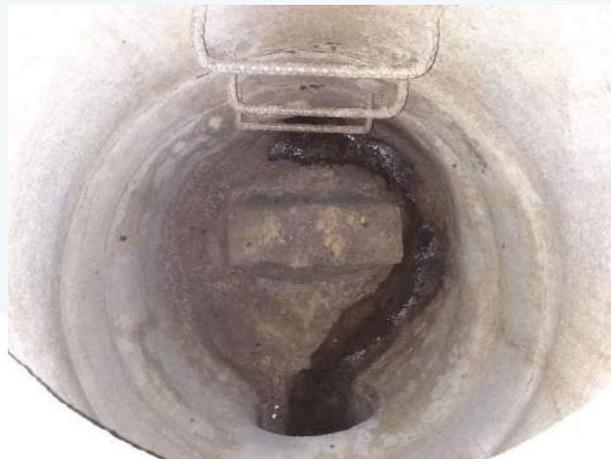
Photo 34. Minor surface damage SWST2412 (VANDA Level 2).

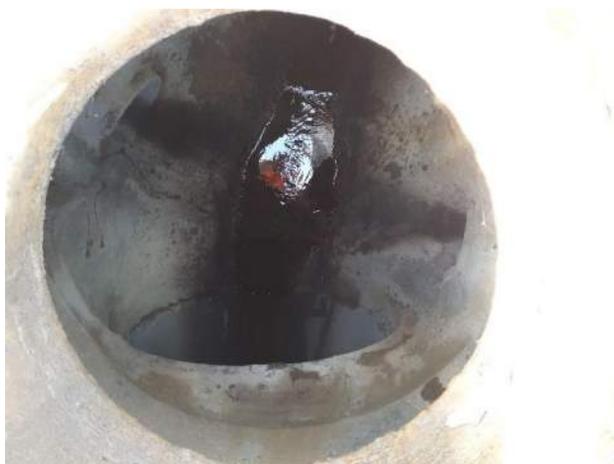
Photo 35. Minor surface damage of SWST1179 (VANDA Level 2).
