## **HAZARDOUS MATERIALS MANAGEMENT REPORT**

FINCH AVENUE PROPERTY PROJECT

10480 FINCH AVENUE

June 25, 2018

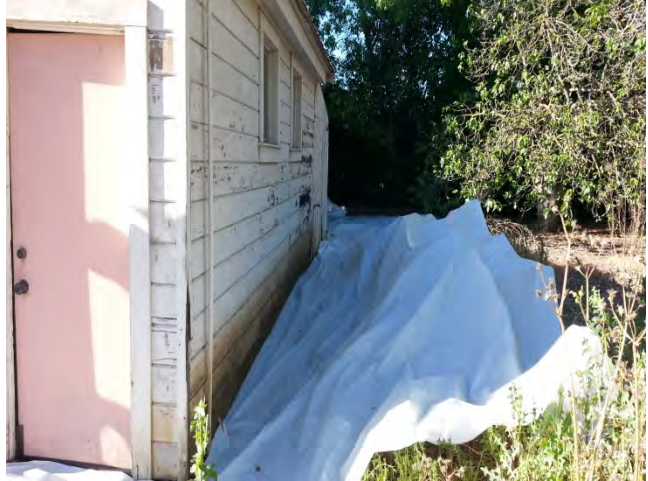
*Zone 1 preparation measures for lead paint removal and stabilization*

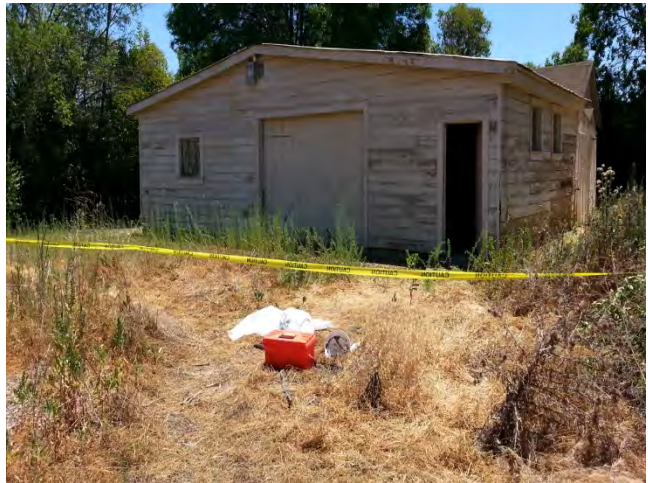
*Zone 1 preparation measures for lead paint removal and stabilization at the shop*

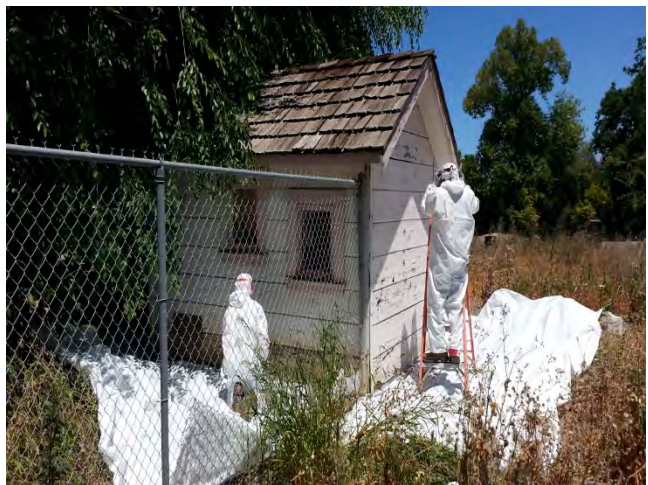
*Zone 1 exterior paint scraping at the central shed*

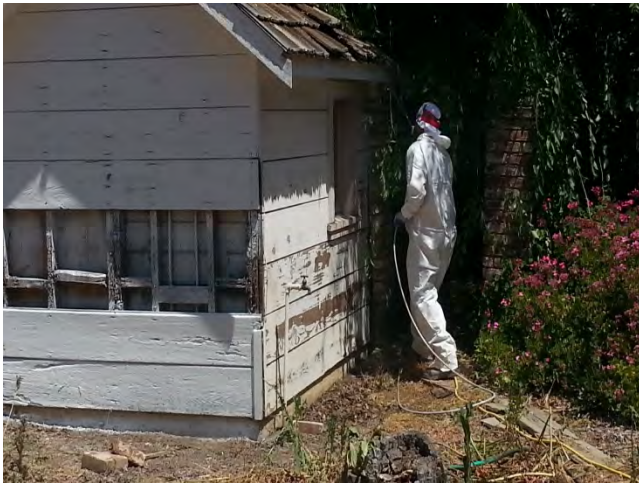
*Zone 1 paint stabilization and repainting of the central shed*

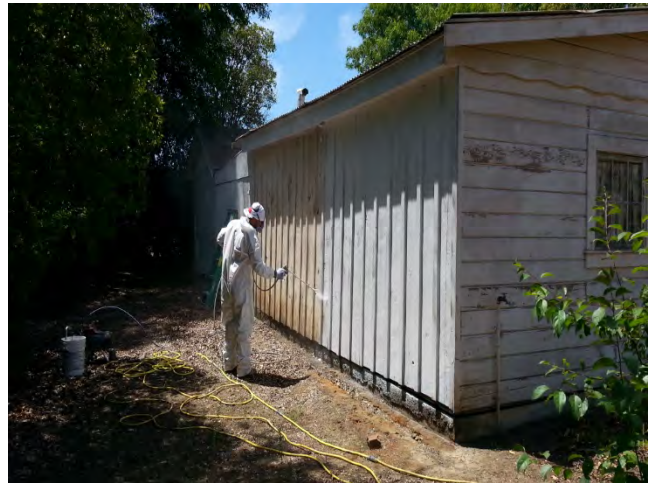
*Zone 1 paint stabilization and repainting of the shop*

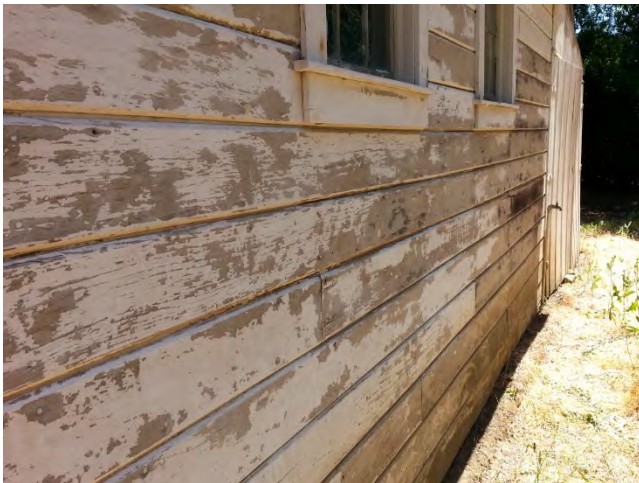
*Zone 1 post removal surface of the shop following paint scraping*

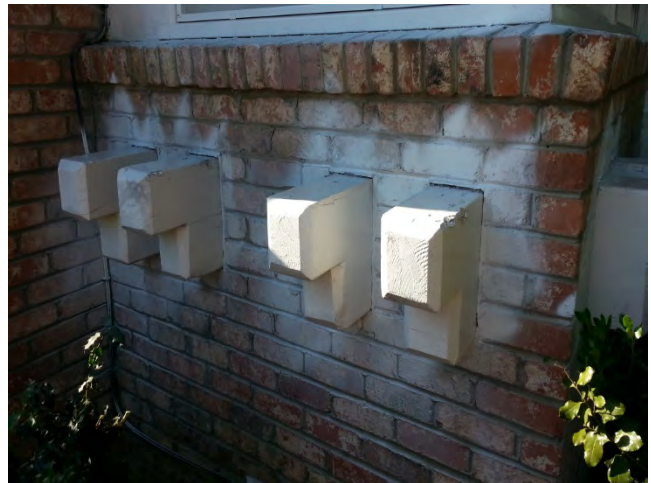
*Zone 1 post removal and stabilization of the flower box shelves of the main house*

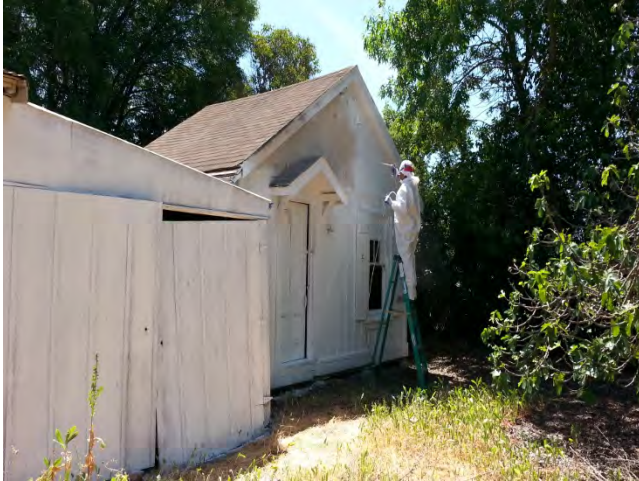
Zone 1 post stabilization painting of the homestead

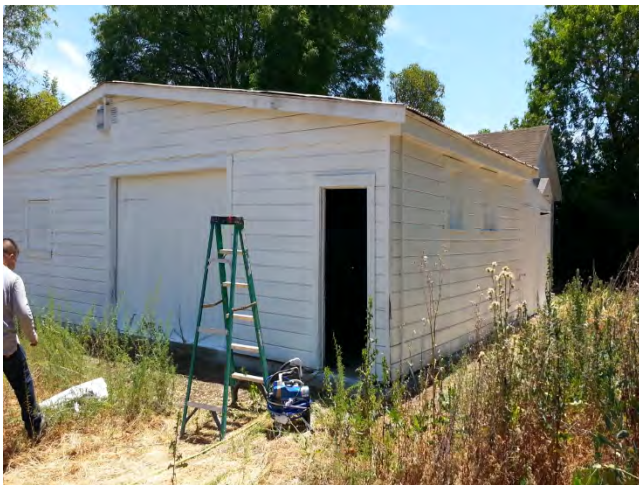
Zone 1 post stabilization painting of the shop

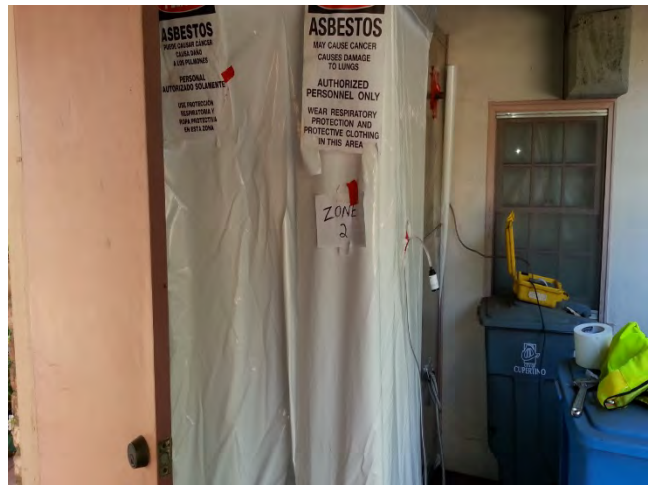
Zone 2 preparation at decontamination chamber at west end of hallway to the garage

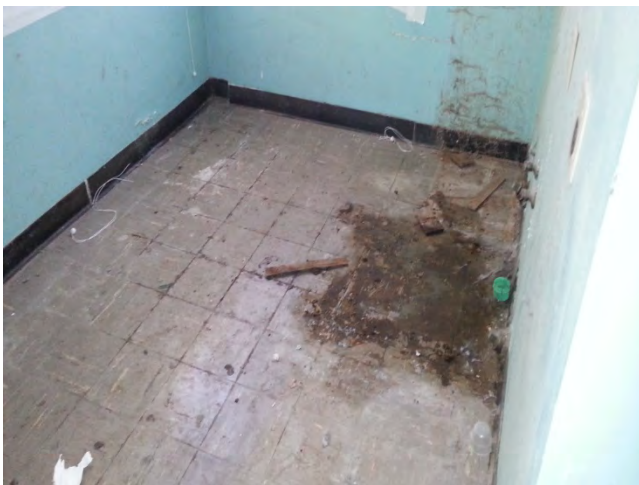
Zone 2 pre-removal view of existing vinyl floor tile

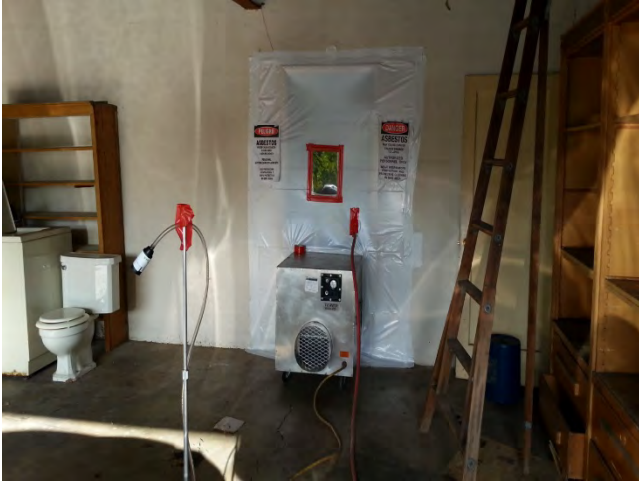
Zone 2 preparation of work area at air filtration exhaust in garage

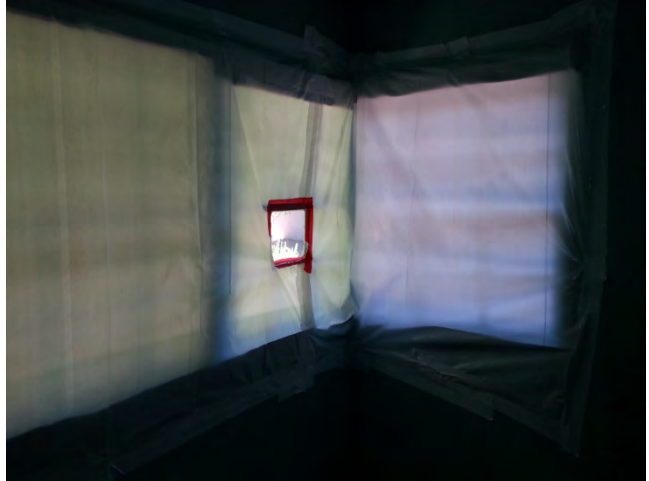
Zone 2 preparation measure including isolation of windows and view port

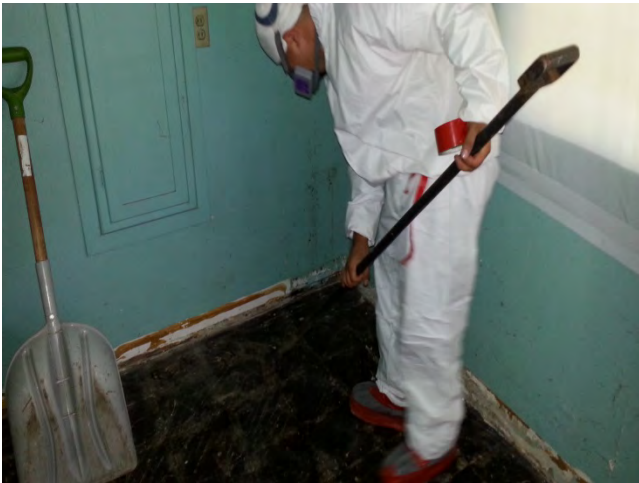
Zone 2 removal work included hand scraping of floor tile in the utility room

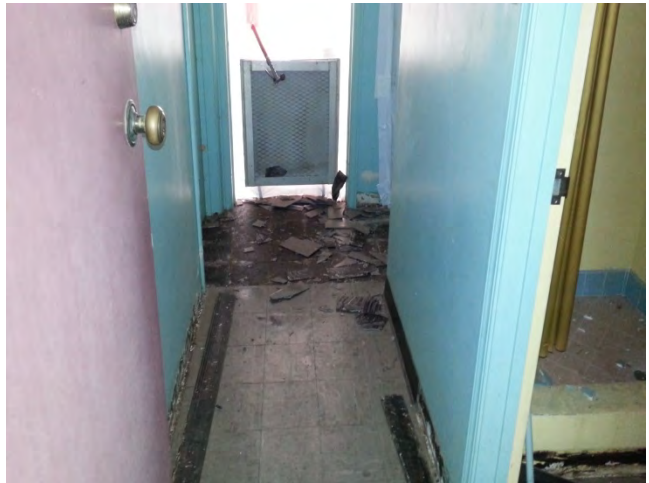
Zone 2 removal work showing partially removed floor tile in hallway to the garage

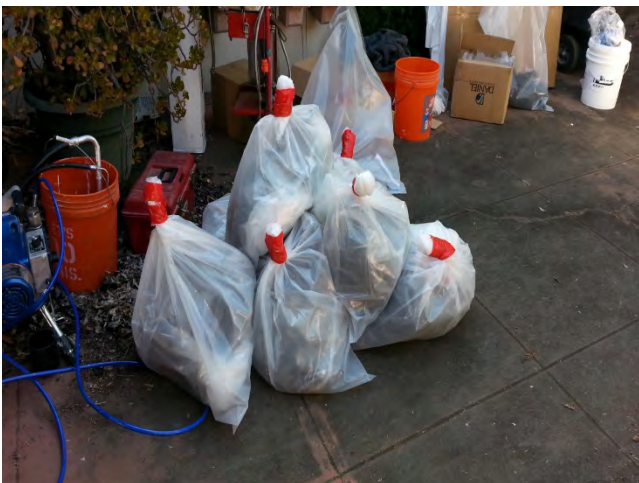
Zone 2 non-friable floor tile waste bags

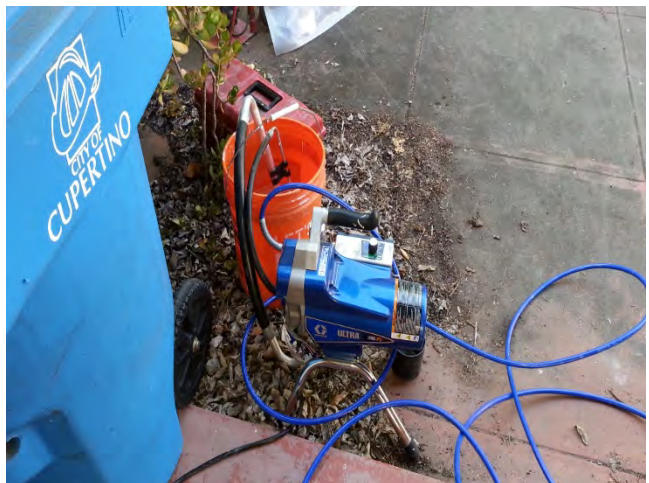
Zone 2 airless sprayer used to wet flooring materials and suppress airborne dust during removal

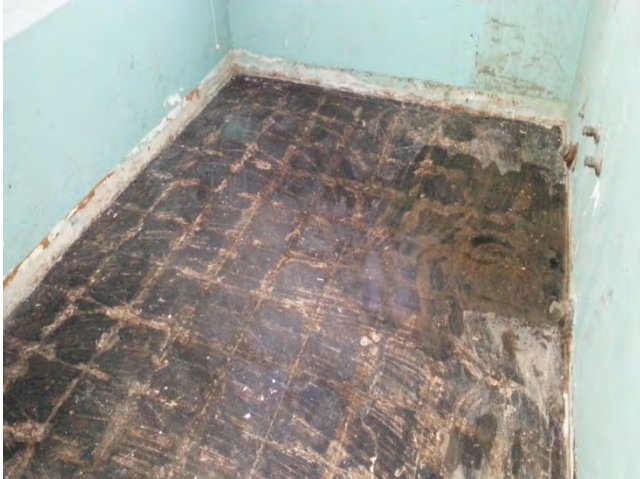
Zone 2 post removal view of utility room showing non-asbestos containing floor mastic remaining after floor tile was removed

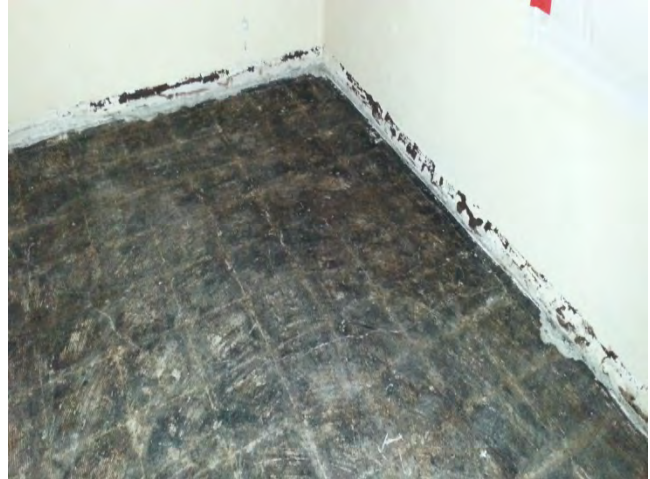
Zone 2 post removal view of restroom showing non-asbestos containing floor mastic remaining after floor tile was removed

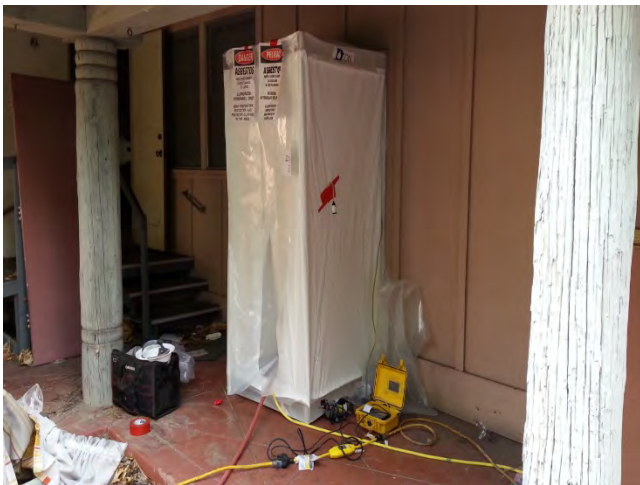
Zone 3 preparation measures showing entrance to basement at decontamination chamber

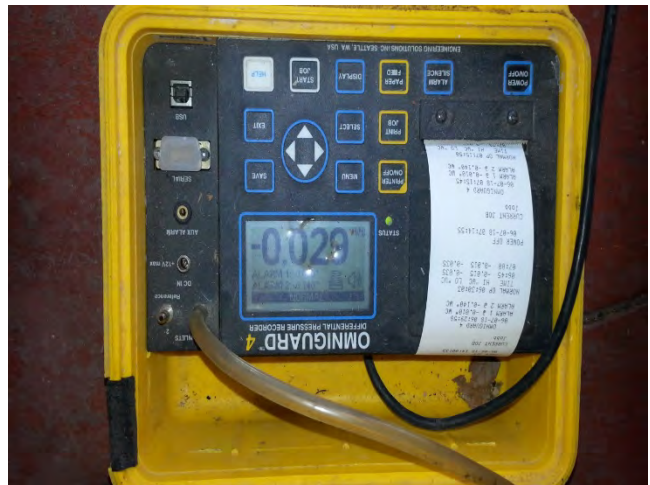
Zone 3 manometer recording sufficient negative pressure inside basement/crawlspace containment

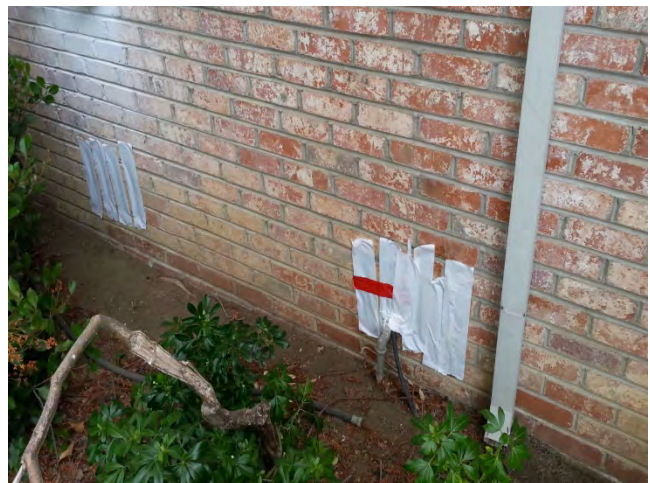
Zone 3 preparation of basement/crawlspace vents to isolate containment

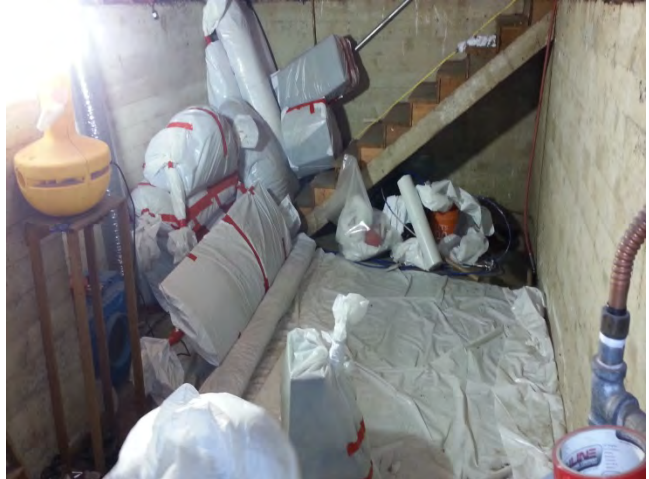
Zone 3 staging area showing HVAC ductwork wrapped and ready for loadout and labeling

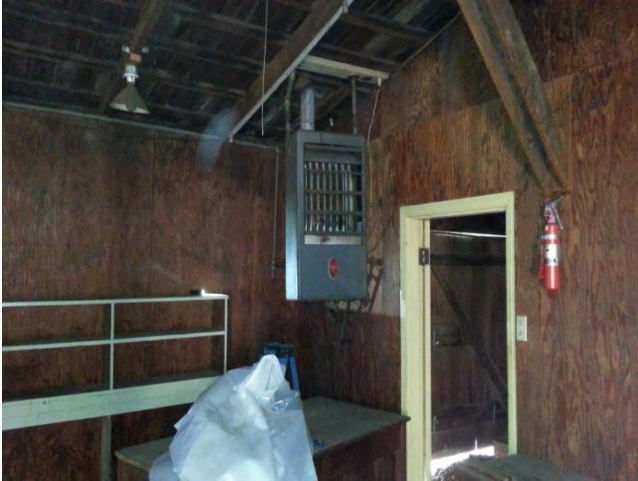
Zone 4 view of ceiling mounted heater in shop prior to removal

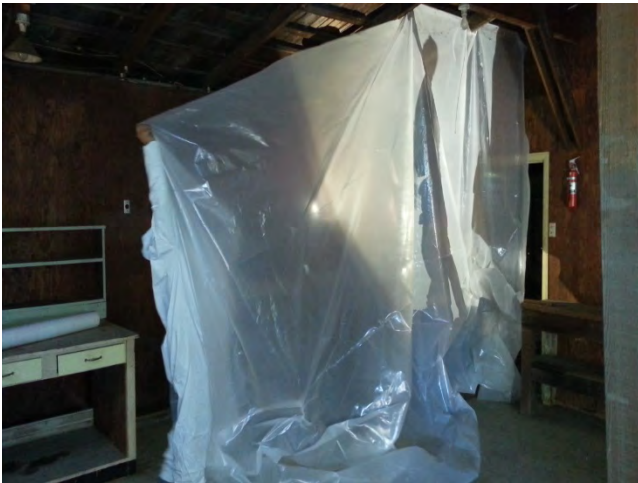
Zone 4 preparation of isolated work area prior to heater removal

| <b>Time</b> | <b>Details</b> |
|---|---|
| 1145 | SES inspected the preparation efforts of the heater in the shop – Zone 4. SES observed the Coastwide worker was not wearing a respirator and suit since the ACM material was inside the heater and would not be disturbed during removal. SES recommended that the worker wear PPE as the ACM is friable and may be dislodge during removal. SES also recommended that Coastwide install a mini containment around the heater work area in order to more easily collect and pass air clearance sampling tomorrow. Ben Cardenas began installing a polyethylene curtain around the work area. |

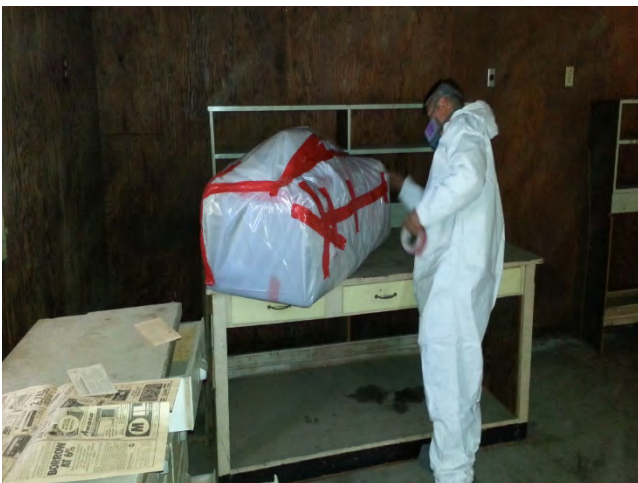
Zone 4 final wrapping of heater

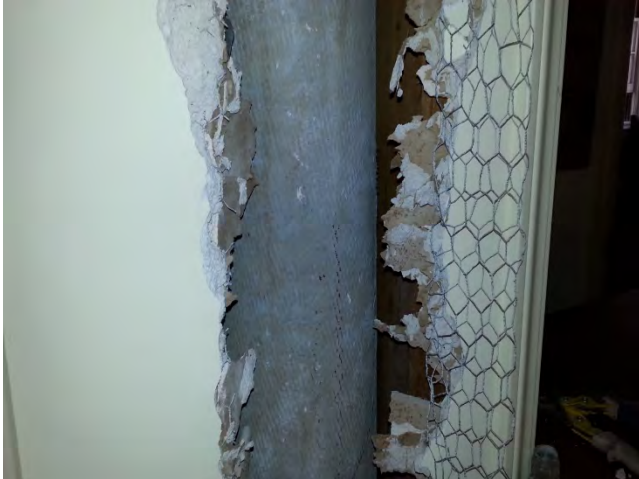
Zone 5 view of transite flue pipe located inside west wall of dining room

| <b>Time</b> | <b>Details</b> |
|---|---|
| 0930 | Ben Cardenas informed SES that his crewmen in the basement had discovered a transite pipe leading from the basement up through the house. SES and Ben Cardenas accessed the roof and opened a plaster wall in the dining room of the house to determine the exact location of the pipe. A 10-inch diameter asbestos cement pipe was revealed inside the wall. SES and Coastwide estimated that the pipe is approximately 12 feet long. SES recommended that Coastwide install a mini-containment inside the dining room since the pipe is too heavy and too long to remove intact without breaking it into sections. Alternatively, Coastwide was allowed to break the pipe within a glovebag; however, Ben Cardenas believed that method would be too difficult to break the pipe inside the confinement of the bag enclosure. |

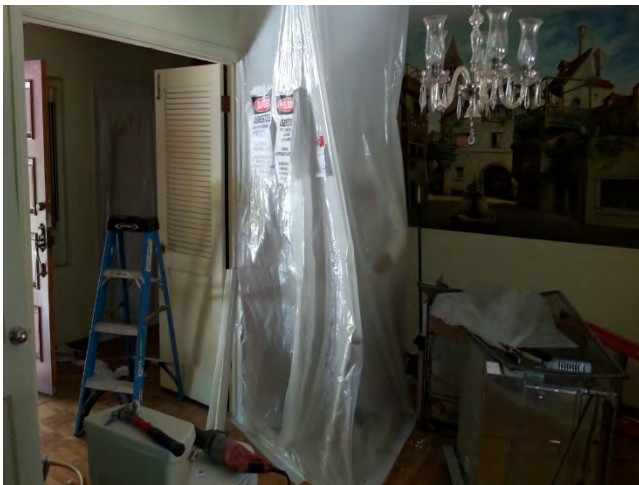
Zone 5 mini-containment constructed to isolate removal of transite pipe during work

| <b>Time</b> | <b>Details</b> |
|---|---|
| 1200 | SES observed that Ben Cardenas had finished installing the mini-containment in the dining room (Zone 5) and he requested a preparation inspection of the work area. SES recommended installing an asbestos sign on the work area before beginning to break the pipe into manageable sections. |

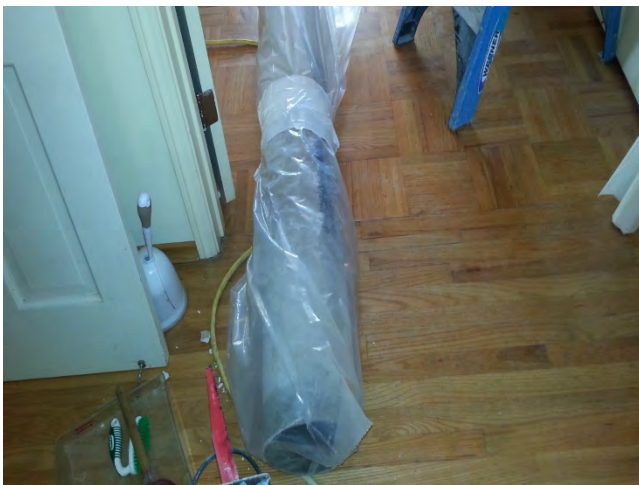
Zone 5 five foot section of transite pipe wrapped in 2 layers of polyethylene sheeting after removal

| <b>Time</b> | <b>Details</b> |
|---|---|
| 1215 | SES approved the containment measures for Zone 5 – transite pipe mini-containment, and Ben Cardenas donned protective equipment and began breaking the pipe. All waste was either burrito wrapped or placed in waste bags. SES observed that the transite pipe was removed intact with minimal breakage at the collar seams. A total of 2 five-foot burritos and 2 waste bags of debris were generated. |

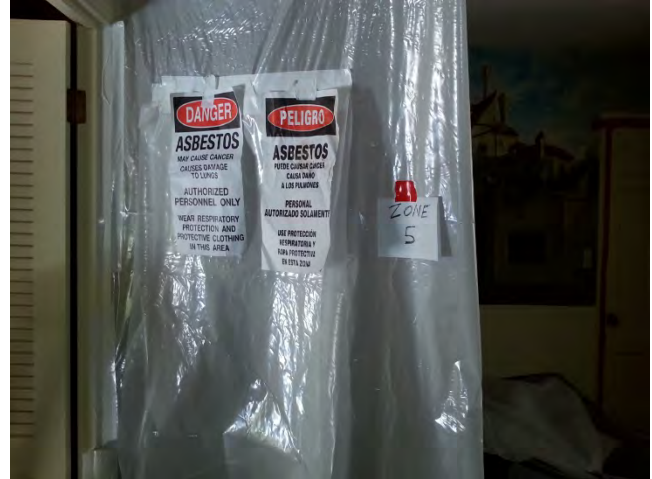
Zone 5 preparation of mini-containment to isolate removal of transite pipe during work

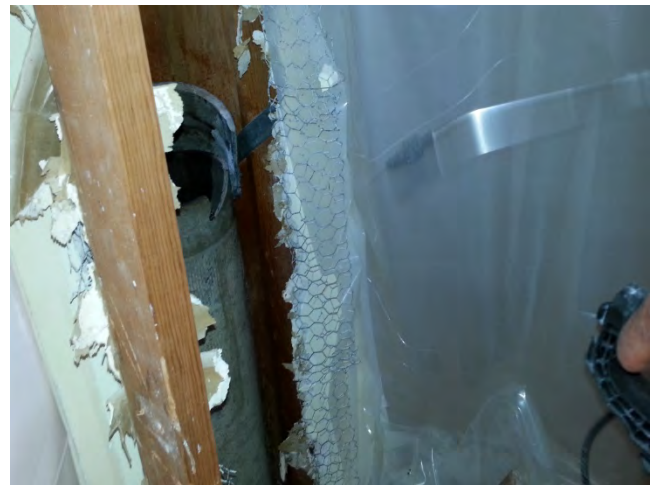
Zone 5 view of transite pipe during process. Note minimal breakage at sections coupling

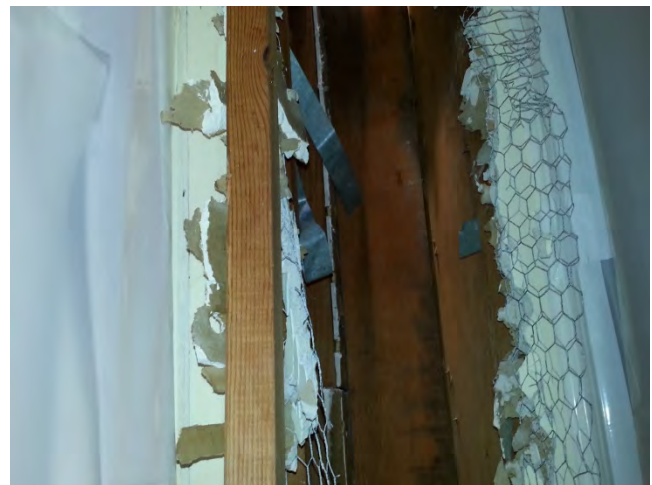
Zone 5 empty wall cavity in west wall of dining room after transite pipe removal

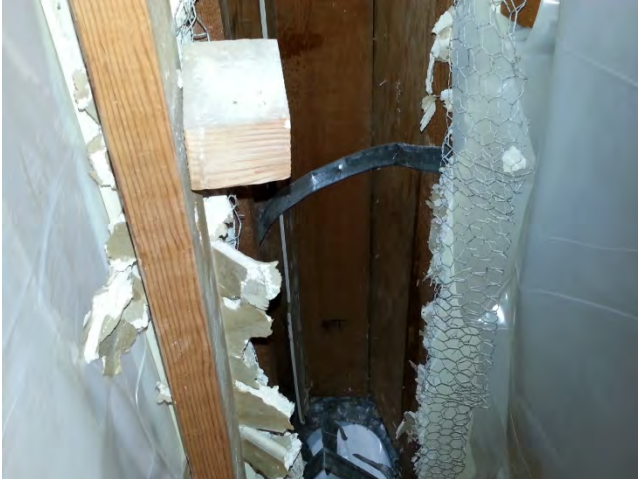
Zone 5 empty wall cavity in west wall of dining room after transite pipe removal

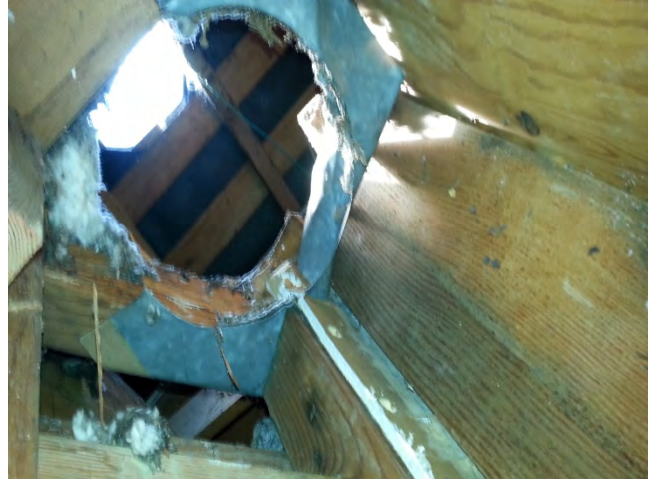
Zone 5 empty ceiling and roof cavity after removal of transite pipe

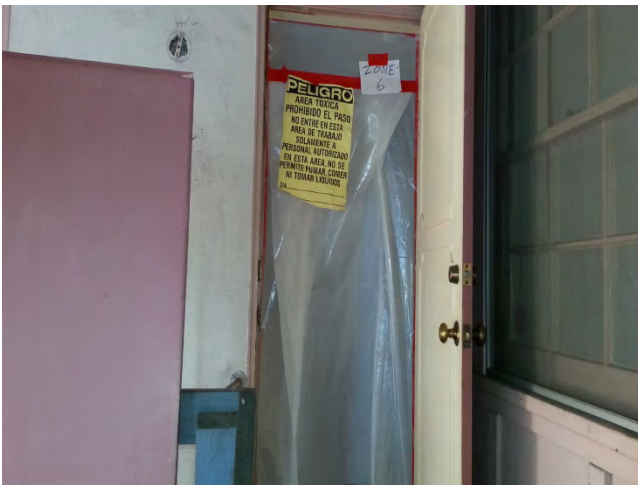
Zone 6 preparation measure to isolate east door of kitchen prior to ceramic tile demolition

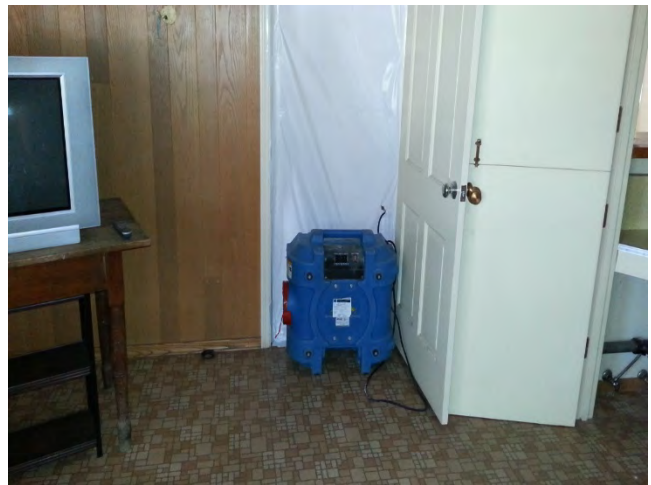
Zone 6 preparation measure to filter and scrub air within the regulated work area using a HEPA air filtration machine

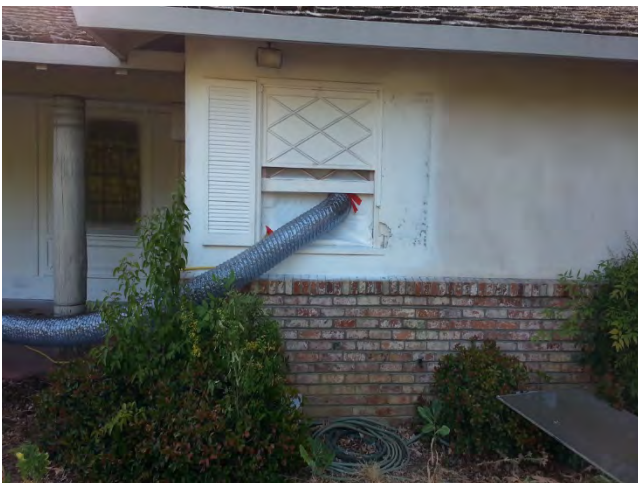
Zone 6 preparation showing HEPA exhaust tubing at master bathroom

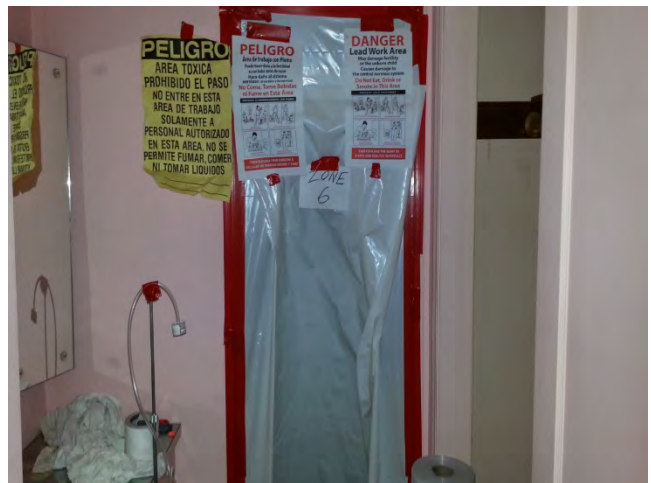
Zone 6 preparation at northeast restroom near garage

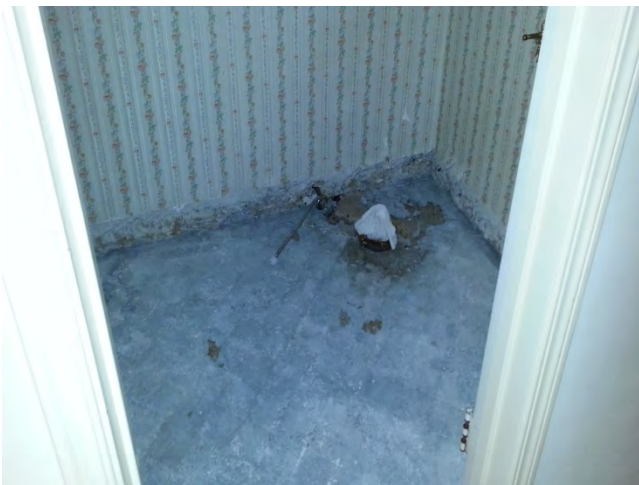
*Zone 6 final condition of northeast restroom floor following removal of ceramic tile*

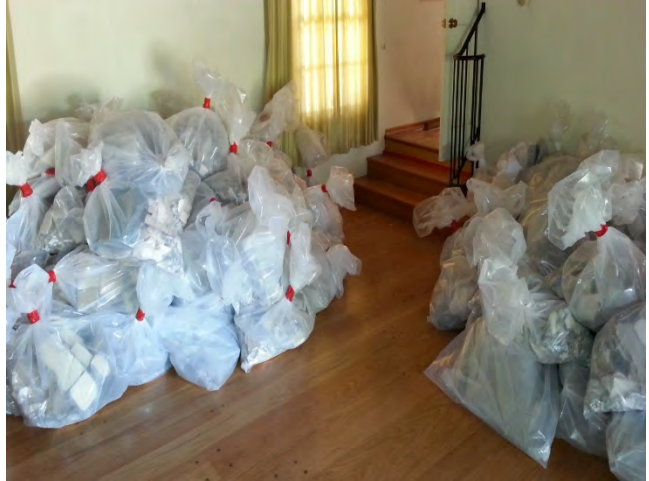
*Zone 6 waste bags of ceramic tile debris*

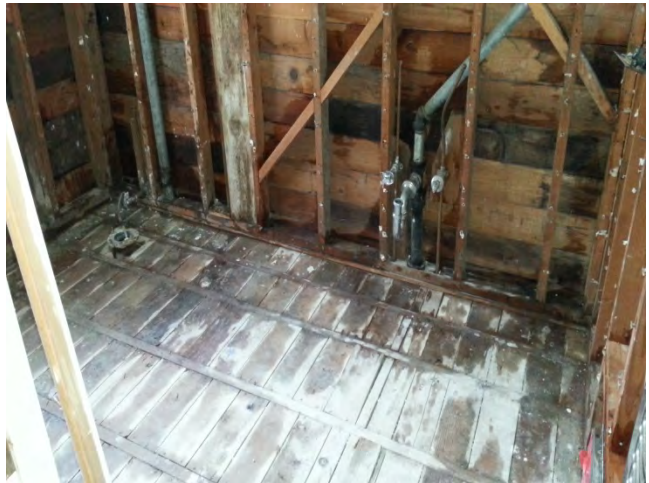
*Zone 6 final condition of master bathroom floor and walls following removal of ceramic tile*

| <b><i>Time</i></b> | <b><i>Details</i></b> |
|---|---|
| 1310 | Coastwide requested a visual clearance inspection of the master bathroom following ceramic tile demolition. The work area was found properly cleaned and SES authorized Coastwide to deregulate the work area and take down the containment barriers and turn off the negative pressure machine. |

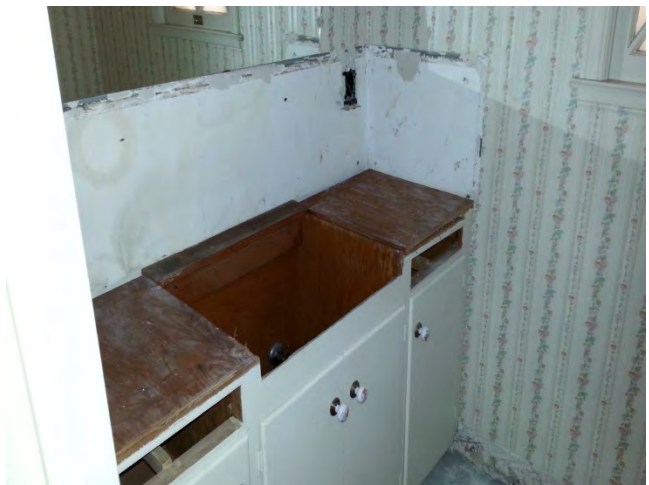
*Zone 6 northwest guestroom counter following removal of ceramic tile counter*
