Subject: Former Sears Automotive Building -- Description of Field Activities in Response to DEH Complaint #CO0145652 in re an Alleged UST, Former Vallco Mall, 10123 North Wolfe Road, Cupertino, CA 95014

APPROXIMATE TEST PIT LOCATIONS—
SEARS AUTOMOTIVE CENTER

Subject: GPR Suvey, Former Sears Automotive Center, Former Vallco Mall, 10123 North Wolfe Road, Cupertino, California 95014

PHOTOGRAPHIC LOG

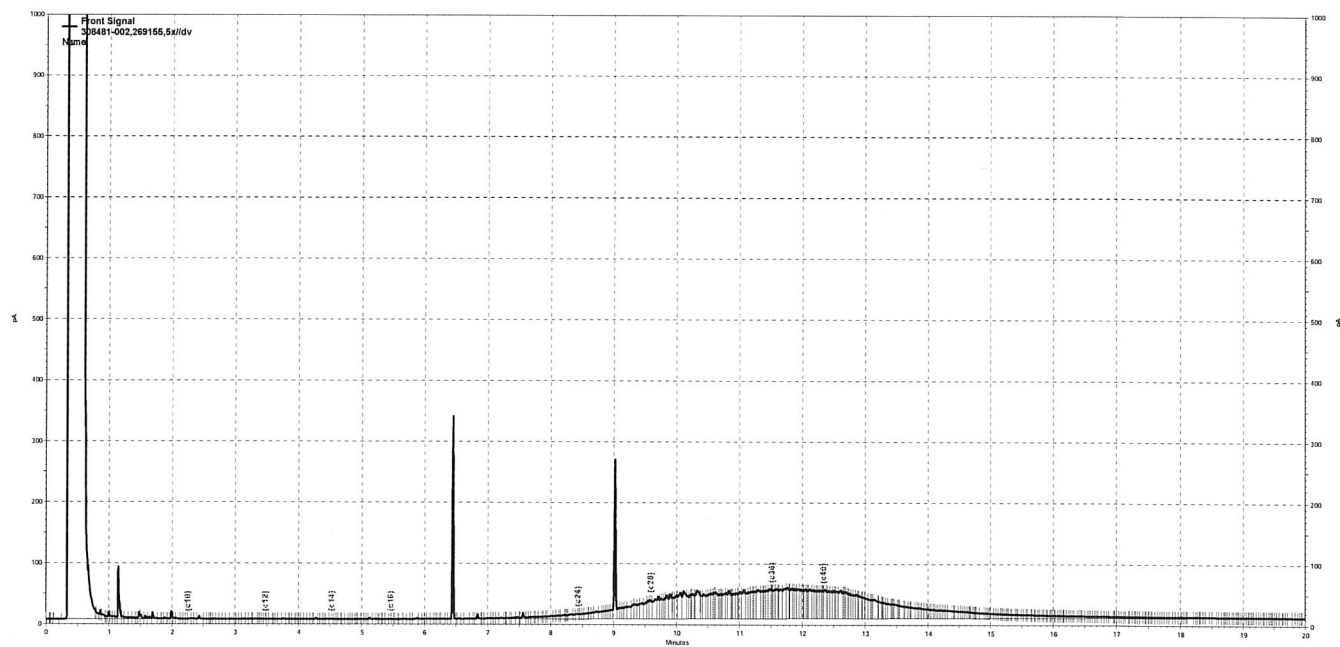
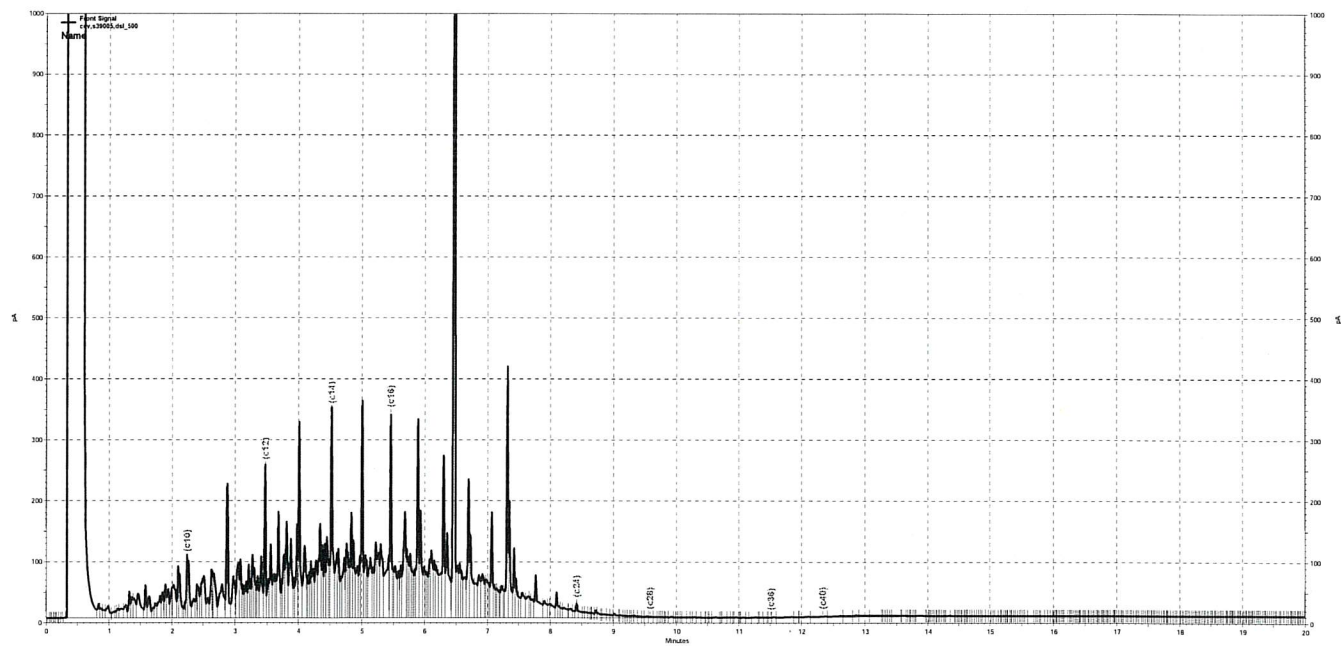
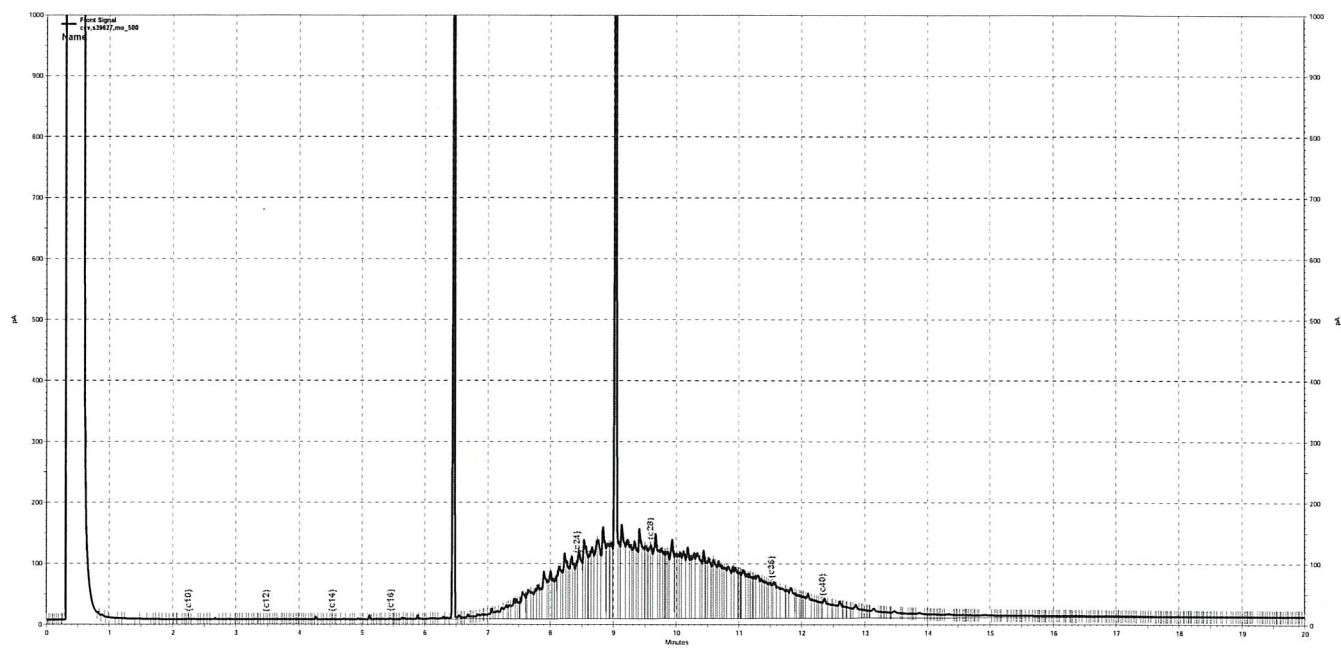
Analyte	Result	Flags	RL	MDL	Units	Basis	IDF	Method	Prep Method
Motor Oil C24-C36	74		25	7.5	mg/Kg	As Recd	5.000	EPA 8015B	EPA 3550C

Two soil samples were collected under the observed pipe, one beneath a section of the exposed pipe closest to the building and one beneath the pipe end cap. Samples were submitted to Enthalpy Analytical of Berkley, a California ELAP certified laboratory. Samples were analyzed for total petroleum hydrocarbons (TPH) as motor oil (TPH-mo). TPH-mo was detected at 74 milligrams per kilogram (mg/kg) in the sample collected beneath the pipe cap. TPH-mo was not detected in the other sample collected beneath the pipe. The detection of TPH-mo beneath the pipe cap is far below the Regional Water Quality Control Board, San Francisco Bay Region Environmental Screening Level (ESL) for residential human health of 12,000 mg/kg and is also below the odor/gross contamination ESL of 100 mg/kg. The TPH-mo is considered residual TPH-mo that may have resulted when the pipe was cut and capped. Sample results are contained in Enclosure 2.

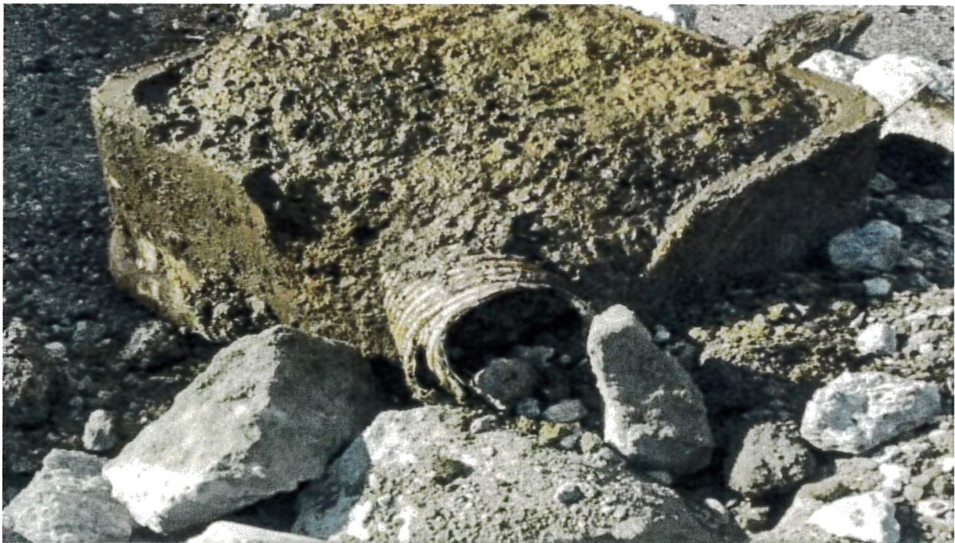
Photo No.	Date	
3	March 26, 2019	
<p>Photo of the removed concrete box. Plastic piping lead from the box towards a nearby storm drain.</p>

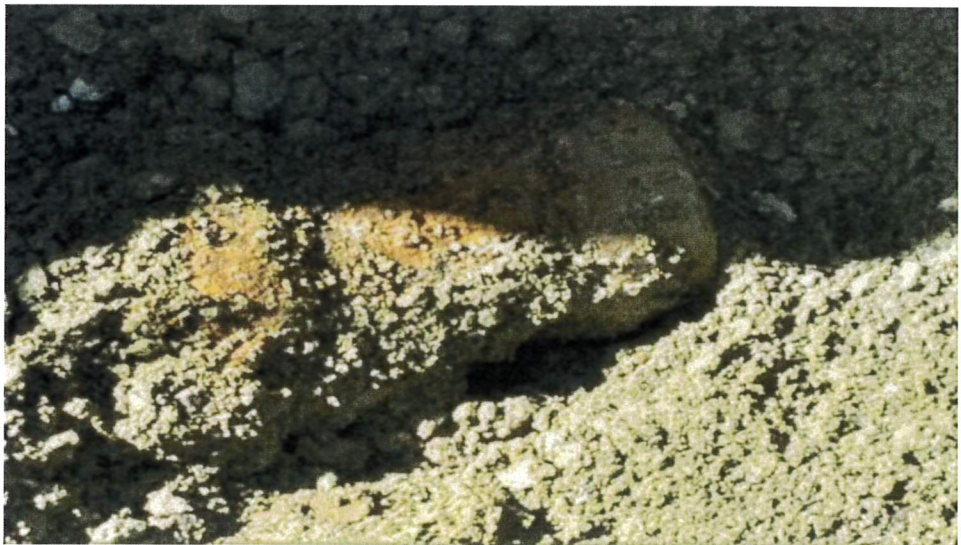
Photo No.	Date	
6	March 26, 2019	
Side view of the end cap of the metal pipe. The metal pipe extended approximately 33 feet west of the Sears Automotive Building.

To ensure no UST was buried in place at the end of the capped pipe, additional test pits were placed approximately 5 feet north and 5 feet south of the pipe end. No UST or additional piping was observed, confirming the findings of the GPR survey. Furthermore, during the test pit activities, no odor or staining was noted. Upon completion of the investigation, all soil was replaced in the test pits and the asphalt was replaced. A photographic log of the test pit field activities is included as Enclosure 3.
