Cupertino City Hall Essential Services Facility Analysis

Final Report, Revision 1
March 27, 2012

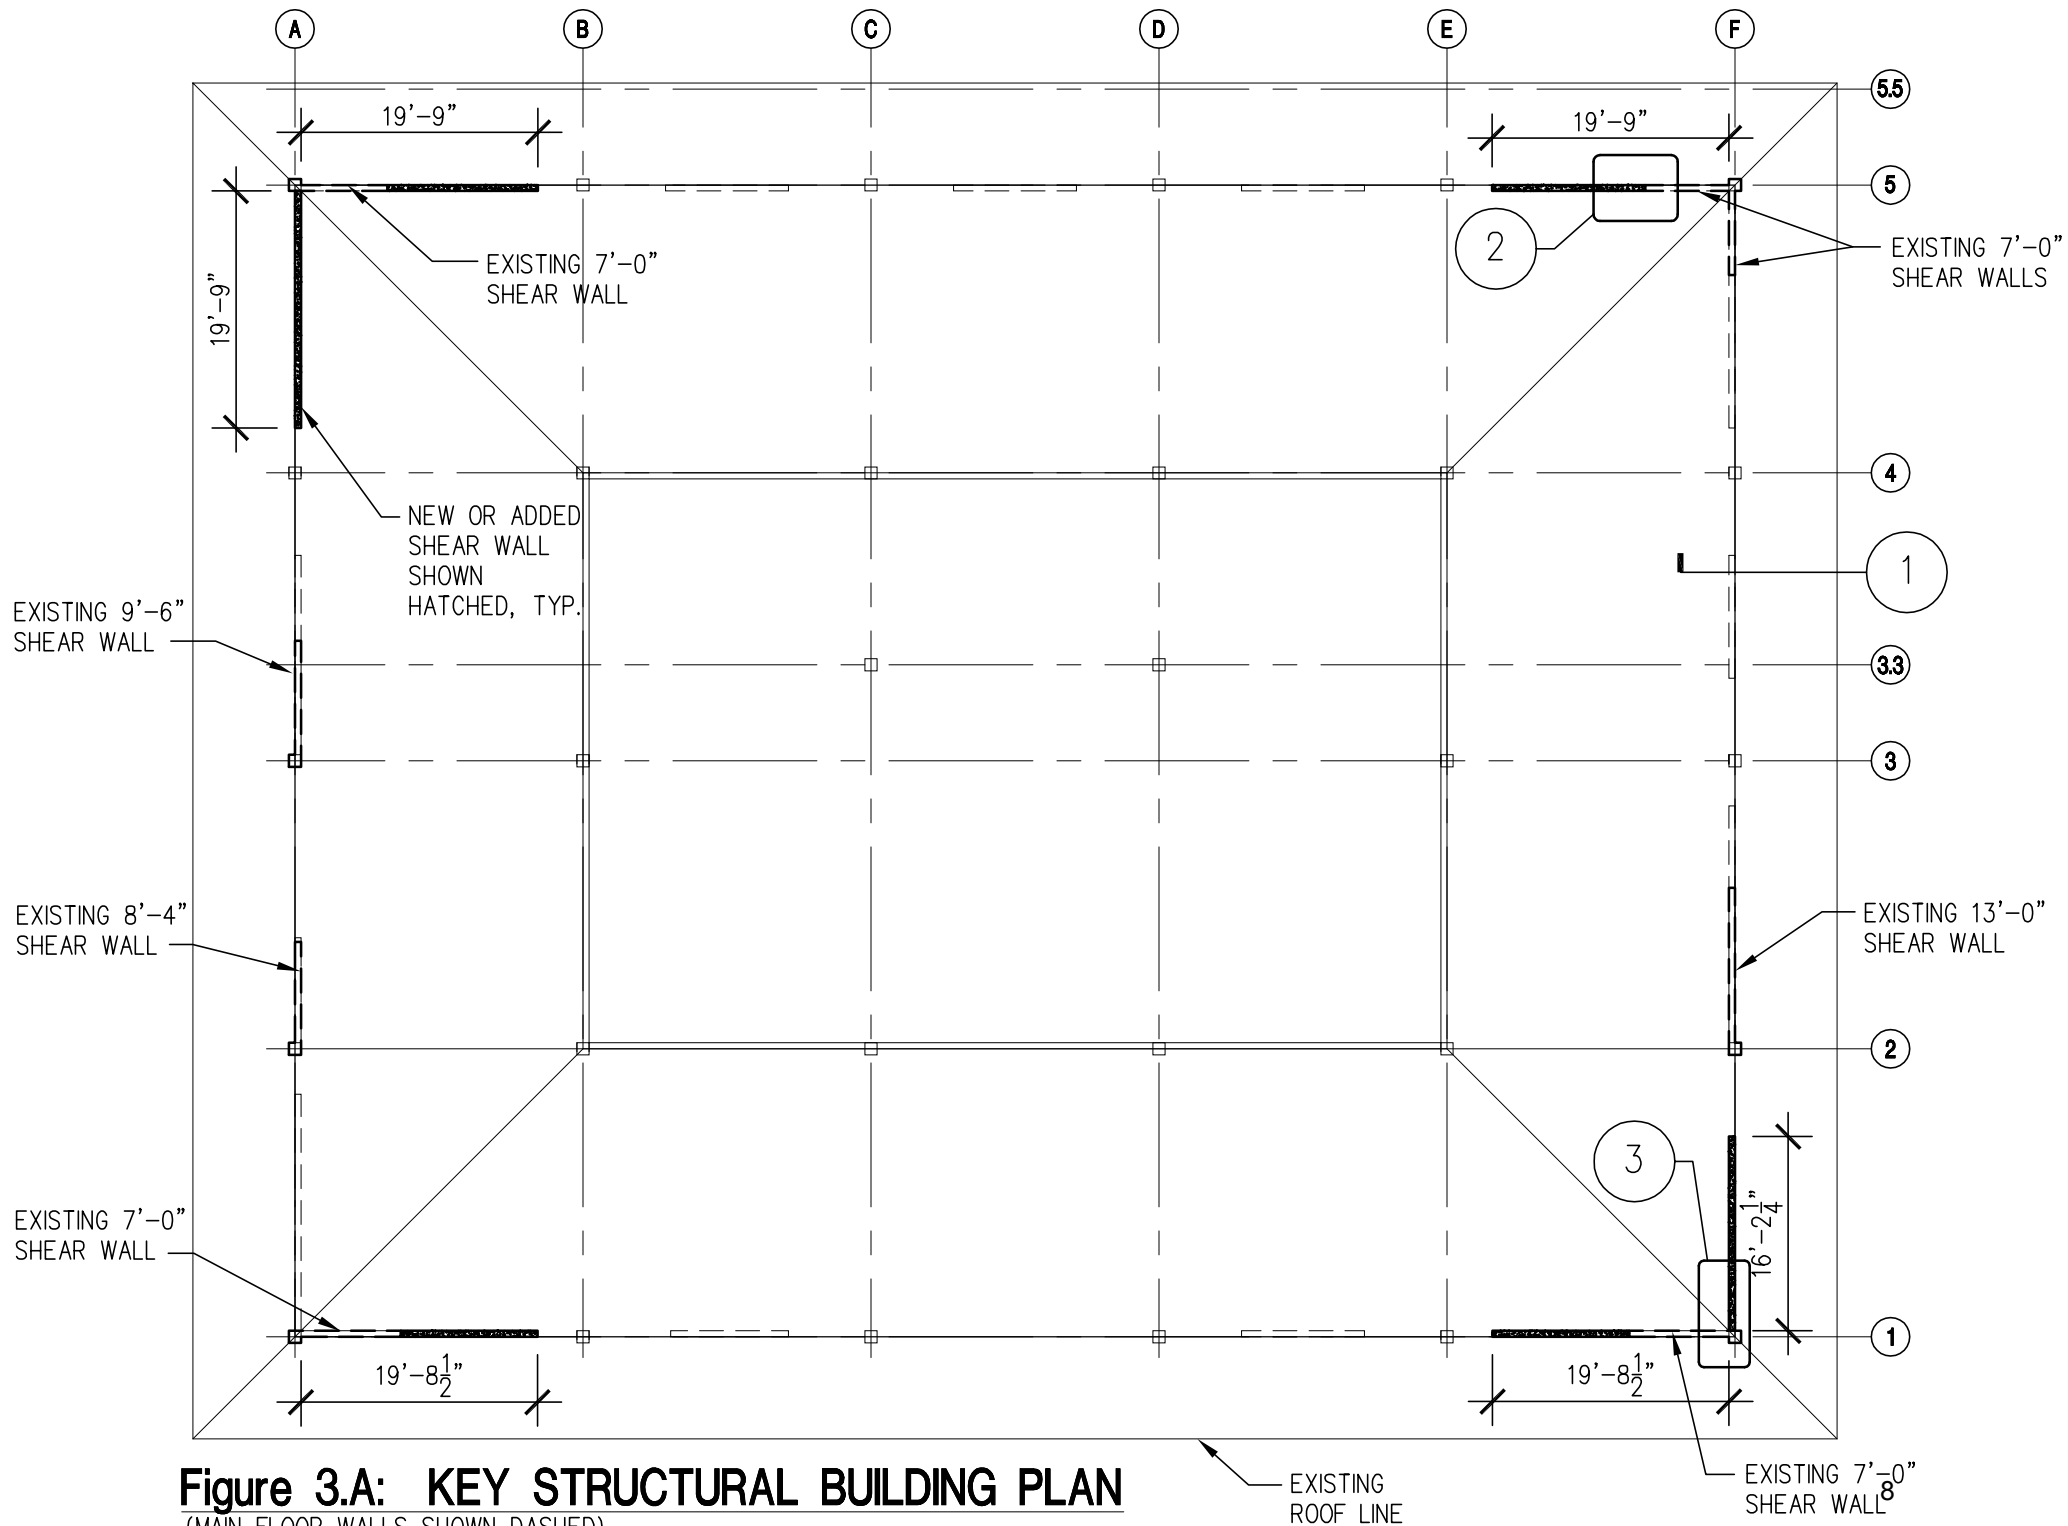
only minimal redundancy. Overall, the smaller number and length of walls result in a structural configuration that has historically performed less than optimally in resisting lateral, seismic forces in moderate and major earthquakes. Therefore we recommend that additional shear walls be added on each side of the structure. The included key plan of the building indicates where concrete walls can be added to the building, utilizing portions of existing solid exterior wall. These proposed locations would affect the building's current aesthetics and function to only a limited degree, if at all. See Fig. 3.A.
