**Seismic Evaluation - Tier 1  
Cupertino City Hall  
10300 Torre Ave  
Cupertino, California**

MME Job No. 21143.P5

April 19, 2021

**Re: Cupertino City Hall Seismic Evaluation – Tier 1**

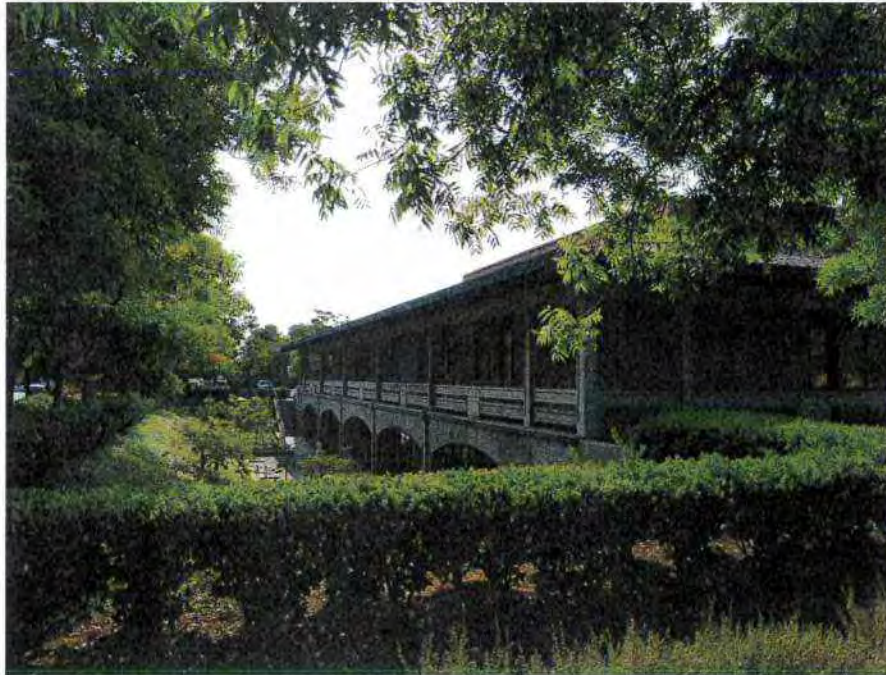
**Original 1965 Construction:** The original building was a one-story structure above grade with a basement below grade. A 1985 remodel opened one side of the basement, introduced openings in the north basement wall, and created an elevated veranda slab on the north side of the building (Photo 1). These changes created a 2 story building. The building is generally rectangular in plan, with the long side oriented in the east-west direction. The building footprint including the roofed veranda is approximately 136 feet by 112 feet. The interior space is 120 feet by 96 feet and the two floors have a combined area of approximately 23,040 square feet.

*Photo 1 North Elevation with Elevated Veranda Slab*

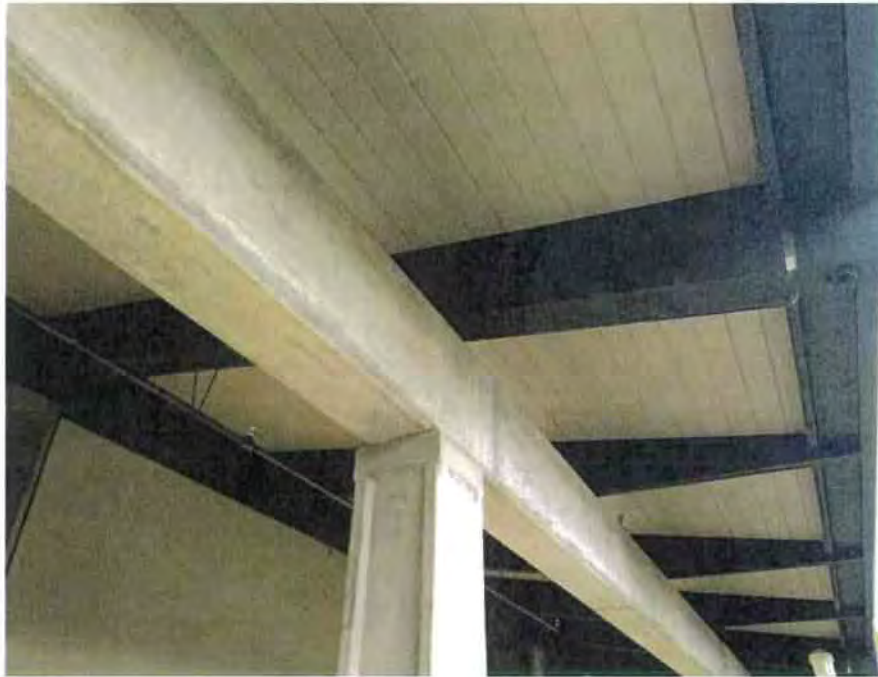
*Photo 2 Veranda Concrete Beam*

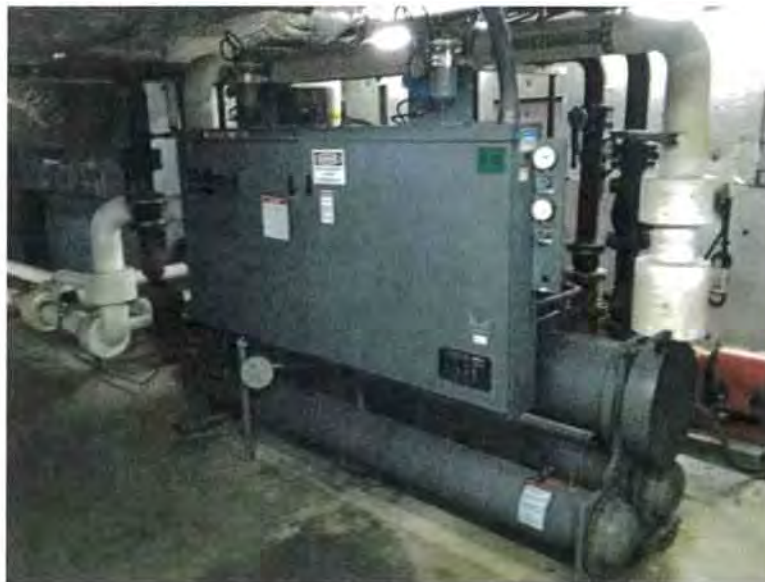
Figure 5B (Water-cooled 70 Ton Chiller)

In the lower level mechanical room, maintenance clearances and an exit pathway may not exist throughout the space. In addition, the combination of chiller, gas boiler, electrical gear, and generator equipment do not meet today's code

requirement to have separate rooms for each of these pieces of equipment. The room is also not equipped with a refrigerant detection and exhaust systems currently required for chiller rooms, and the combustion air ducts in the boiler room need to be routed to an outdoor location.

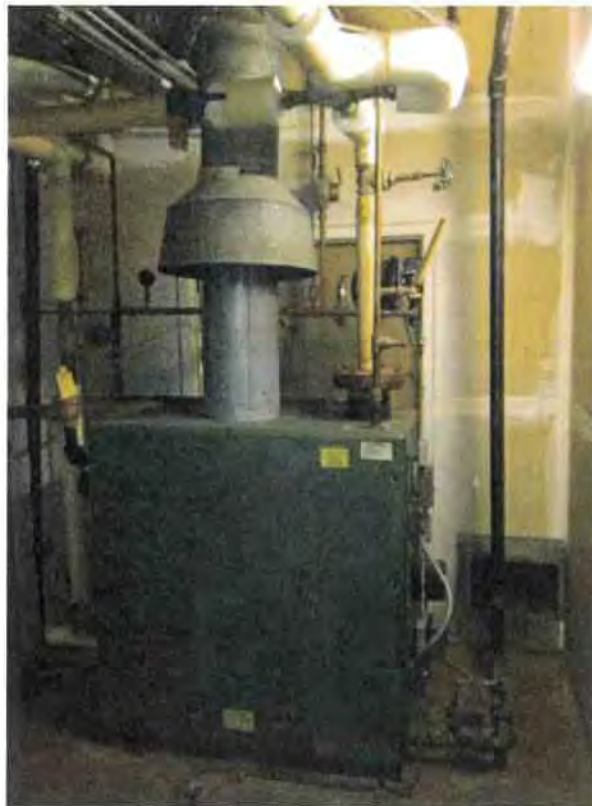
Figure 5C (Gas Fired Boiler)

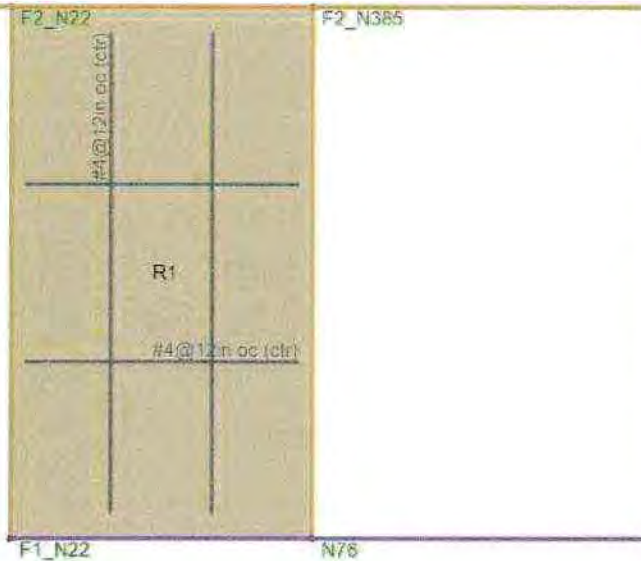
| Limit State | Gov. LC | Required | Available | Unity Check | Result |
|---|---|---|---|---|---|
| UC Max In-Plane | | | | 4.1699 | FAIL |

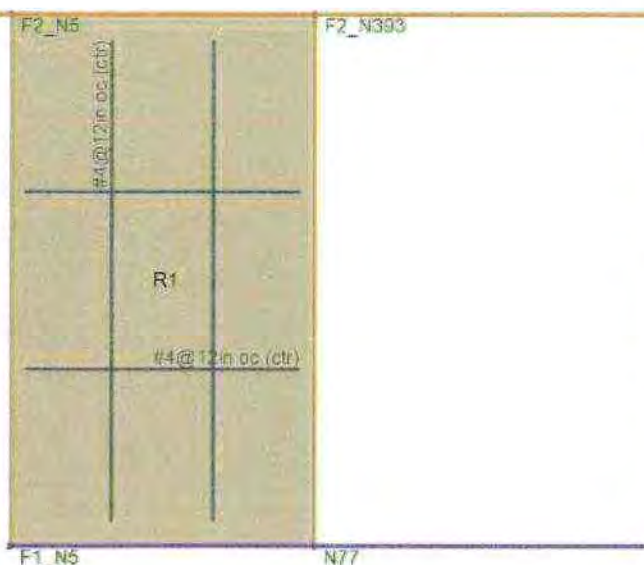
| Limit State | Gov. LC | Required | Available | Unity Check | Result |
|---|---|---|---|---|---|
| UC Max In-Plane | | | | 4.1618 | FAIL |

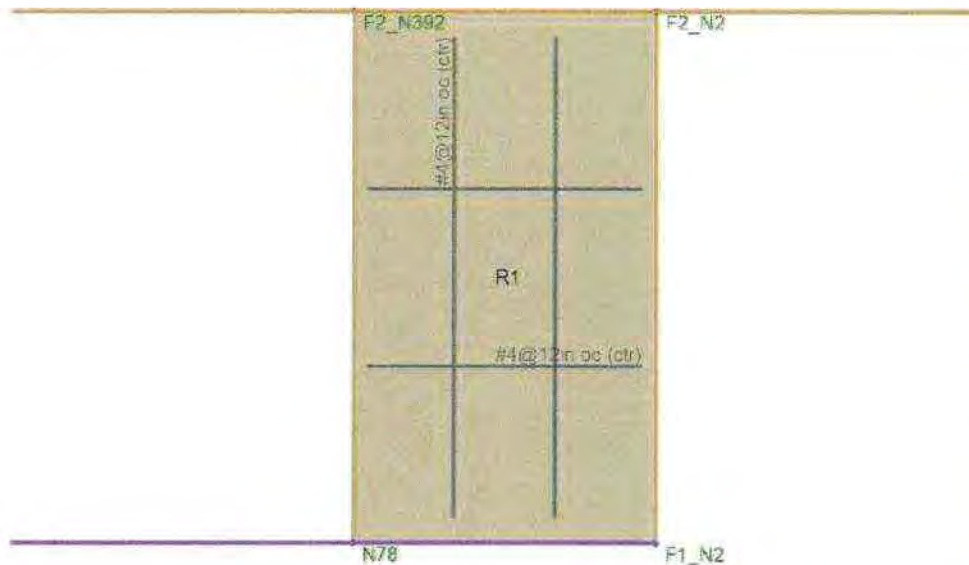
## Detail Report: SW35

| Limit State | Gov. LC | Required | Available | Unity Check | Result |
|---|---|---|---|---|---|
| UC Max In-Plane | | | | 3.6942 | FAIL |
| UC Max Out-of-Plane | | | | 1.461 | FAIL |

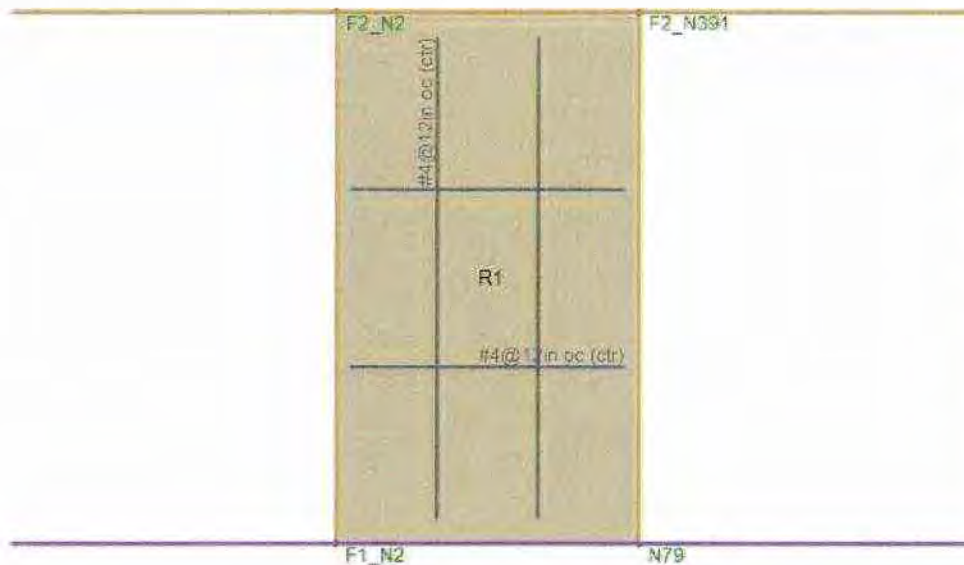
| Limit State | Gov. LC | Required | Available | Unity Check | Result |
|---|---|---|---|---|---|
| UC Max In-Plane | | | | 3.2381 | FAIL |
| UC Max Out-of-Plane | | | | 1.6314 | FAIL |

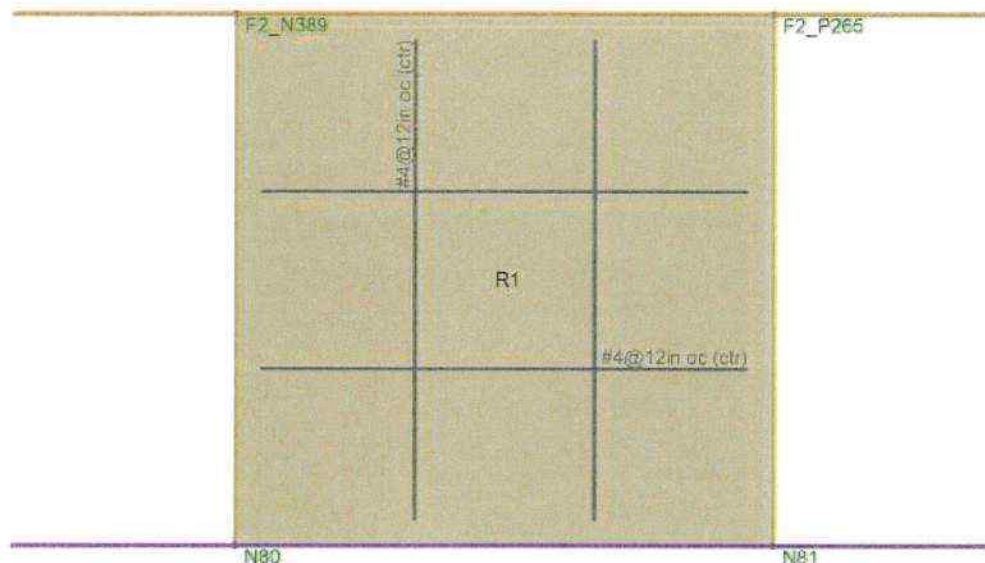
## Detail Report: SW37

| Limit State | Gov. LC | Required | Available | Unity Check | Result |
|---|---|---|---|---|---|
| UC Max In-Plane | | | | 1.3477 | FAIL |

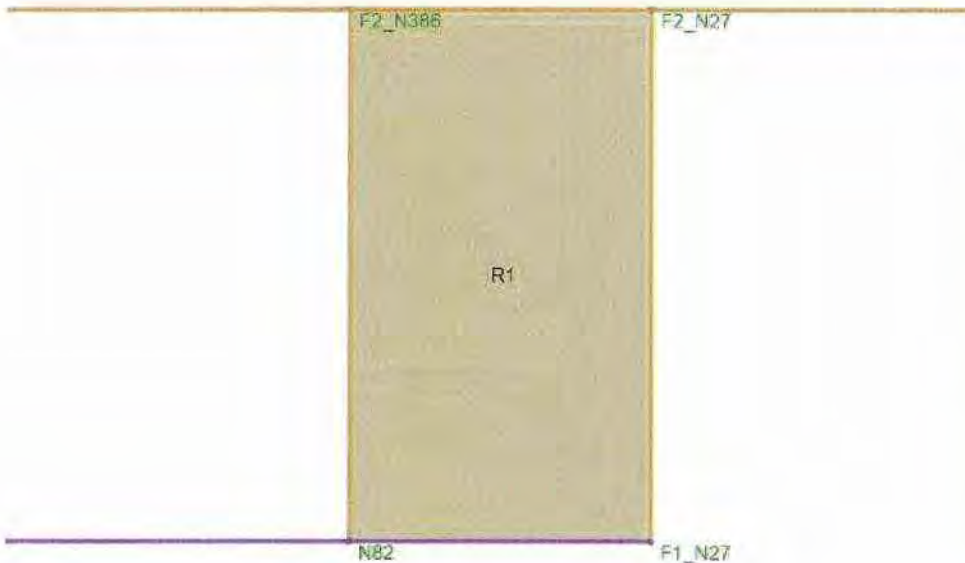
| Limit State | Gov. LC | Required | Available | Unity Check | Result |
|---|---|---|---|---|---|
| UC Max In-Plane | | | | 4.1277 | FAIL |

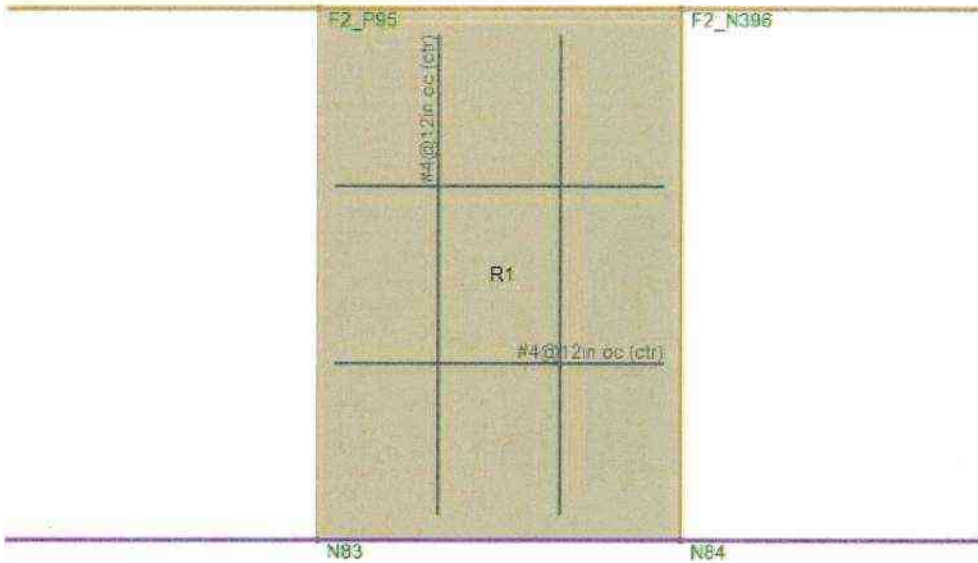
| Limit State | Gov. LC | Required | Available | Unity Check | Result |
|---|---|---|---|---|---|
| UC Max In-Plane | | | | 2.7359 | FAIL |

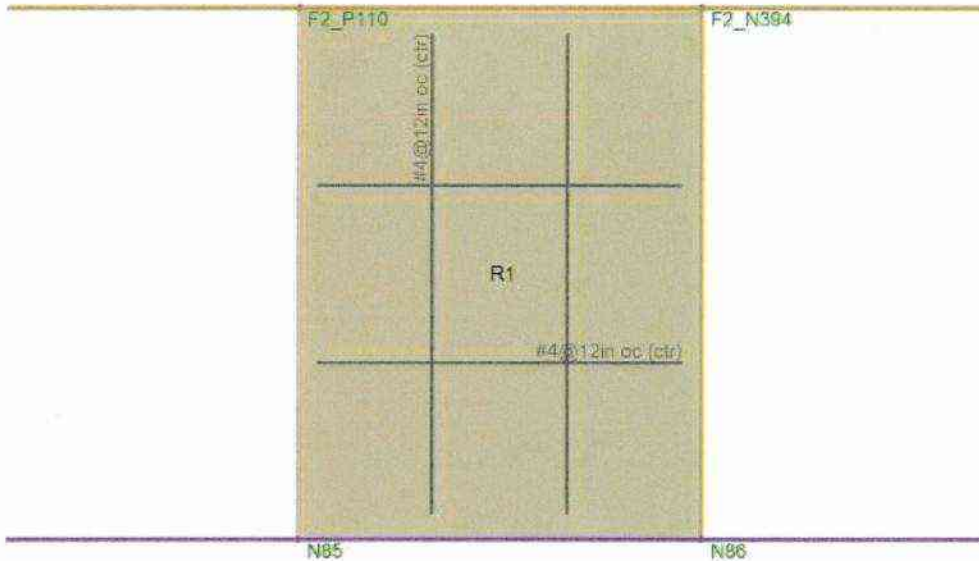
**Input Data:**

Code: ACI 318-14  
 Design Rule: WALL 6"  
 Seismic Rule: None  
 Loc of r/f: Centered  
 Outer Bars: Vertical  
 Vert Bar Size: #4  
 Horz Bar Size: #4  
 Transfer In?: Yes  
 Transfer Out?: Yes  
 Group Wall?: Yes

| Limit State | Gov. LC | Required | Available | Unity Check | Result |
|---|---|---|---|---|---|
| UC Max In-Plane | | | | 3.1426 | FAIL |
| Region R1 (In-Plane) | | | | 3.1426 | FAIL |
