# **ARBORIST REPORT**

## **HYATT HOUSE HOTEL AT VALLCO PARK**

**WOLFE ROAD & INTERSTATE 280  
CUPERTINO, CALIFORNIA  
(APN 316-20-092)**

July 24, 2014

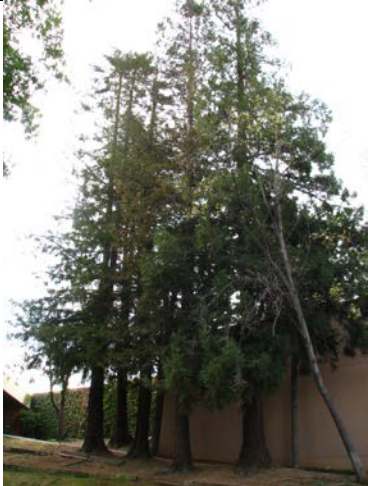
| Tree # | Image | Tree # | Image |
|---|---|---|---|
| Close-up of tree 267 to be removed, which exhibits a severe girdling root issue due to planting strip width which severely restricted normal lateral root extension from the trunk | | Grove of redwoods 204 to 218 to be removed just west of Dynasty Restaurant. | |

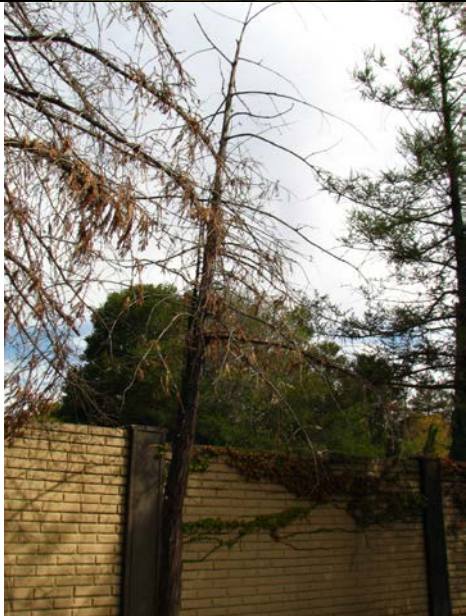
| Tree # | Image | Tree # | Image |
|---|---|---|---|
| Looking south down west perimeter road, at rows starting with tree 240 on left (row to be removed), and 703 at right (row to be retained) | | Redwood specimens along the west side of west perimeter road are suffering severely from soil moisture deficit, and are generally declining or dying | |

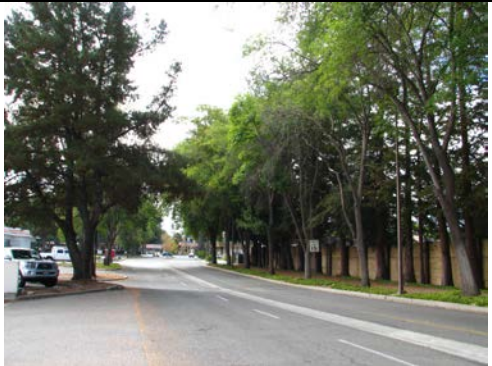
| Tree # | Image | Tree # | Image |
|---|---|---|---|
| The dense screen along the west side of west perimeter road as shown here near tree 771 is in danger of dying due to soil moisture deficit. Replacement of these high water use trees with drought tolerant evergreen species is a viable option. | | | <p>Looking south along west perimeter road.</p> <p>The trees at right are trees 752 southward, and 852 southward, and are currently proposed to be retained.</p> <p>Trees along the left side (east side) of west perimeter road are to be removed.</p> |

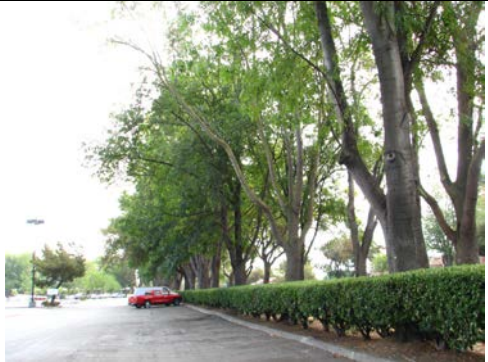
| Tree # | Image | Tree # | Image |
|---|---|---|---|
| Shamel ash trees 8 and 9 to be retained at the southwest corner of the Vallco site.<br><br>Note curb and asphalt displacement from root growth. If this hardscape is removed and replaced, severe root loss and root damage may result, ending in further tree decline or death. | | | <br><br>Shamel ash 9 to 36 to be retained along this south border of the site, looking east. Again, removal of or alternation of existing curb and asphalt materials could cause severe root damage to these already drought-stressed specimens, resulting in further tree decline or death. |

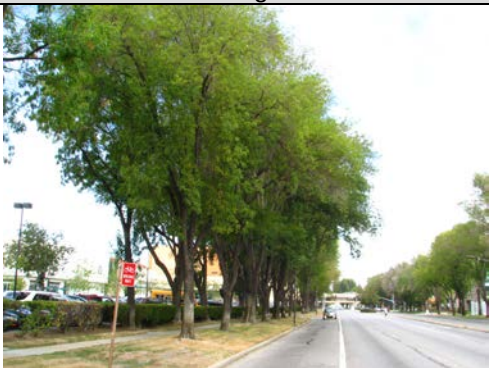
| Tree # | Image | Tree # | Image |
|---|---|---|---|
| Monterey pine 51 at southeast corner of the Vallco site. This tree is dead, and needs to be removed at this time as a high risk of failure and impact to targets. | | Looking north at shamel ash 55, 57, 59, 61, 63, 65 to be retained. | |
