ARBORIST REPORT

HYATT HOUSE HOTEL AT VALLCO PARK

**WOLFE ROAD & INTERSTATE 280
CUPERTINO, CALIFORNIA
(APN 316-20-092)**

July 24, 2014

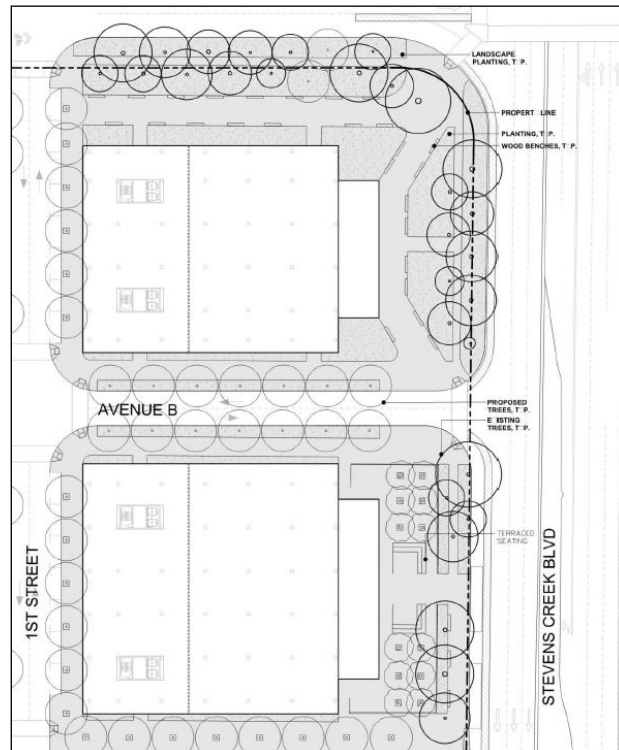
Demolition of existing curbs, planting areas, asphalt parking stall surface materials, etc. to make way for new landscaping may cause significant or severe damage to the below ground portions of trees being retained such as shamel ash at the southwest end of the site along the south boundary of the existing SEARS parking lot. The image capture at right shows a portion of project team sheet P-0609 main entry area landscaping proposed for this southwest corner area of The Hills project:

Some of the trees such as those circles drawn along the hard black line property boundary that rings the site are shamel ash specimens being retained, while other trees drawn on this sheet by the landscape architect are proposed new “in-fill” trees to augment existing screening.

WLCA's main concern in areas such as this involves demolition crew activities during removal of surface hardscape and deep curbs, which may be comingled with existing woody tree root systems. When pulling out the curbs and hardscape piece by piece, these roots may become tangled with the machinery bucket teeth and be pulled, ripped, or otherwise destroyed or damaged in the process. Therefore, an arborist monitor is suggested during demolition of any material within approximately 20 feet of a tree to be retained. As noted above in this report, we know that woody tree roots can extend laterally as far as 3x to 5x the canopy dripline distance from the trunk edge, which means that a 20 foot radius canopy tree may theoretically have roots extending as far as 60 to 100 feet radius out from trunk, even under asphalt, if there are no physical impediments to growth extension such as deep curbs or deep foundation footings.

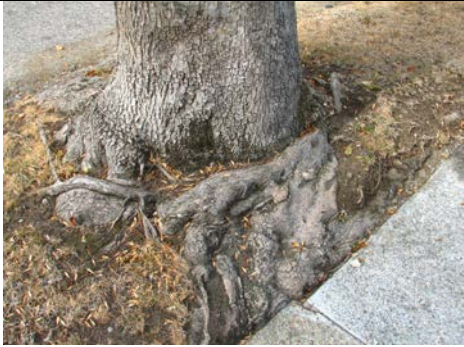
Tree #	Image	Tree #	Image
Close-up of tree 267 to be removed, which exhibits a severe girdling root issue due to planting strip width which severely restricted normal lateral root extension from the trunk

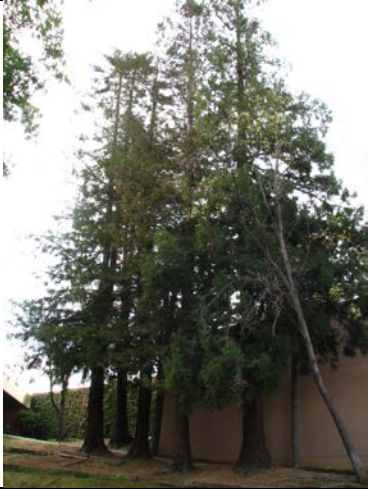
Grove of redwoods 204 to 218 to be removed just west of Dynasty Restaurant.

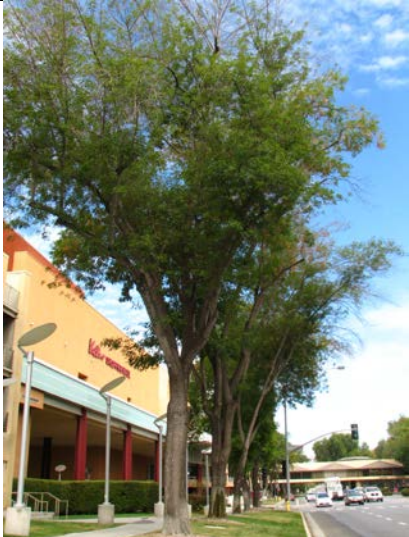
Looking north at shamel ash 102, 103, 104, and 105 to be retained. Note canopy dieback in the form of live twig density decline.
