ARBORIST REPORT

HYATT HOUSE HOTEL AT VALLCO PARK

**WOLFE ROAD & INTERSTATE 280
CUPERTINO, CALIFORNIA
(APN 316-20-092)**

July 24, 2014

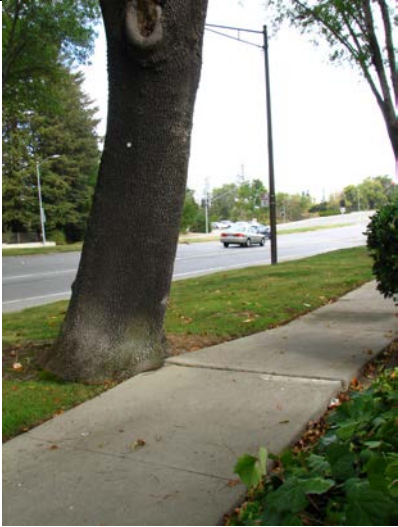
Tree #	Image	Tree #	Image
Sidewalk heave (vertical displacement) along the east side of tree 431 to be retained. Infrastructure such as this with roots likely travelling under the hardscape should be left in-situ instead of being removed (if possible), since severe root loss could occur if the walk were rebuilt. Use diamond grinding to level.

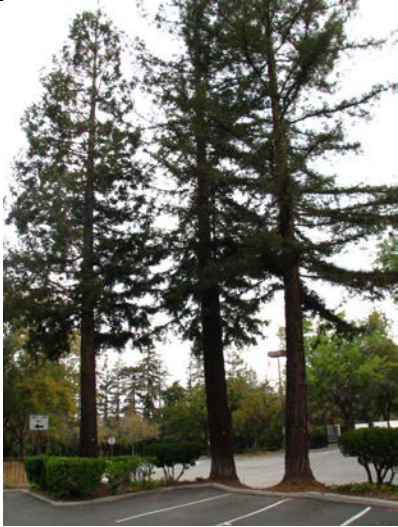
Redwoods 423, 424, 425 to be removed at the steakhouse parking lot.

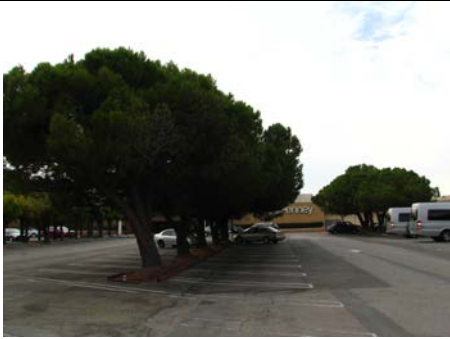
Example of redwoods and ash specimens 332, 333, and 335 in very poor condition due to soil moisture deficit, at the JC Penny parking lot.

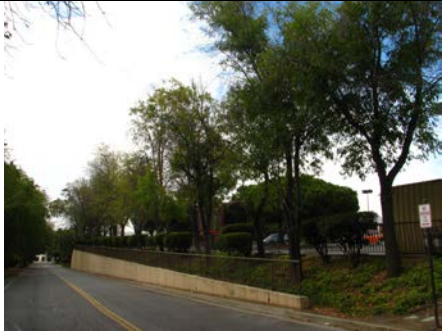
Tree #	Image	Tree #	Image
Trees 338 to 358 to be removed along the east side of the JC Penny parking lot.

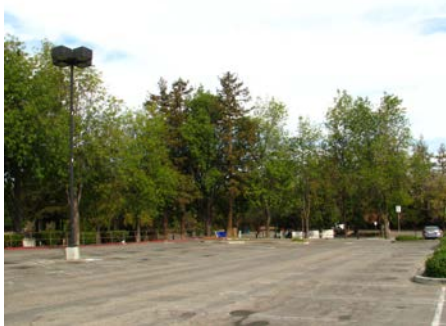
Shamel ash and redwoods 396 to 404 to be removed at the west side of JC Penny parking lot

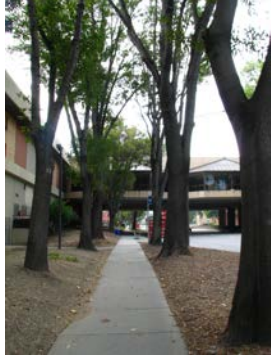
Shamel ash 452 to 457 to be removed from the east side of N. Wolfe Rd.

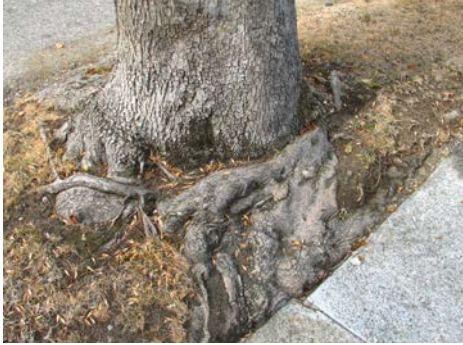
Tree #	Image	Tree #	Image
Close-up of tree 267 to be removed, which exhibits a severe girdling root issue due to planting strip width which severely restricted normal lateral root extension from the trunk

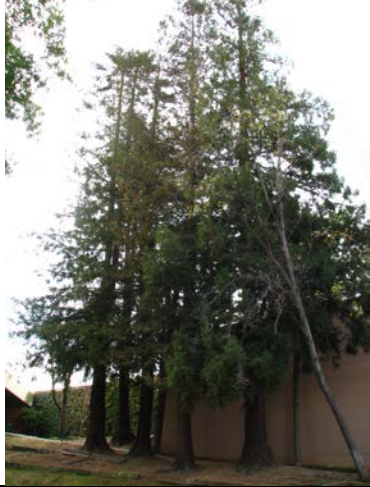
Grove of redwoods 204 to 218 to be removed just west of Dynasty Restaurant.

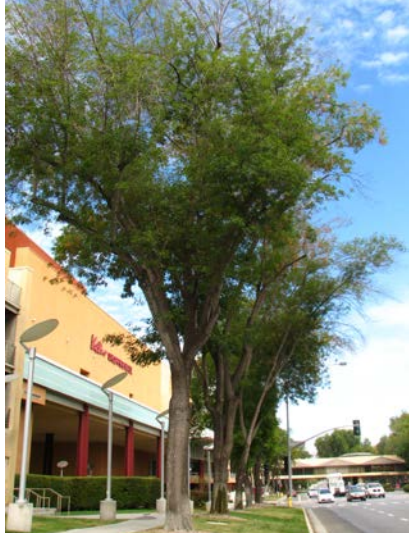
Looking north at shamel ash 102, 103, 104, and 105 to be retained. Note canopy dieback in the form of live twig density decline.
