# **Blackberry Farm Golf Course – Analysis of Minimal Repairs and Conversion of Irrigation to Well Water**

**City of Cupertino**

May 2022

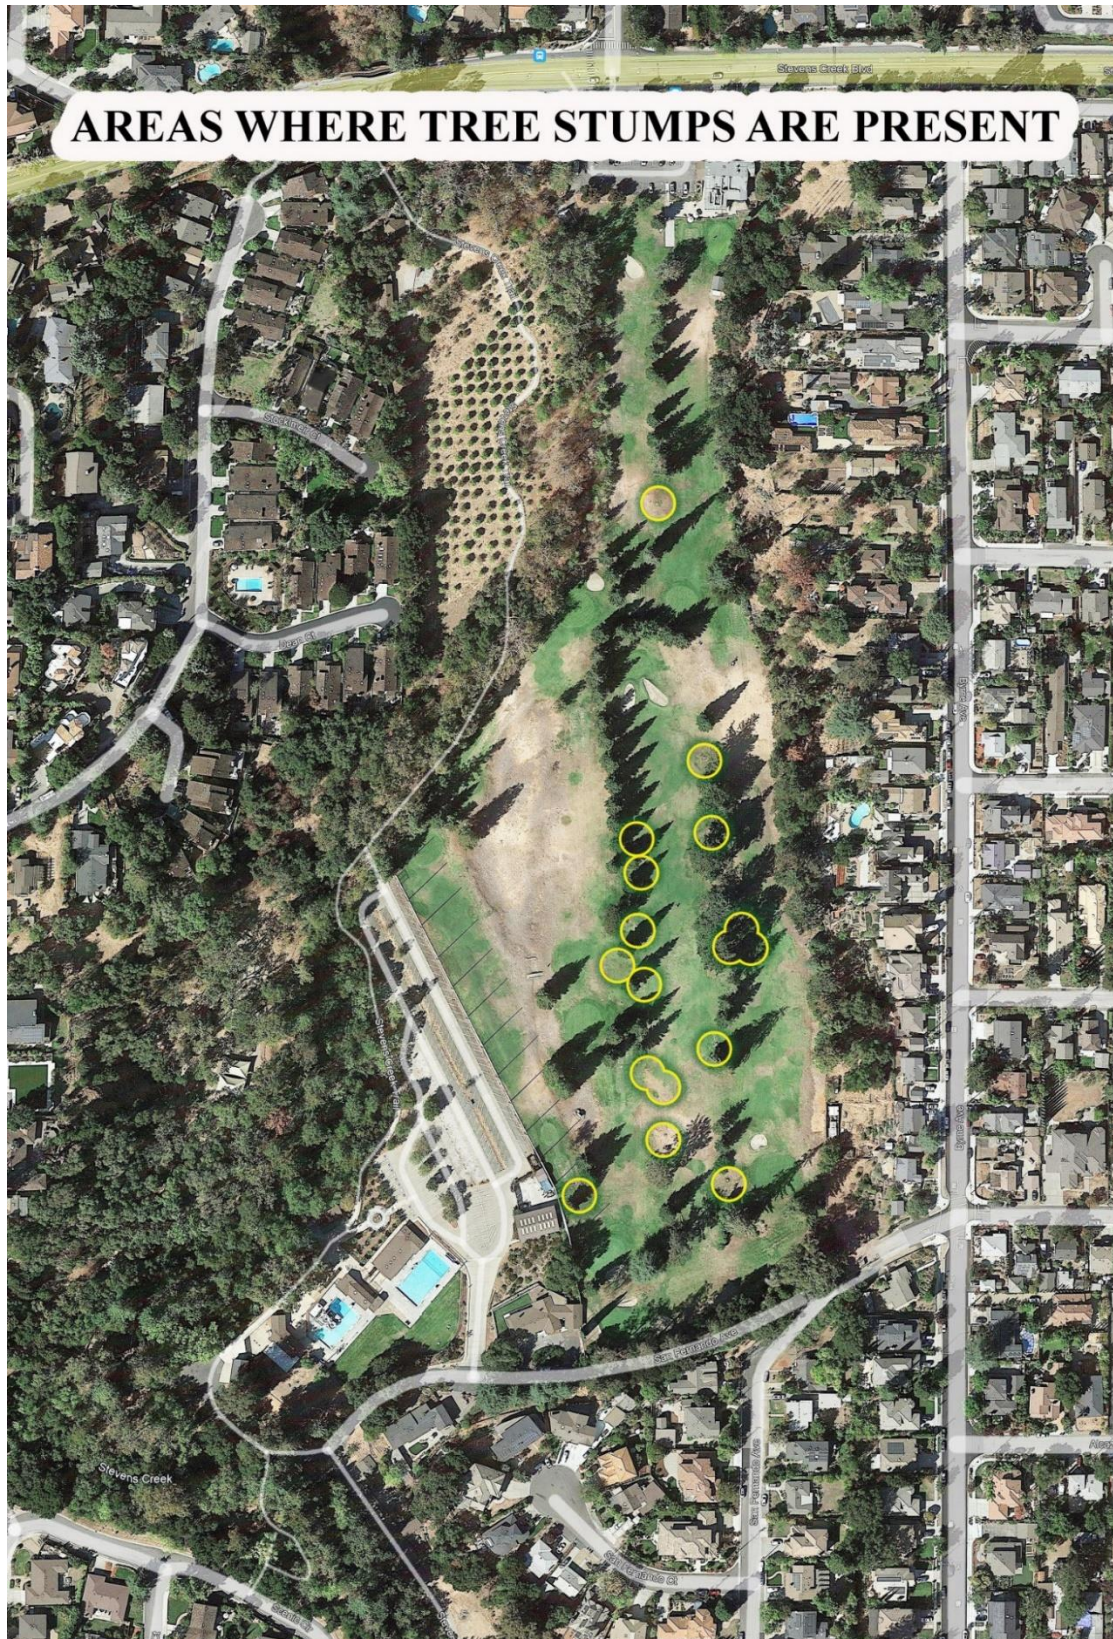
### Exhibit 3 – Areas Where Tree Stumps are Present

**Fairways and Roughs**: Turf quality is average-to-poor, with shaded areas being in the worst condition. In recent years, the City has tried to address this through in-house tree removal. However, as of 2022, seventeen (17) stumps ranging from 18 inches to 36 inches remain in place. Turf conditions beyond the root structure seem to be improved, but not still cannot be considered up to high standard. Drainage is lacking at points where natural grades do not convey water to low areas and the few drains installed on the course. Turf is a variety of Bermudagrass, ryegrass and kikuyugrass. Some small patches of fescue-type turf and hearty bentgrass (likely left over from original greens planting) can also be found. Compounding turf conditions is the antiquated irrigation system that delivers poor coverage, inefficient irrigation pressure, and is a constant source of leaks and breaks.

Where trees have been cut down, several stumps remain (see image below [Appendix C, Exhibit 3](#)). As of 2022, seventeen (17) sizable stumps remain, which has somewhat improved localized turf conditions. However, with stumps and root structure still intact, limiting the benefit to turf and golfer experience. If left in their current state some trees and/or the remaining stumps from removal may cause potential safety issues for golfers including but not limited to:

Minimal work is proposed under the minimal repair approach, with only certain areas to be considered. These include removal of tree stumps and roots - primarily for safety and efficient maintenance access and practices - and restoration of the abandoned pond areas with appropriate hydroseeding/planting, slope stabilization and drainage.
