# Limited Phase II Subsurface Investigation Report

10857, 10867, 10877, and 10887 Linda Vista Drive  
Cupertino, California 95014

AEI Project No. 482220

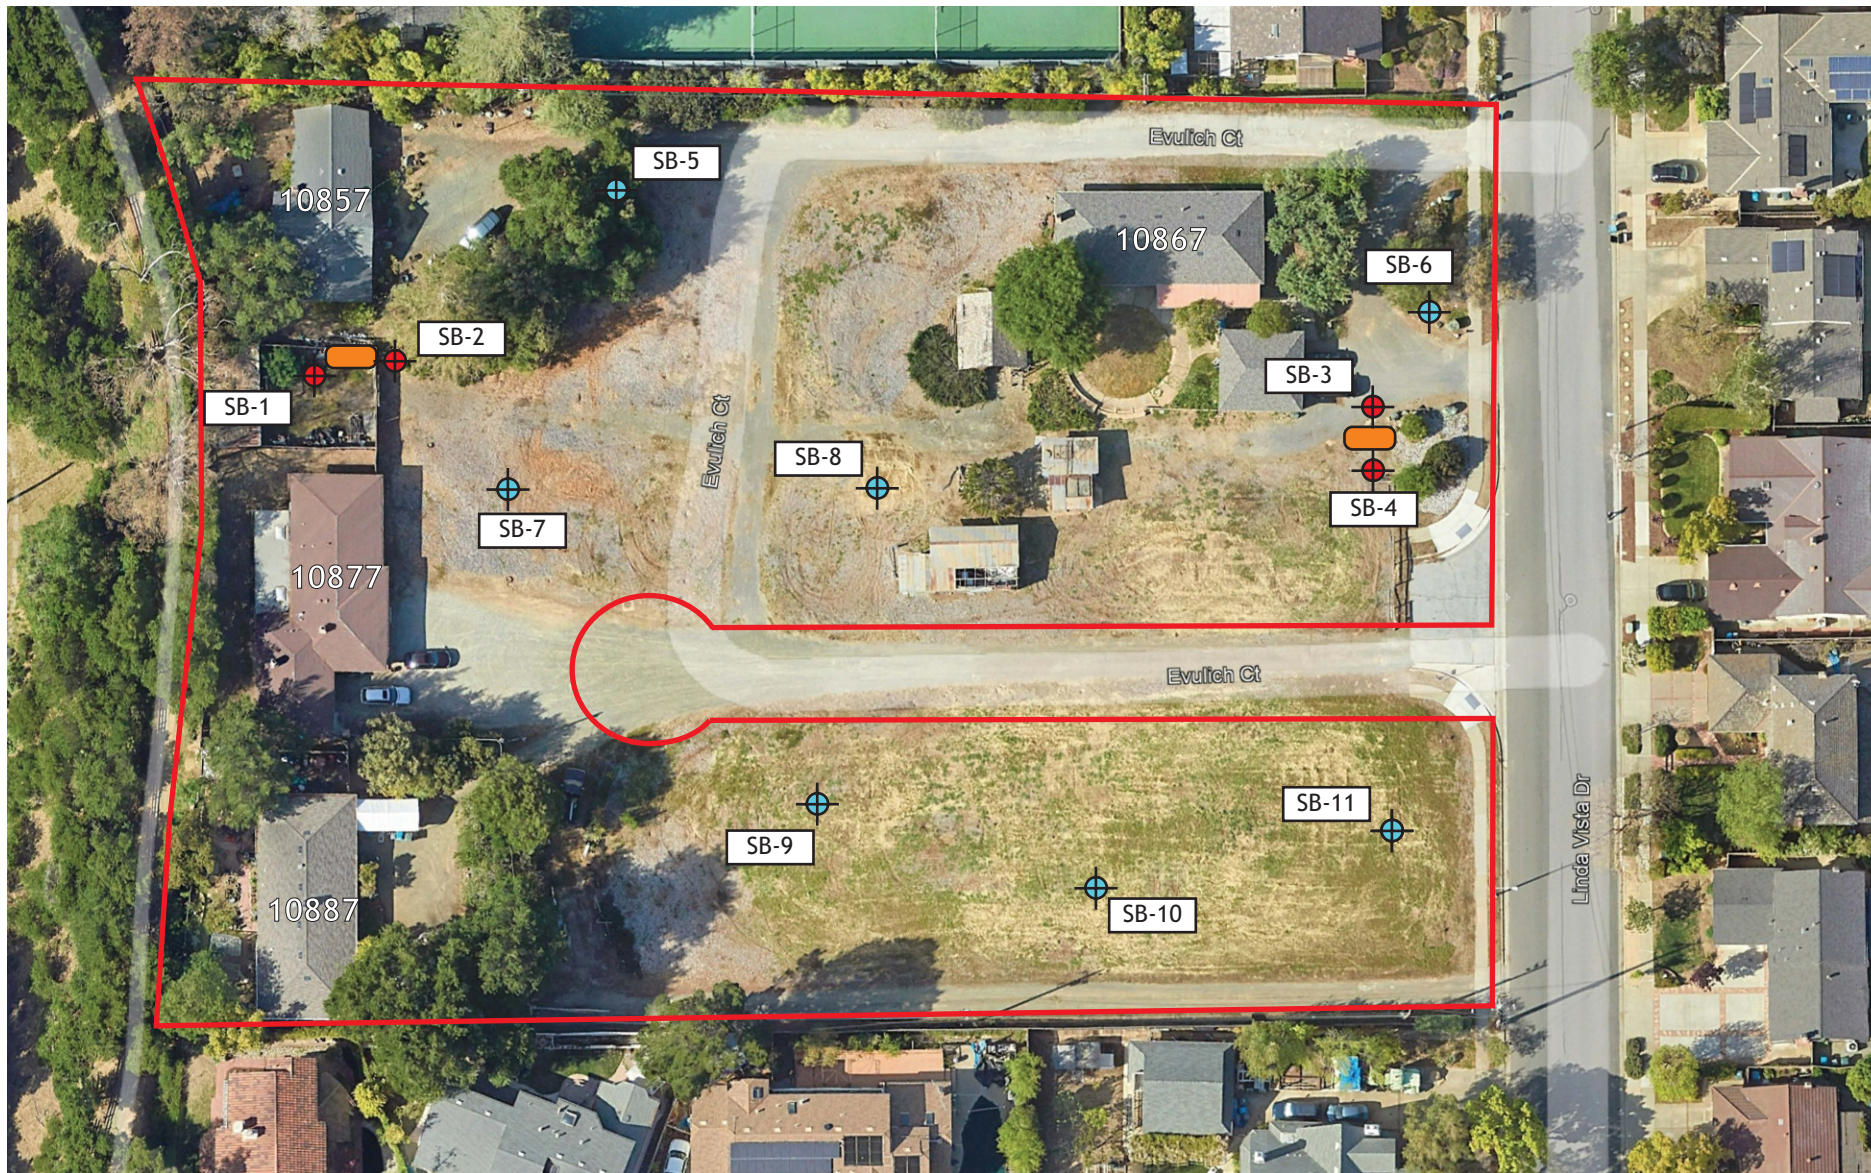
**FIGURE 2**  
Project No. 482220

The boring locations are shown on the sample location map in Figure 2. The completed Site activities are summarized below.

On September 19, 2023, under the direct supervision of AEI, eleven exploratory soil borings, SB-1, SB-2A, SB-3B, and SB-4 through SB-11 were advanced at the Site by ECA Inc. using a truck-mounted direct push drilling rig at the locations shown on Figure 2. The locations of the borings are listed below:

- Boring SB-1 and SB-2 were advanced to a total depth of 12 feet bgs, adjacent to the abandoned UST in the western portion of the Site;
- Boring SB-3 and SB-4 were advanced to a total depth of 12 feet bgs, adjacent to the abandoned UST in the eastern portion of the Site;
- Boring SB-5 was advanced to a total depth of 4 feet bgs, on the northwest portion of the Site;
- Boring SB-6 through SB-11 were advanced to a total depth of 4 feet bgs across the Site to provide lateral coverage to assess historical agricultural use.

The locations of the borings were chosen in part based on the results of the utility clearance, the locations of the identified USTs (SB-1, SB-2A, SB-3A, and SB-4), and to provide general lateral coverage of the Site (SB-5 through SB-11).

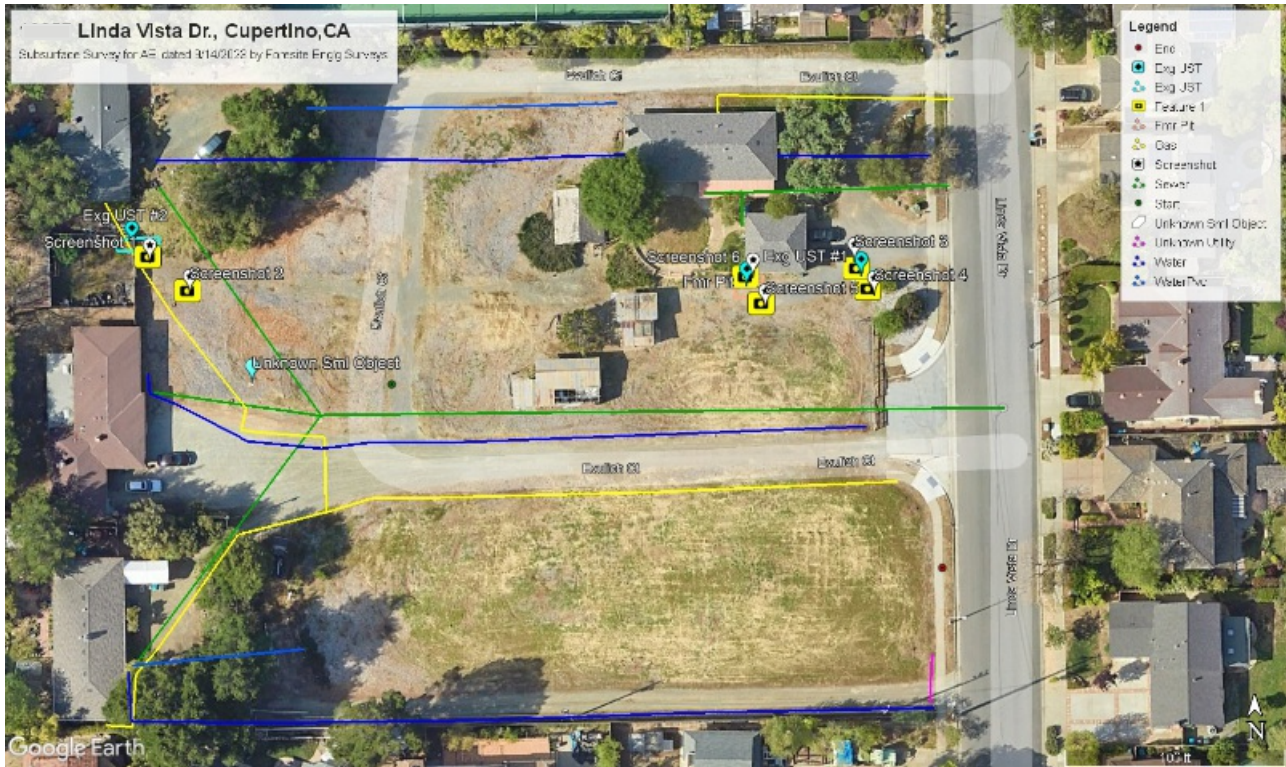
**Figure 7**

On September 14, 2023, in addition to the utility locating activities, a geophysical survey was conducted by Foresite Engineering Surveys. The geophysical survey was conducted across the Site, in the area of the two known USTs and at other accessible areas of the Site. The purpose of the survey was to evaluate the potential presence of USTs and/or associated piping. The geophysical survey was conducted using ground penetrating radar (GPR) and reflective induction (RI). During the scanning process, subsurface visibility was noted to be up to 8 feet below ground surface (bgs). During geophysical scanning, evidence of two existing USTs on the Site was confirmed at the areas shown on Figure 2, which correlates with the location of the two known tanks identified by property management and observed by AEI during the Phase I ESA. No evidence of additional USTs was identified in the areas scanned; therefore, AEI anticipates that only two USTs, not four, are present at the Site.

Subsurface anomalies not consistent with the presence of USTs were identified near the garage in the eastern portion of the Site. The anomalies appear to be up to 8 feet in depth, indicative of debris, which based on conversations with the owner, likely consists of concrete and wood debris buried over time. An additional isolated anomaly, likely cement debris, was additionally noted west of the residence at 10877 Linda Vista Drive at approximately 2.5 feet bgs. The geophysical survey report prepared by Foresite Engineering Surveys, including mapped locations of utilities and detected anomalies, is presented as Appendix A.

Results of survey shown on Google image for properties 10857,-67,-77 & -87 Linda Vista Dr,Cupertino,CA

Based on the results summarized above, no additional investigation is recommended for the Site. However, it is recommended that the two onsite abandoned USTs be formally closed/removed from the Site.
