# **Blackberry Farm Golf Course – Analysis of Minimal Repairs and Conversion of Irrigation to Well Water**

**City of Cupertino**

May 2022

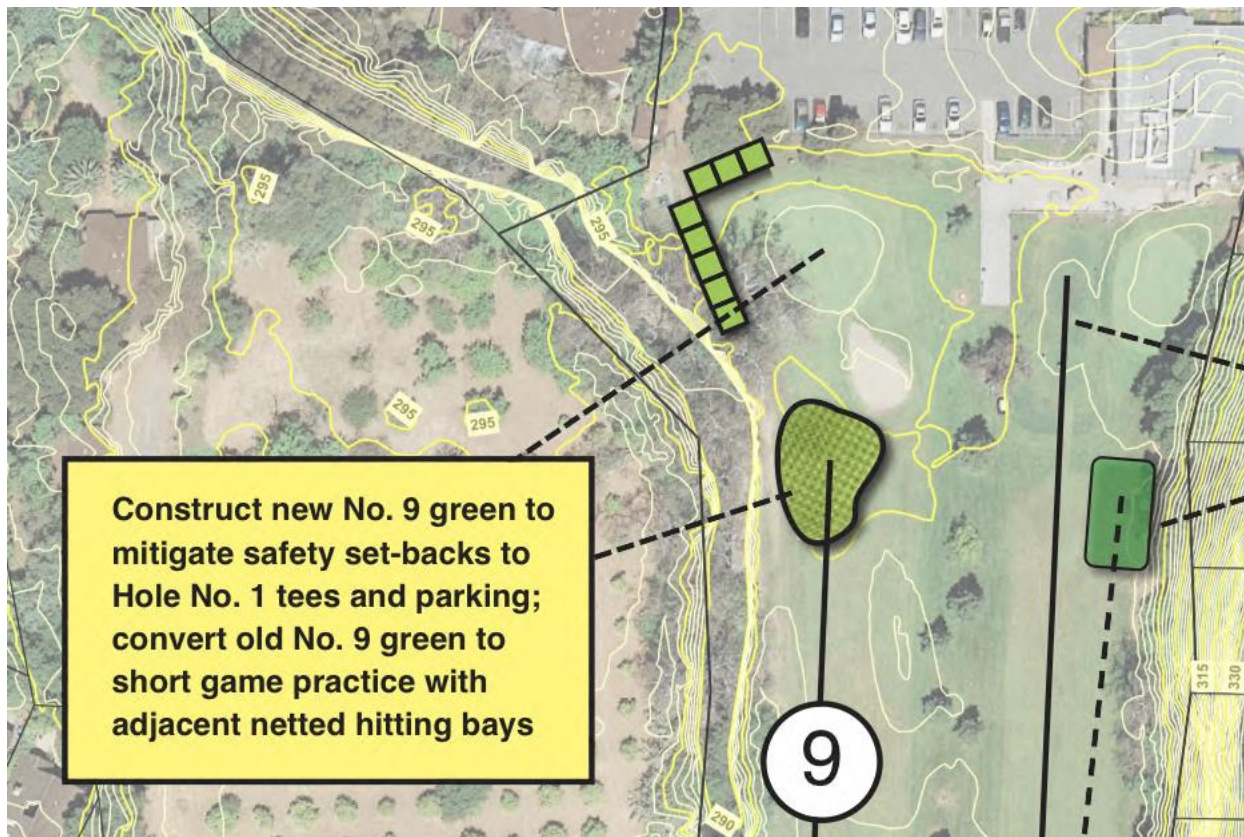
The proposal for minimal improvements included changes to the areas of the property occupying Hole No. 9 and the practice facility. The need for expanded practice facilities and efficient use of space can be realized through aligning the practice area hitting bays with proximity to the parking lot. Shortening Hole No. 9 frees up space to provide a short game development area between the 9<sup>th</sup> green and eight (8) hitting bays. The spatial arrangement also has the potential to reduce the probability of golf balls leaving the course and entering the parking lot, thus improving one of the most bothersome safety concerns on the property.

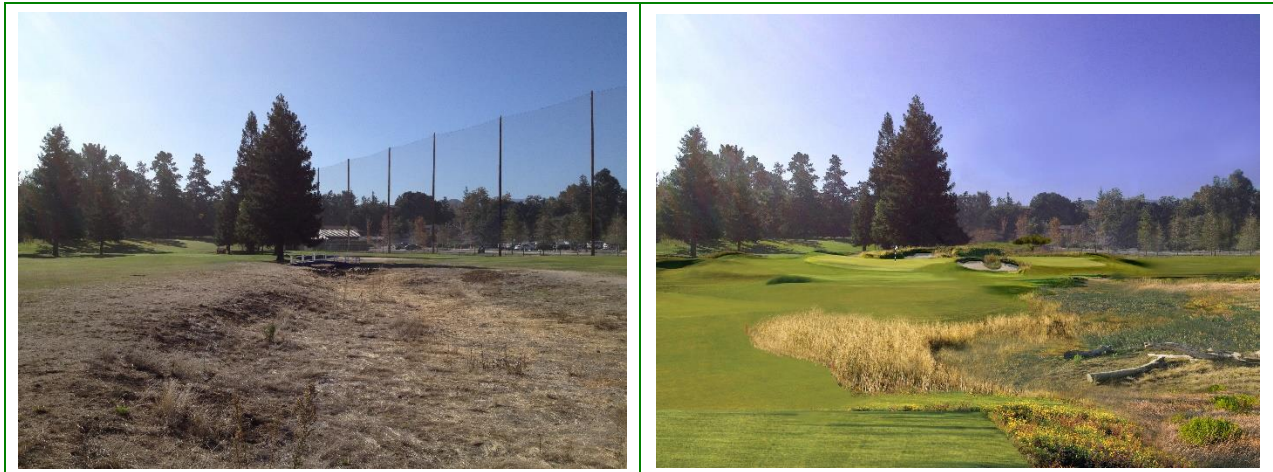
As of early 2022, the former pond is serving the purpose of dry detention. The former pond has been overtaken by the establishment of a variety of grasses and weeds, and resembles more of

a dry basin. Further work needs to be done to specify a more appropriate mix of wildflowers and/or native plant material to realize full environmental benefit. By converting the old pond areas to biofiltration basins, less water is required and maintenance can be aimed at greens, tees and playable areas of turf. Converting this area into a native lowland landscape is considered in the updated probable cost estimates.

These images depict potential “before” and “after” comparisons from the original 2014 report, showing the conversion of the old pond area to a natural “meadow” lowland area. While this specific view shows the conceptual view of Hole No. 8, it is also indicative of the transformation in landscape that could also be facilitated through turf reduction and native area establishment under the Minimal Repairs improvement plan.

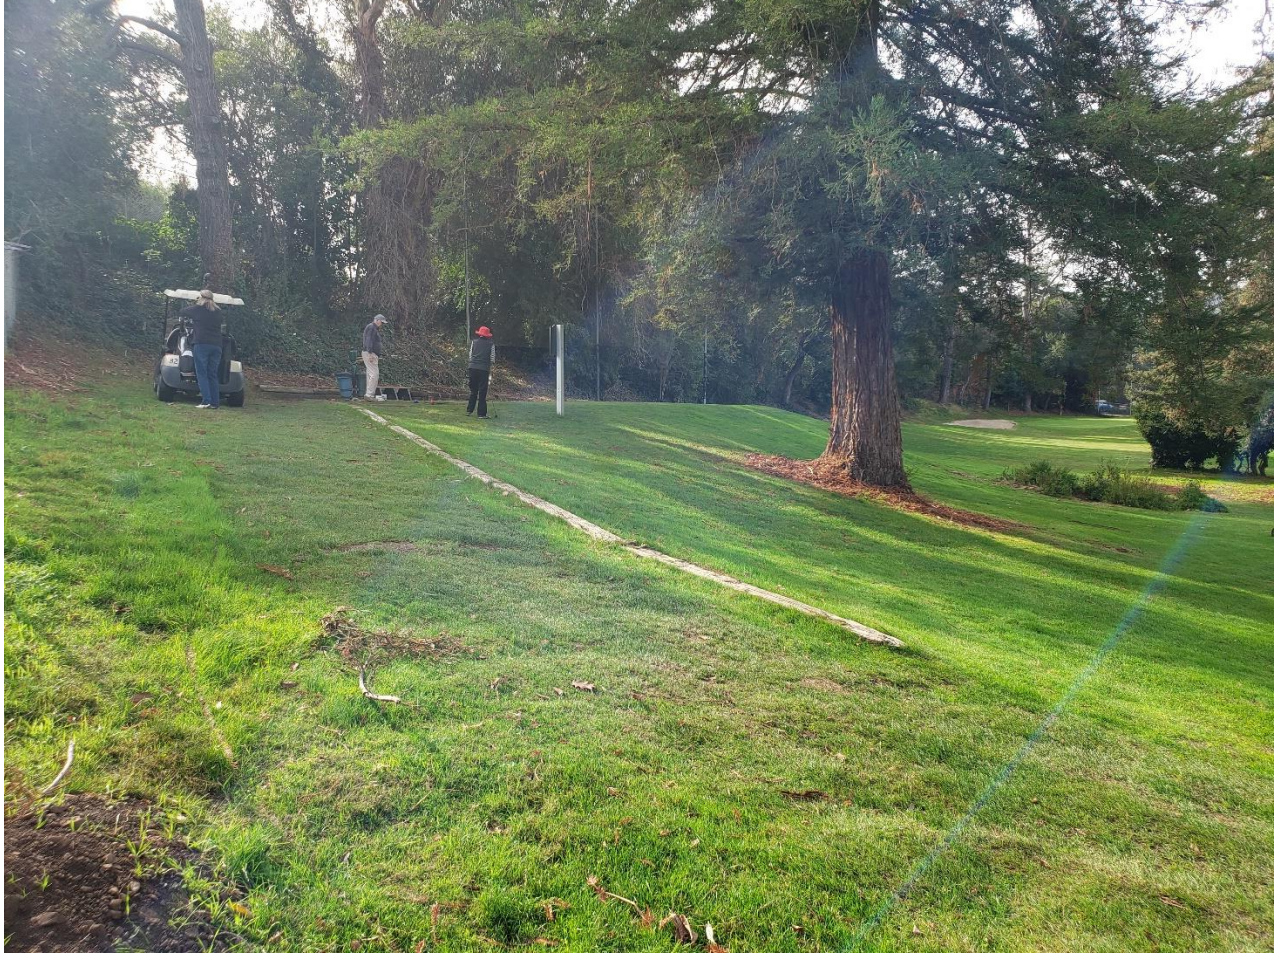
**Cart Paths:** The facility has 4 carts for patrons who are not able to walk the 9-hole course. Where paths are present (at just a few locations) they are narrow and not configured well. There is little compliance with ADA guidelines in terms of curbing or access. The cart paths, where present, are showing their age with declining functionality for their intended purpose. In addition, carts are expected to navigate the hill between Hole Nos. 3 and 4. This slope and informal path are difficult for people to navigate on foot, let alone by cart. Ground moisture and muddy conditions can make this a challenge, further adding to the wear and tear on the golf course, but more importantly presenting a potential accessibility and safety issue for golfers and patrons.

The absence of cart paths in general means guidelines for accessible ingress/egress from golf features, use of accessible routes, and accommodation for alternative cart usage is poor. (Guidelines for accessible golf courses can found in the separate attached report titled “Accessible Golf Courses” by the United States Access Board).

Our area of focus is on the golf course itself. To mitigate these conditions as noted, the approach assumed in the renovation/re-construction scope will be to create logical parking areas for a standard golf car (cart) at each tee and green with removal of any existing curbing, edge material, hedge or steps. Exceptions at tees may include steeper areas where steps or paths need to remain, but only in the event that an alternate tee is provided.

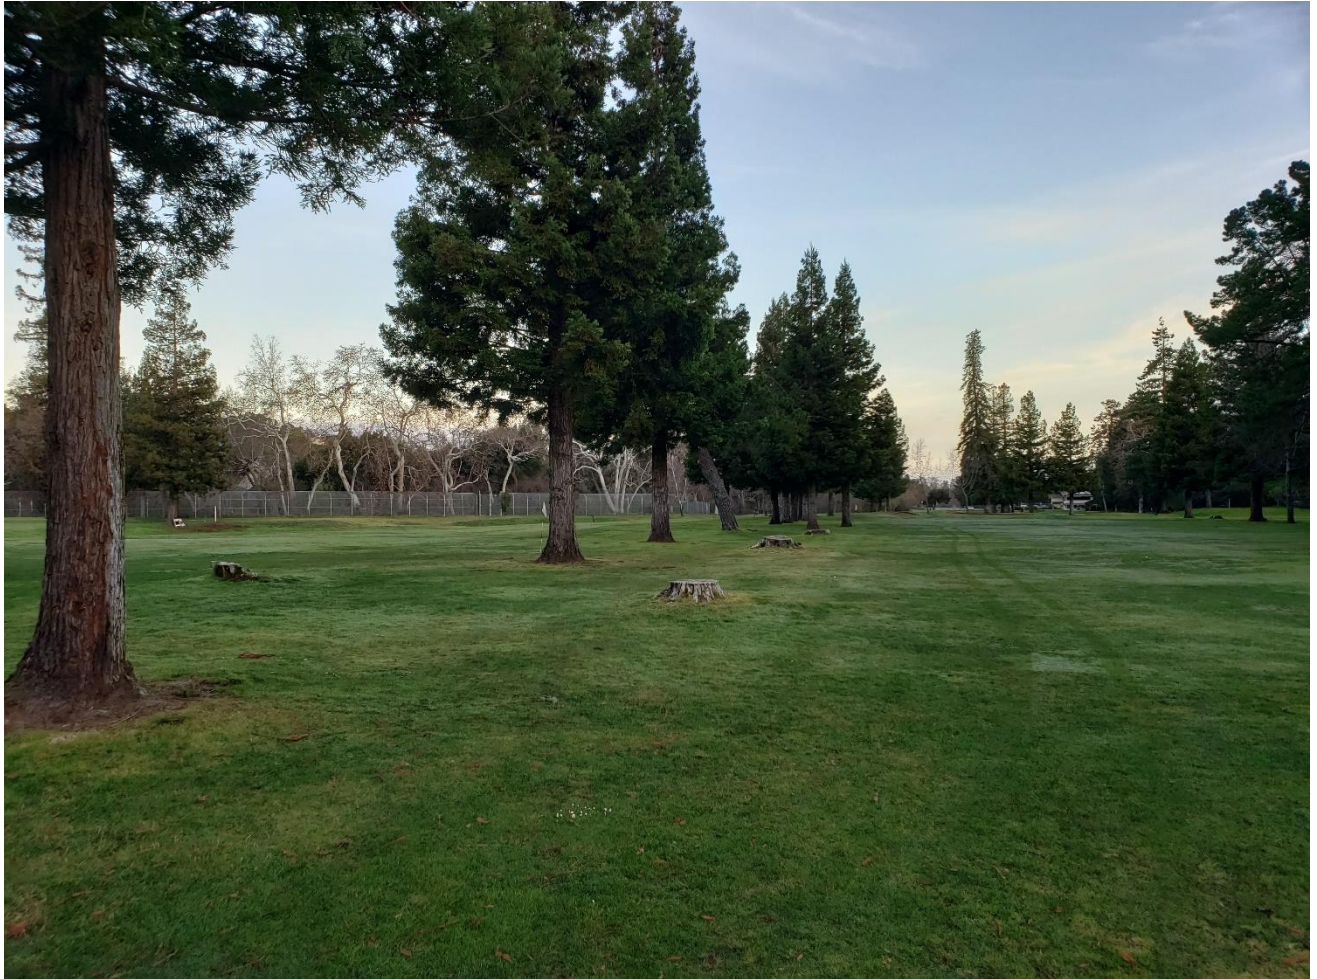
Where trees have been cut down, several stumps remain (see image below [Appendix C, Exhibit 3](#)). As of 2022, seventeen (17) sizable stumps remain, which has somewhat improved localized turf conditions. However, with stumps and root structure still intact, limiting the benefit to turf and golfer experience. If left in their current state some trees and/or the remaining stumps from removal may cause potential safety issues for golfers including but not limited to:

- If players hit their shot without being aware that persistent roots are just under the surface, they risk significant injury.
- Roots systems, if driven over, may cause loss of control with golf course or a tripping hazard for walkers.

- The remaining stumps present the possibility of ricocheting golf shots that may strike golfers on the same or adjacent holes.
- The presence of these root systems presents challenges to accessibility in general.

Minimal work is proposed under the minimal repair approach, with only certain areas to be considered. These include removal of tree stumps and roots - primarily for safety and efficient maintenance access and practices - and restoration of the abandoned pond areas with appropriate hydroseeding/planting, slope stabilization and drainage.

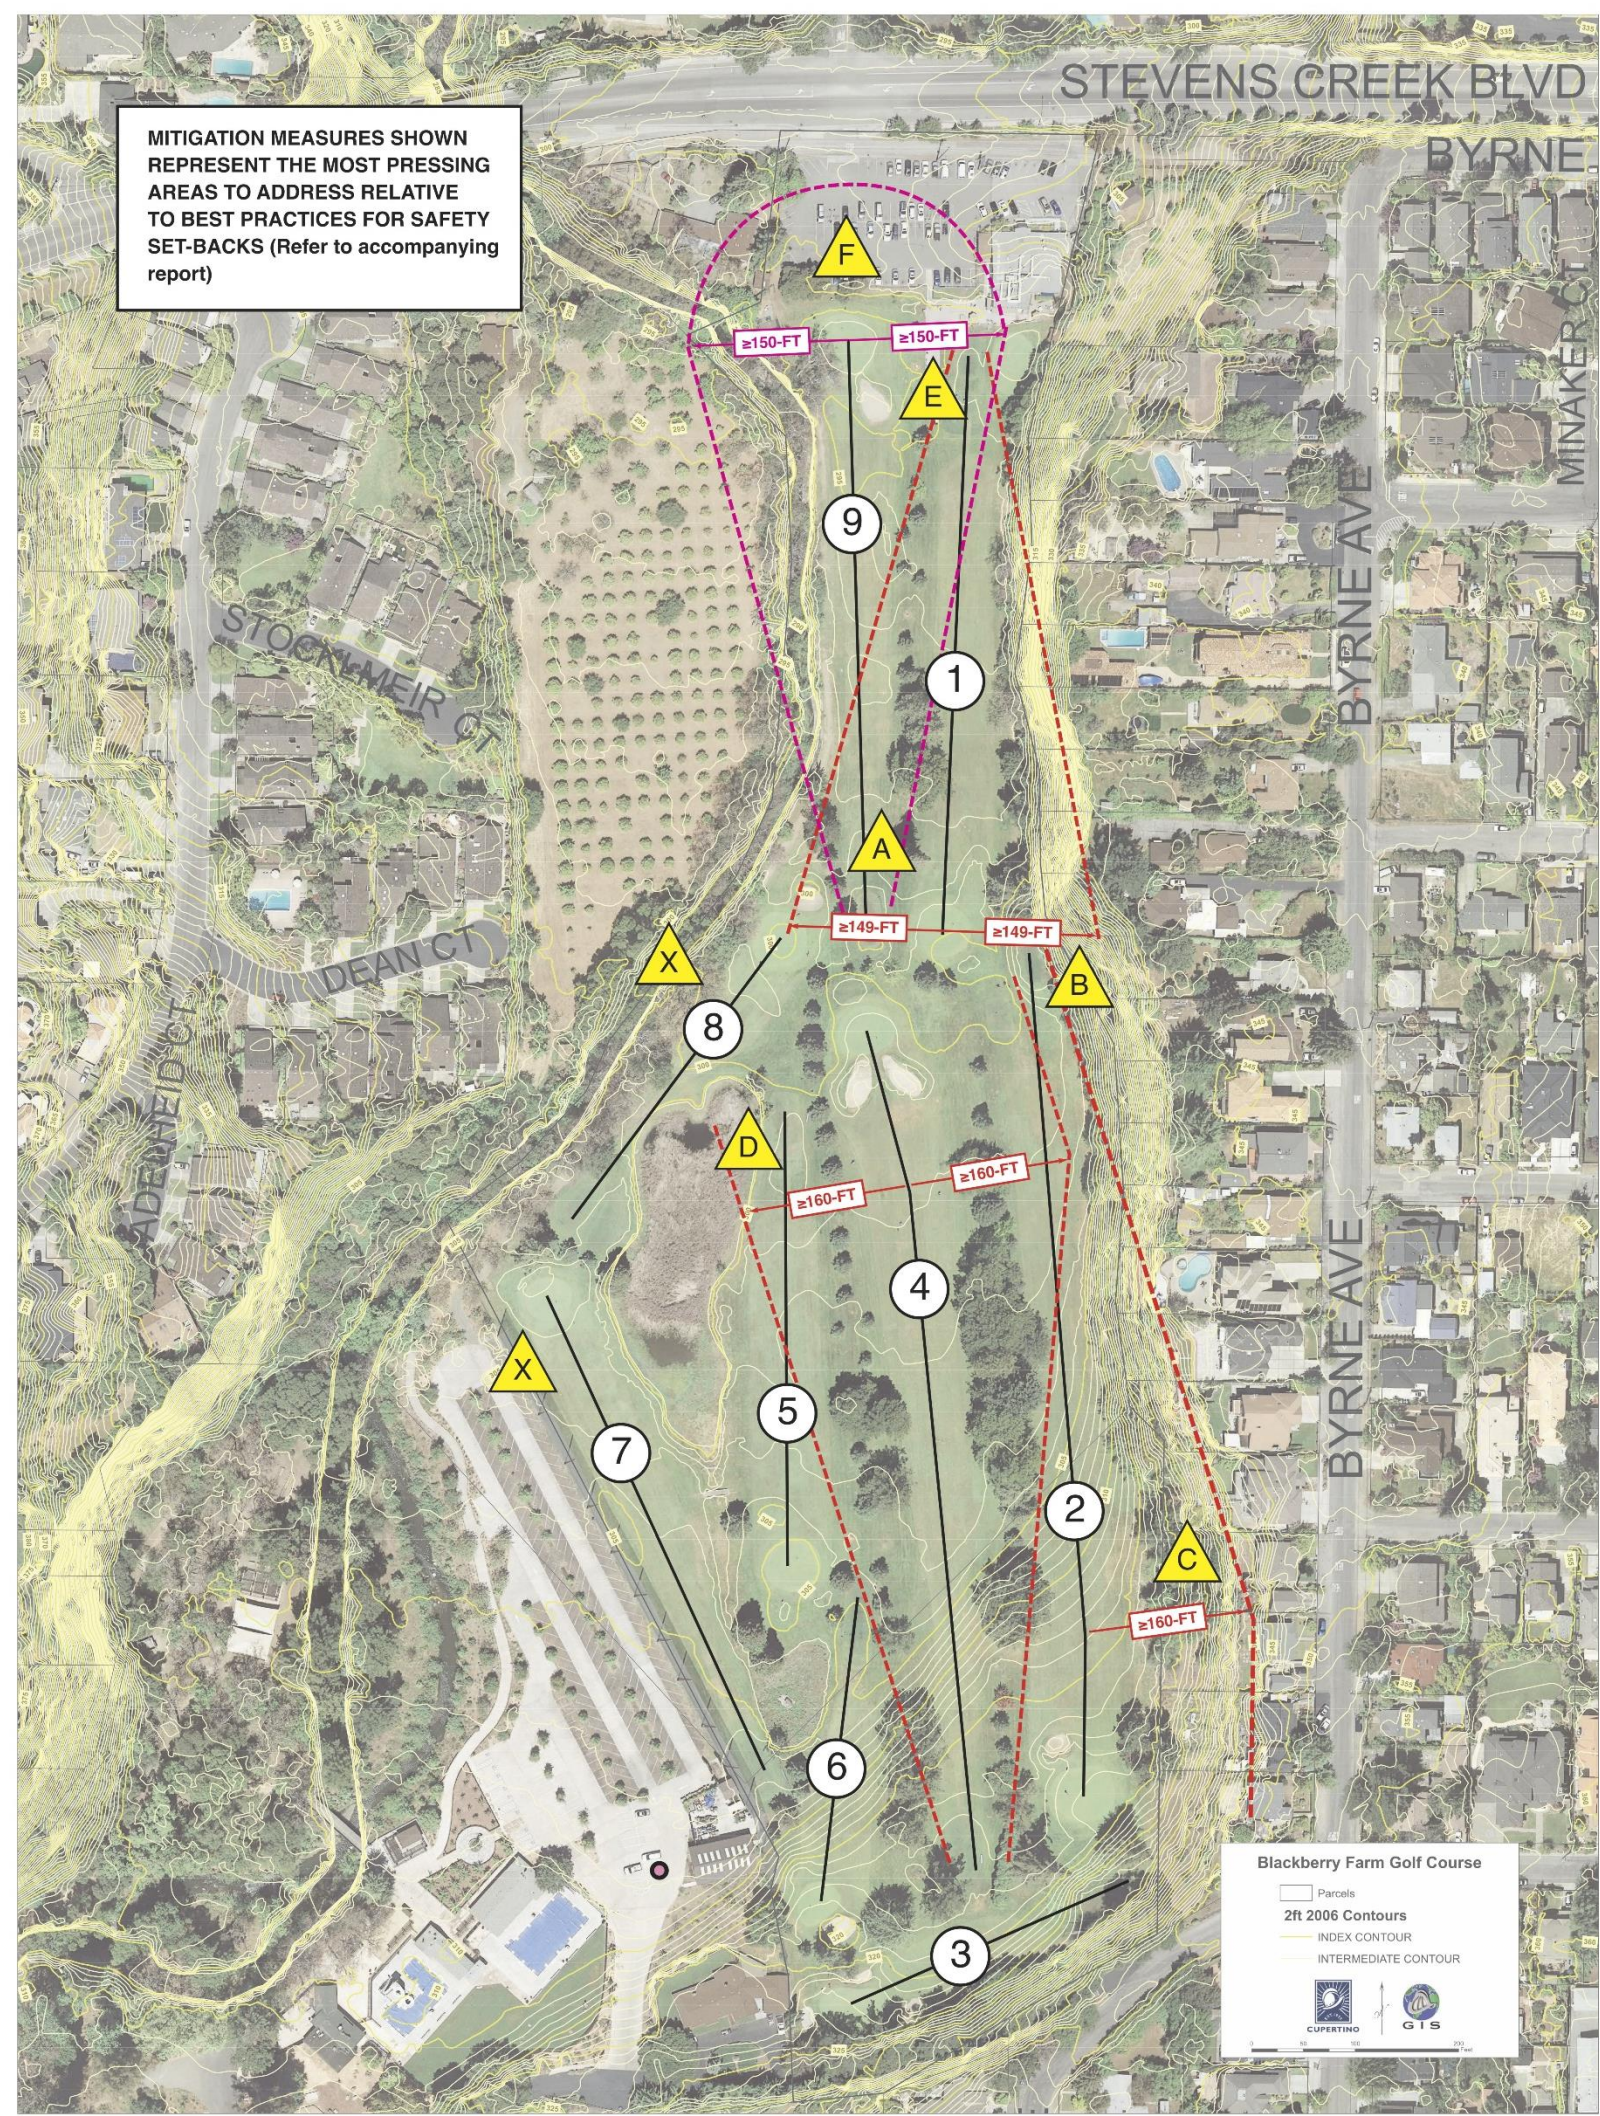
APPENDIX B – MINIMUM SAFETY SET-BACKS EXHIBIT

**Area A:** The tee shot at Hole No. 1 is  $\pm 186$  yards. A typical required minimum safety set-back to both sides the nominal center line is calculated at  $.8 \times$  the yardage, expressed in feet ( $186 \times .8 = 148.8$  feet). This dimension is shown on the exhibit. “A” references the primary area of concern, which is the tee of Hole No. 9. To the left of Hole No. 1 is private property where errant balls regularly fall. Because this area is a steep hillside and generally unused, it is assumed to be an existing condition without high priority to be mitigated.

**Area X:** Represents golf holes that are too close to neighboring park uses and trails, yet have been mitigated with screening, fences and/or netting. “J-fence” has been used successfully along the trail spans to protect trail users. Netting on higher poles has been used in other locations, but with limited success. In many areas netting has deteriorated. In other instances, it is not high enough to fully contain shots. These areas (“X”) are specifically removed from study as the City indicates that replacement screening will be handled under separate contracts and work.

The installation of nets between Hole Nos. 4 and 6, as proposed by the City under the Minimal Repairs improvement plan, does **not** adequately address existing set-back conflicts between Hole Nos. 4, 5 and 6. As shown on the safety exhibit, Hole No. 5 tees are in conflict with the tee shot at Hole No. 4. This is in addition to conflicts with the Hole No. 6 tees.

BLACKBERRY FARM GOLF COURSE  
MINIMUM SAFETY SET-BACKS

The minimum remediation measures outlined above and shown on the exhibit are only representative of the absolute measures identified by Mr. Richardson that the City should undertake to make the facility safer than it is presently. We recommend that a more comprehensive trajectory and errant ball study be performed prior to the City renovating the facility, and prior to investing in new, replacement screening. Such study will yield whether additional absolute measures are appropriate.

The best practices recommendation is to try and avoid any use of poles and netting and, in lieu of these vertical structures, to shift tees at Hole Nos. 4 and 5, nominally shortening both holes. This approach is anticipated to cost less than the investment of pole and netting, but will require further study and cost estimating to confirm. NGF Consulting does not recommend the mitigation measure as shown in the Probable Cost Estimate. The \$172,000 should be retained and applied toward the recommended best practices mitigation as described.

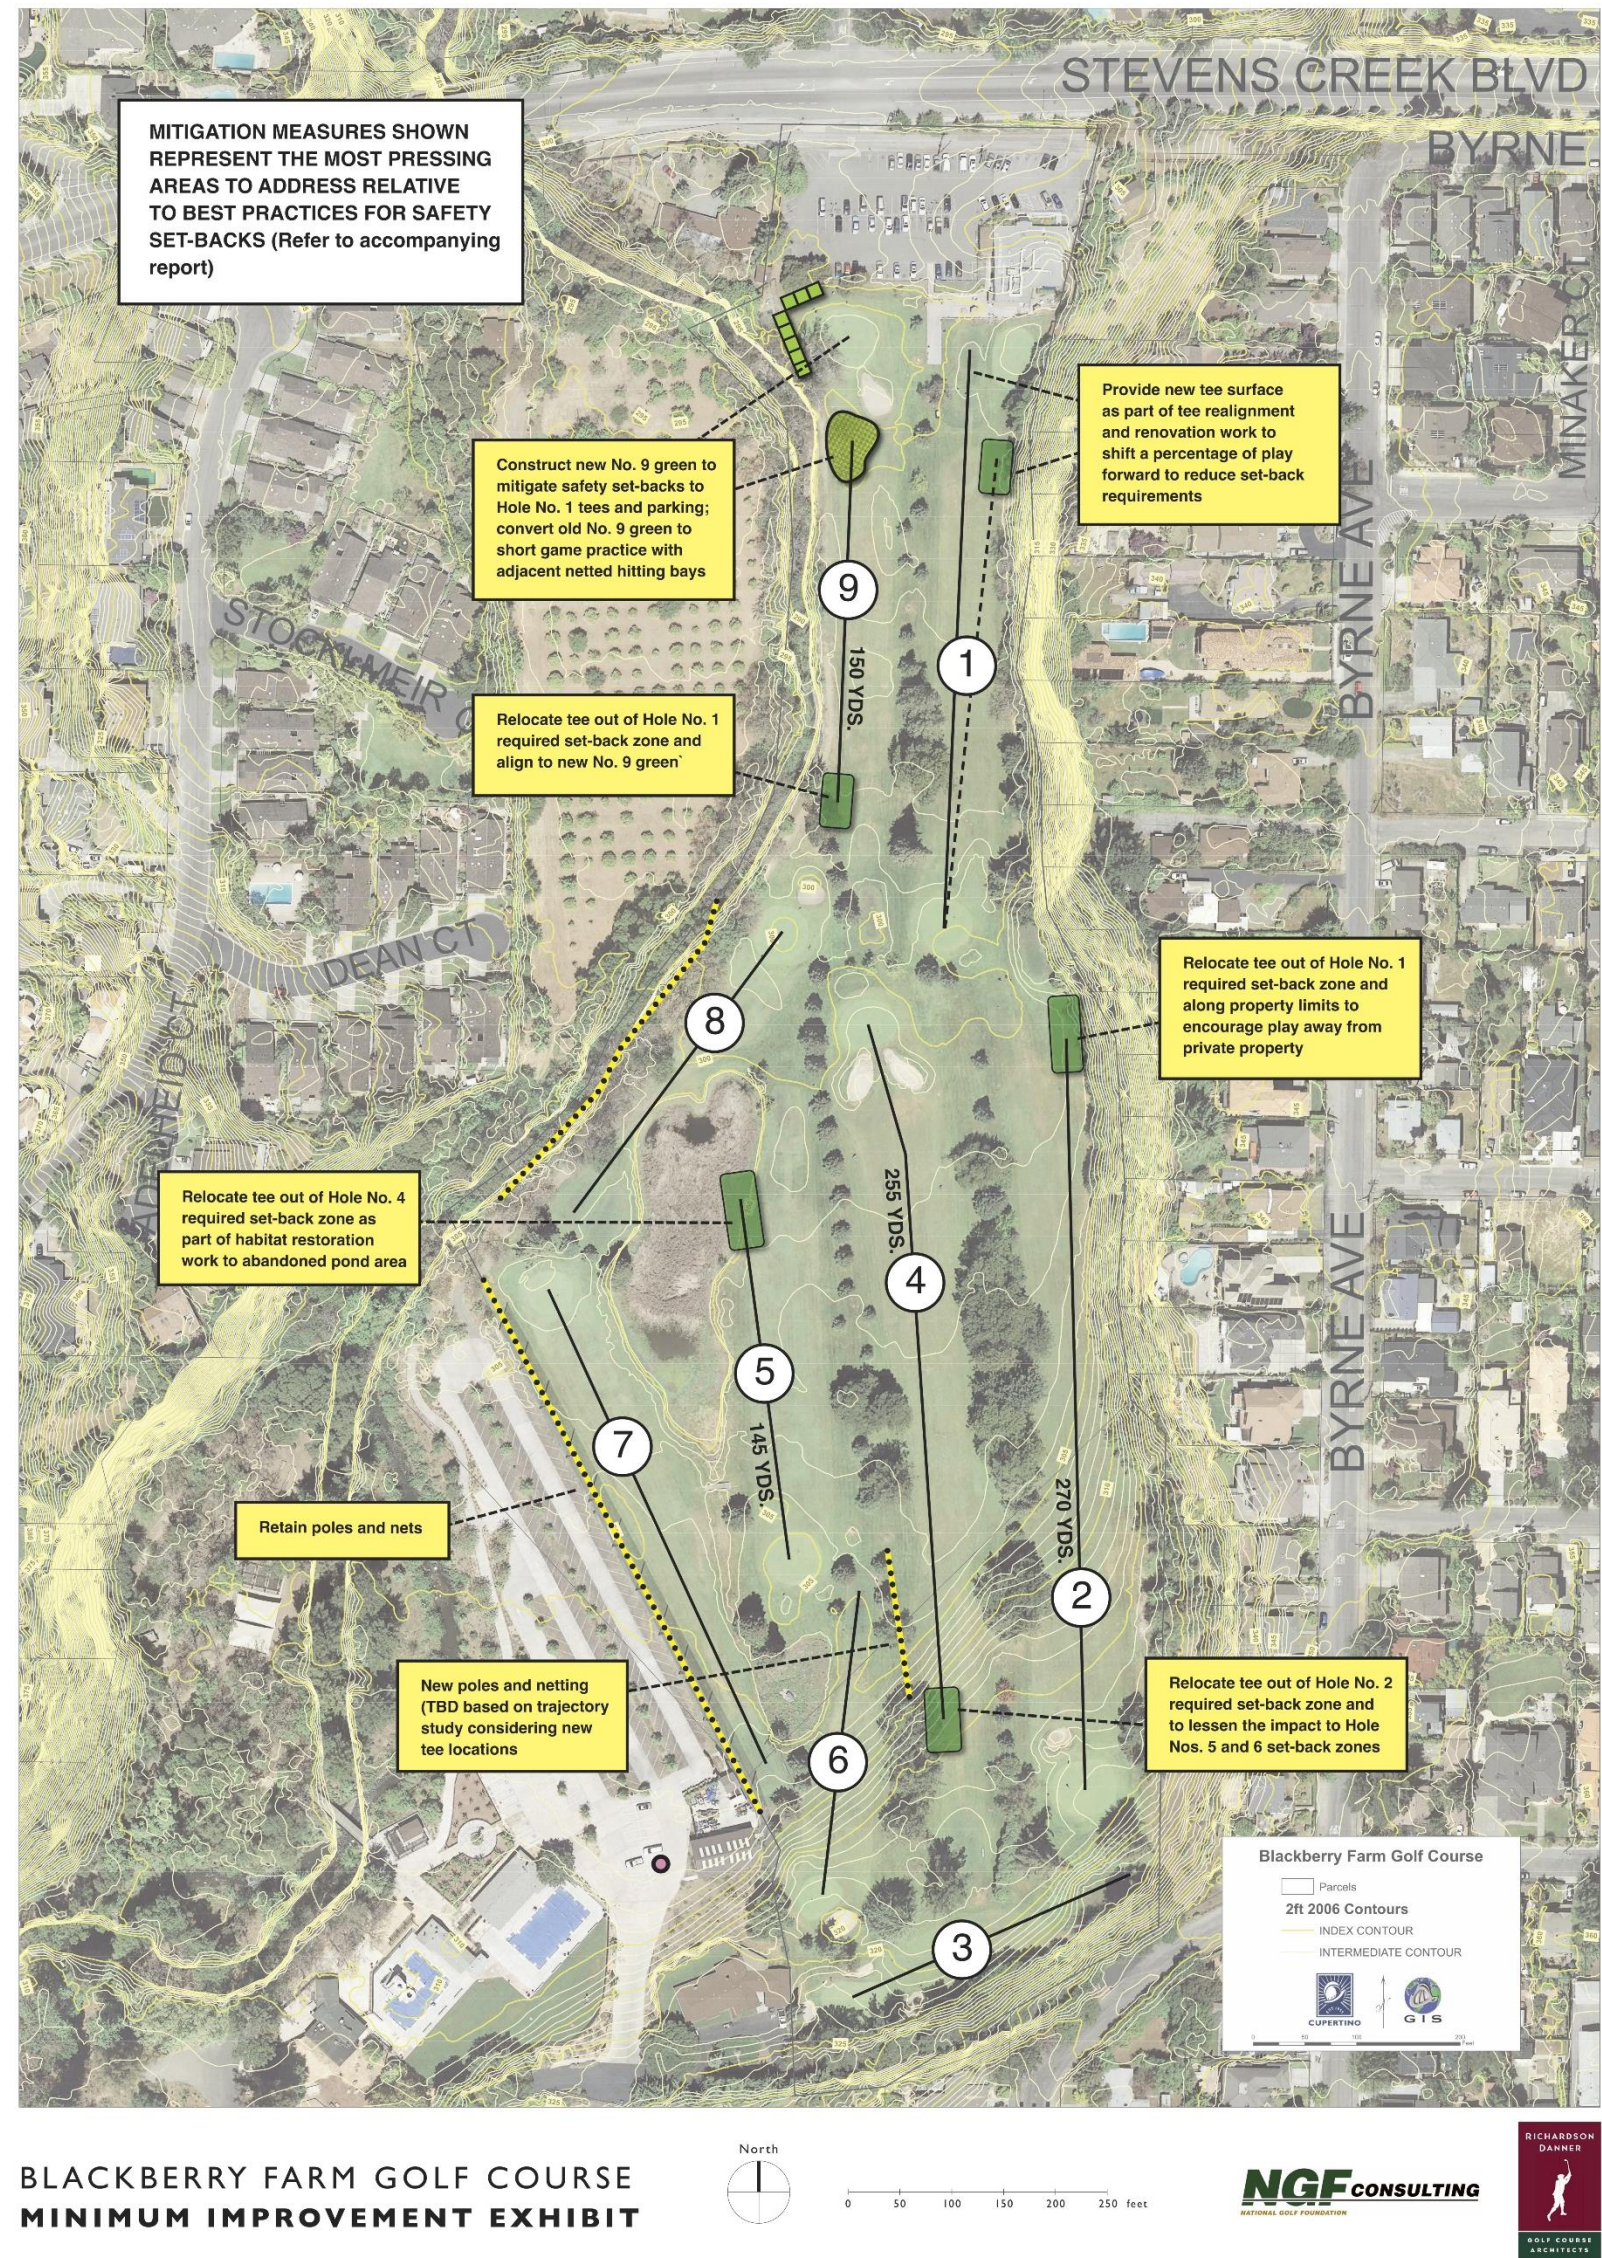
Exhibit 1 - Minimum Improvement Exhibit

The Minimum Improvement Exhibit proposes relocating the Hole No. 2 tee away from the Hole No. 1 set-back zone. Shifting the tee also angles play away from the property line to improve the conditions described in (B) and (C) above.
